Hazardous Materials Survey Report

Recreational Building Demolition Project

Green Hill School

December 24, 2018

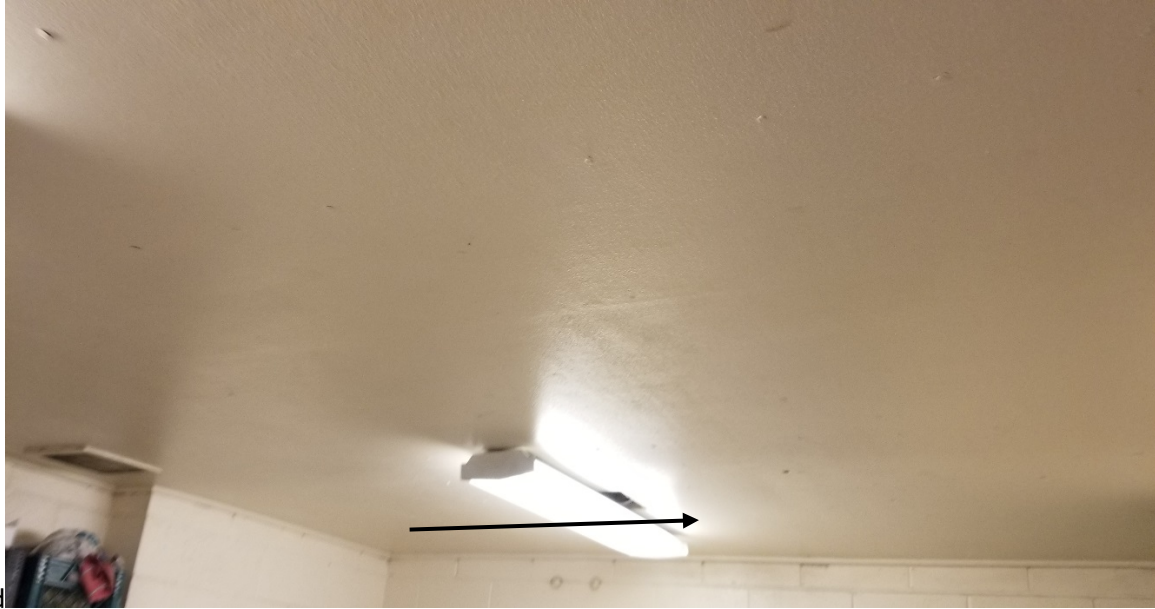
Typical ACM skim coat on GWB ceiling. Rm's 102 – 105, 112, 114 – 119, 120, & 122 – 126

PBS recommends that all exposed and concealed ACM to be impacted by the demolition be removed prior to construction activities. A qualified Washington State licensed asbestos abatement contractor should be employed to remove all such ACM according to applicable local, state and federal regulations.

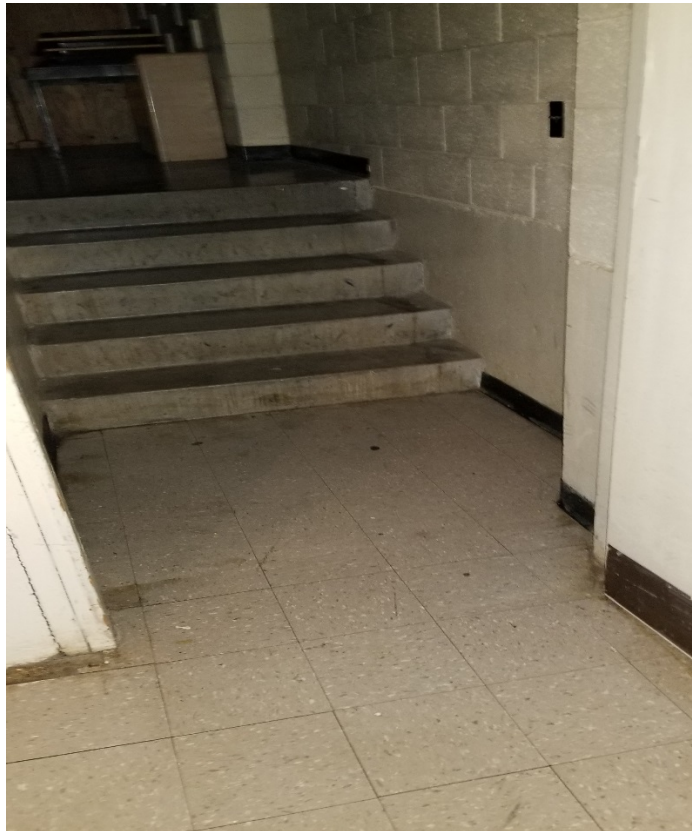
Typical 9" Light Brown vinyl tile. The mastic is non-ACM. Lobby of Restroom SE off Gym, Rm 108 – 111, Rm 114, Rm 116, & Rm 117

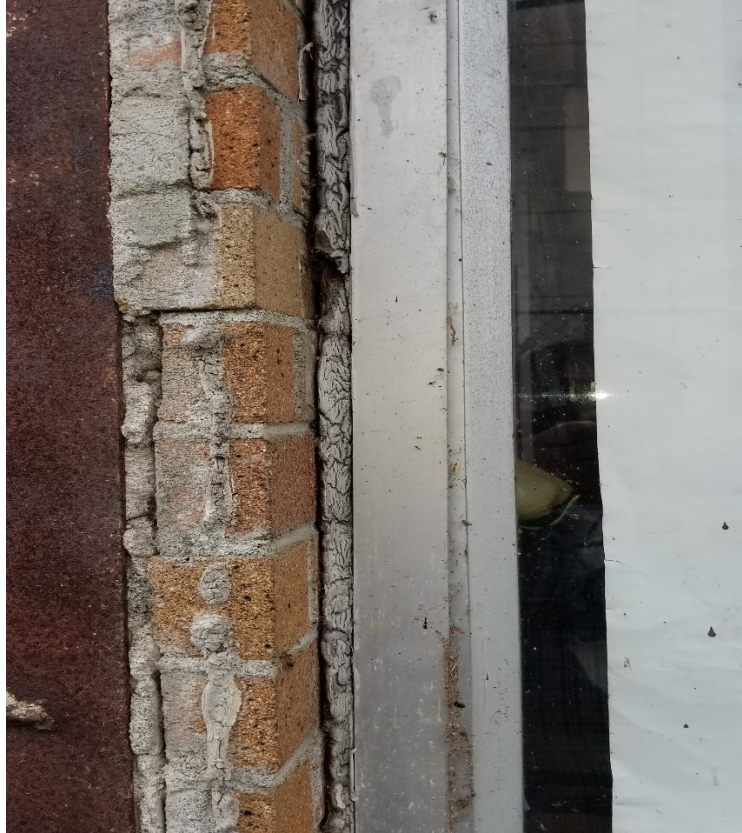
Exterior ACM window frame caulk. Northeast corner of building at Rec. Manager's Office

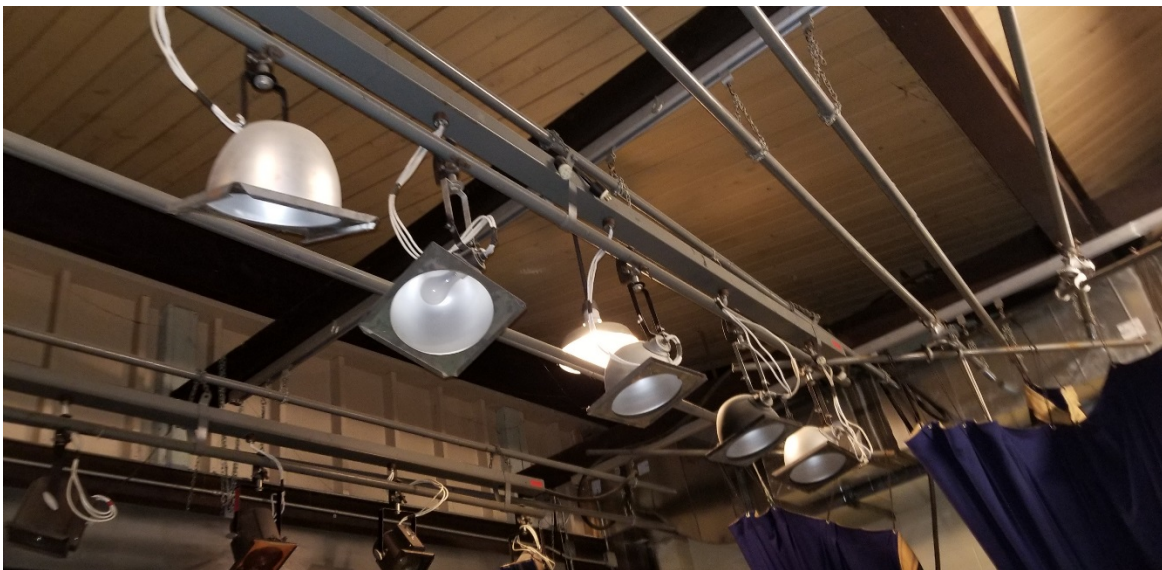
Presumed ACM white insulation on stage light wiring.
