# FIRE DEPARTMENT BUILDING UPDATE

FEBRUARY 11, 2019

# BUILDING “STRUCTURAL SYSTEMS” UPDATE

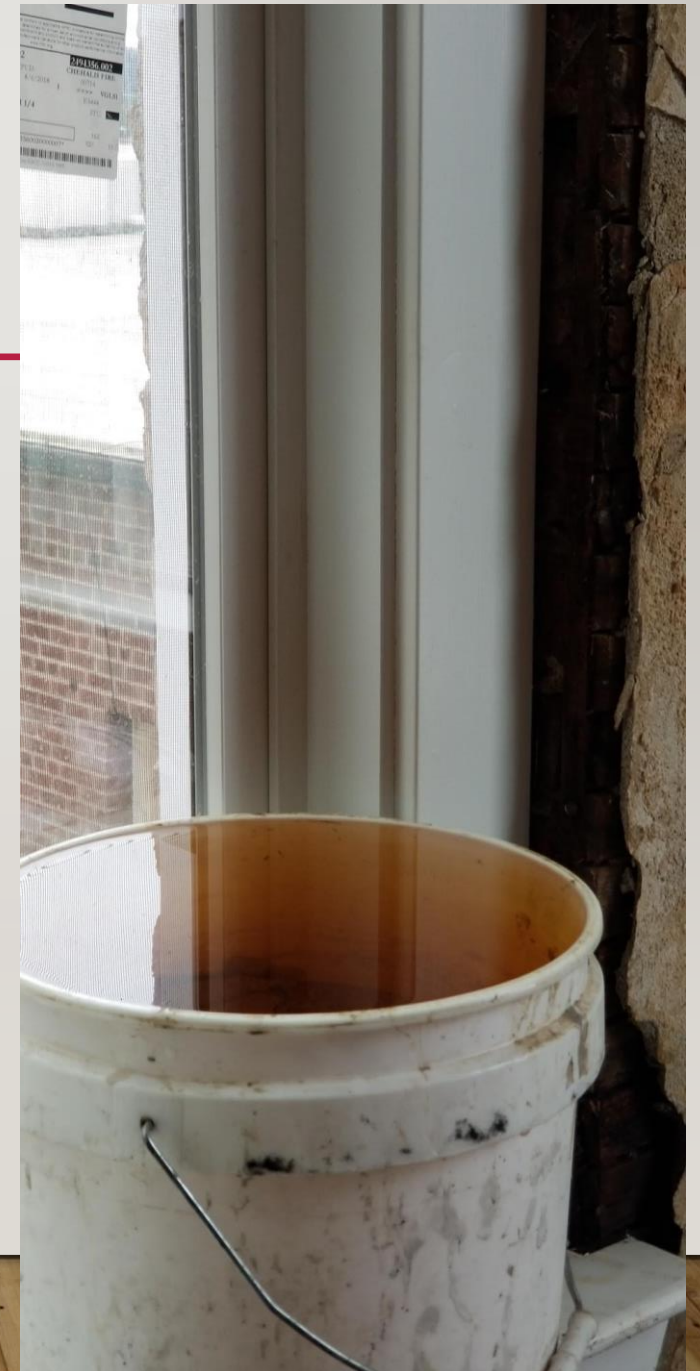
- During 2017/2018 winters, additional roof problems began occurring after the roof replacement project (completed about 5 years ago?)
- In August, 2018 a contractor making improvements to the building created a situation where the building had to be vacated due to presence of airborne asbestos
- City Determined Costs to Improve Building will actually cost much more than anticipated.

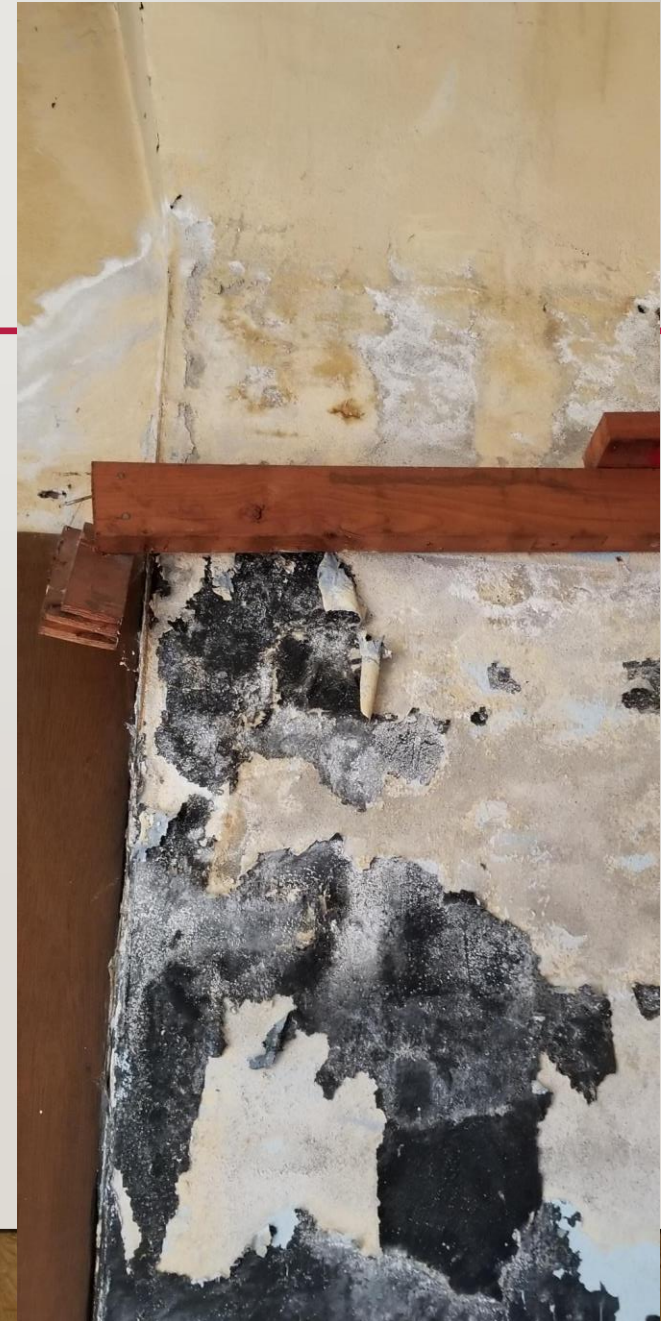
- With known conditions of exposed structural components, it is “reasonable to assume”:
  - It is likely that additional deficiencies will be discovered when architectural coverings are removed to improve known deficiencies

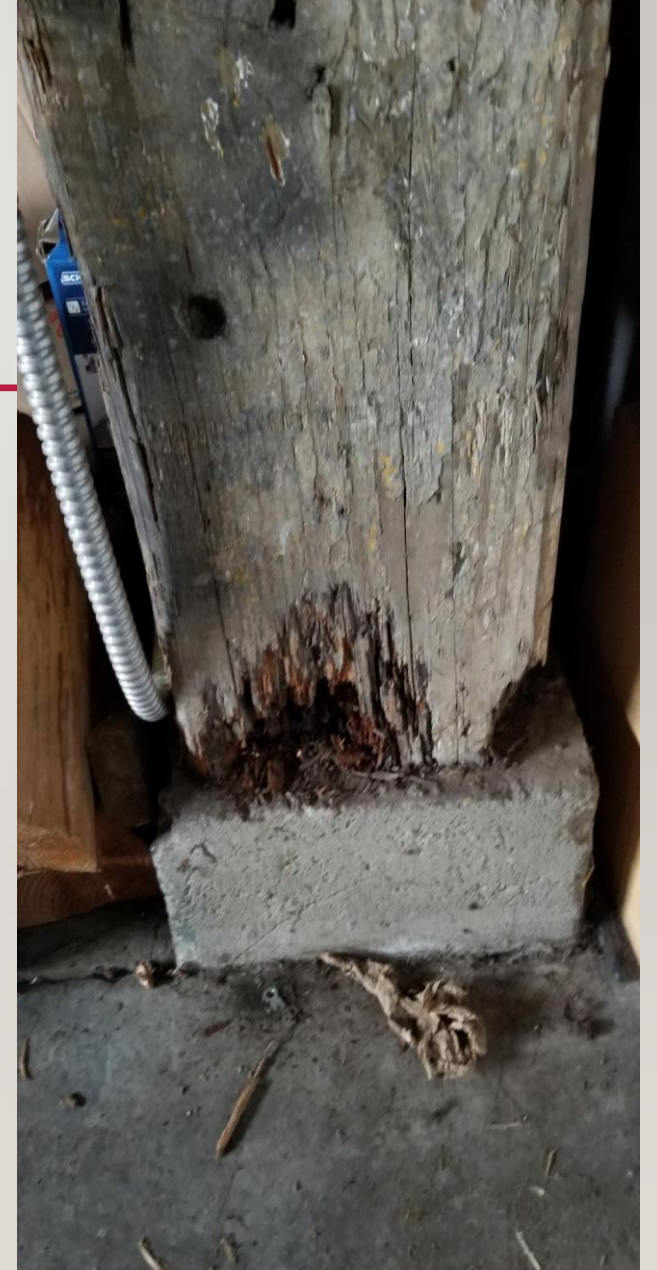
- Roof Structure

- Significant corrosion is present in the steel reinforcing angle at the side of the second floor window adjacent to roof leak.
  - Constant saturation has weakened the mortar joints in the vicinity of the leak
  - Condition of the wood roof and floor framing in the vicinity of the leaks have likely been compromised by degradation due to wood rot.
  - Staining on skip sheathing observed on Auditorium roof rafters
    - Indication of prolonged leaks
    - High potential for degradation due to wood rot in the skip sheathing and roof framing.

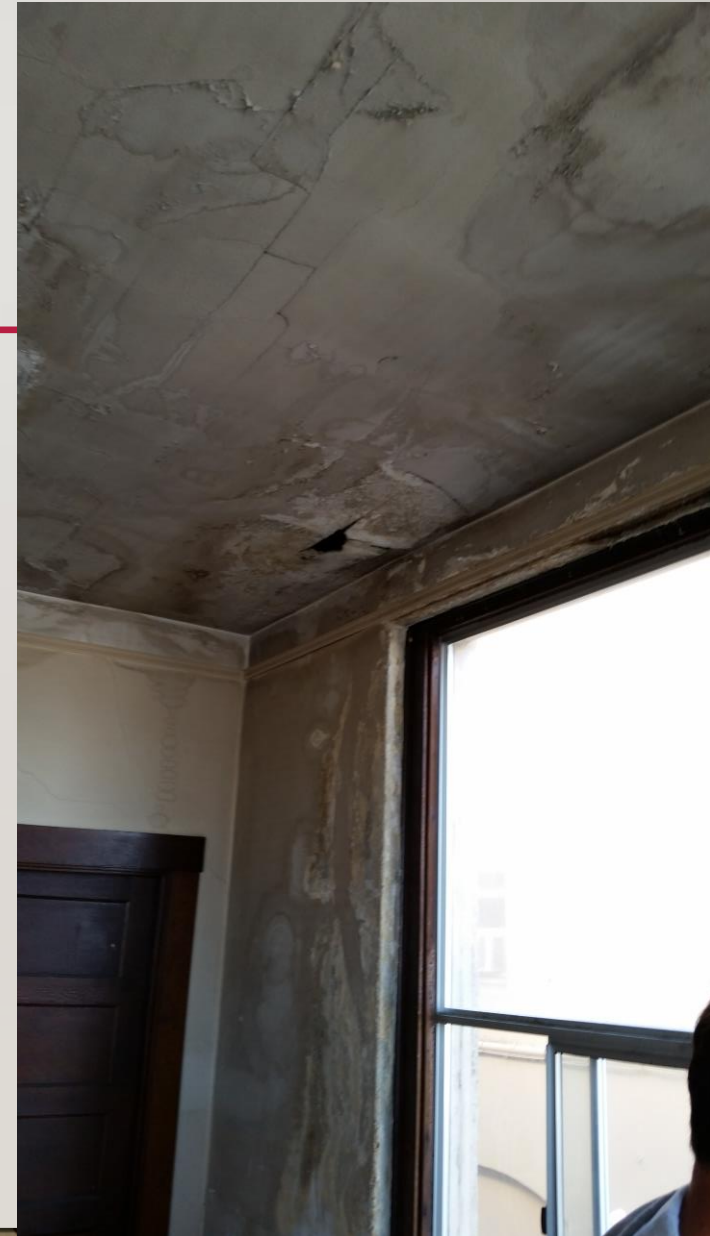
- Main Structure

- Does not appear to be any positive connections (bolts or lag screws) between the steel wide flange (WF) beams, the girders, or the columns.
- The roof and floor girders are supported on the URM masonry pilasters with beam pockets without the benefit of positive connections such as seismic straps or bolts.
- Plaster and lath ceilings have failed due to saturation
- T-Bar ceilings have recently failed

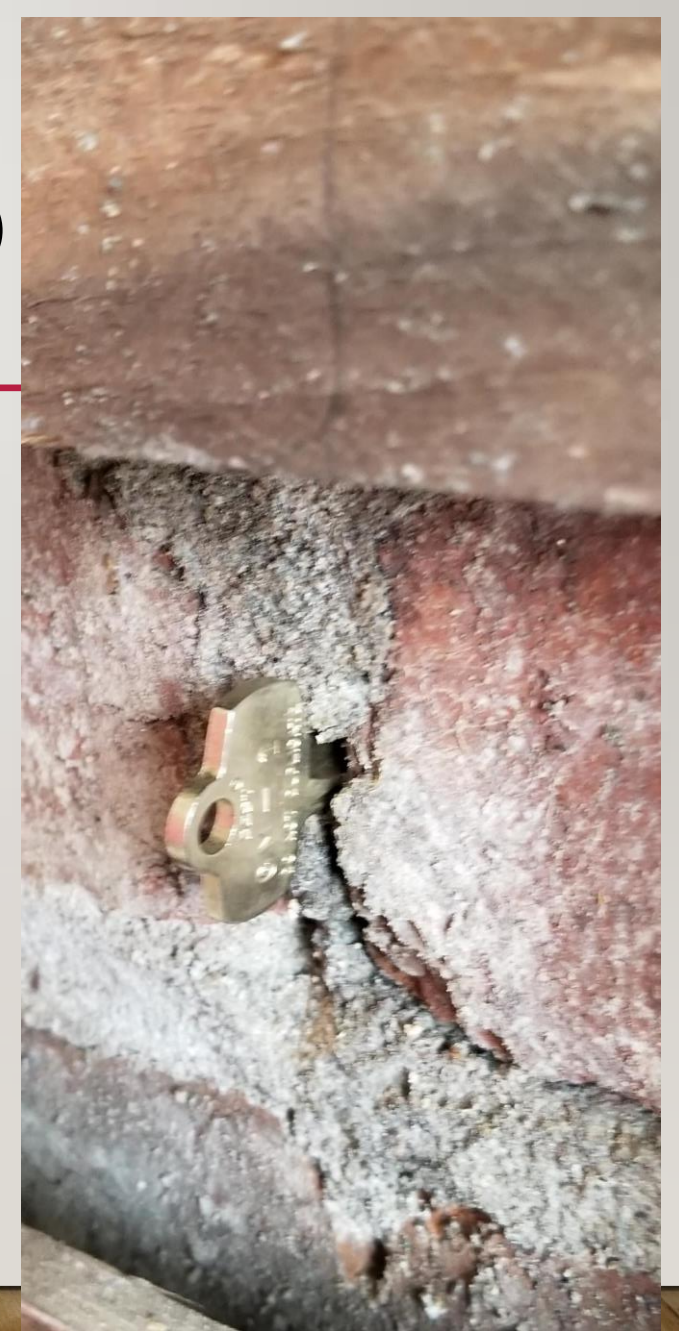
- Main Structure (Cont.)
  - Longitudinal shrinkage cracks exceed more than 1/3 depth of member – effects structural capacity
  - Stairway guardrail is loose and failing
  - Masonry and mortar rot/degradation
