PRELIMINARY GEOTECHNICAL ENGINEERING EVALUATION

Kroger (Fred Meyer) Chehalis Property Distribution Center Complex
Jackson Highway & Rush Road
Chehalis, Washington

Project No. 2424-17-005.01

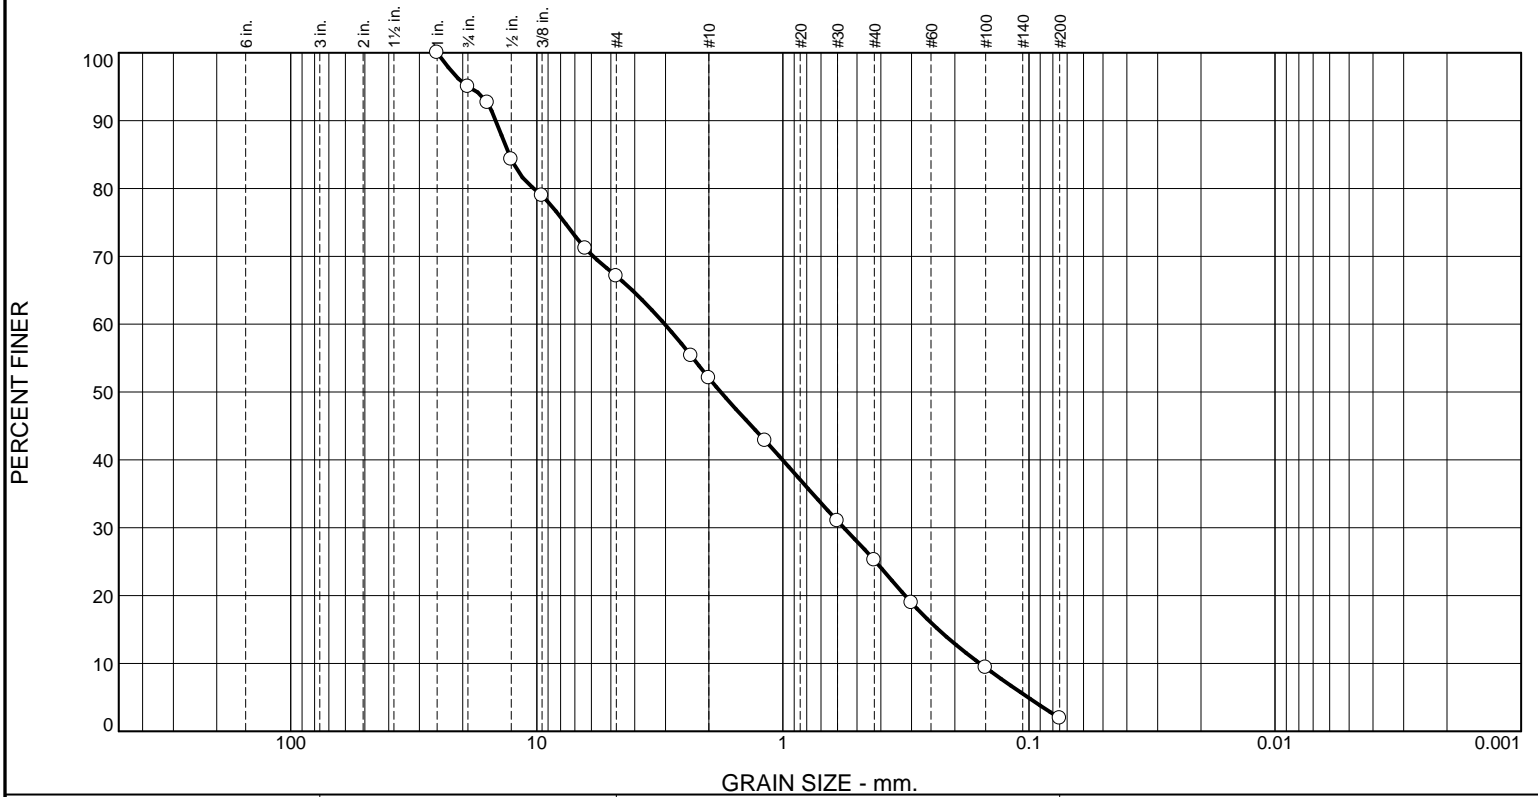
Particle Size Distribution Report

% +3"	% Gravel		% Sand			% Fines	
	Coarse	Fine	Coarse	Medium	Fine	Silt	Clay
0.0	5.0	27.9	15.0	26.9	23.3	1.9

SIEVE SIZE	PERCENT FINER	SPEC.* PERCENT	PASS? (X=NO)
1"	100.0		
3/4"	95.0		
5/8"	92.6		
1/2"	84.3		
3/8"	79.0		
1/4"	71.2		
#4	67.1		
#8	55.4		
#10	52.1		
#16	42.8		
#30	31.0		
#40	25.2		
#50	18.9		
#100	9.4		
#200	1.9

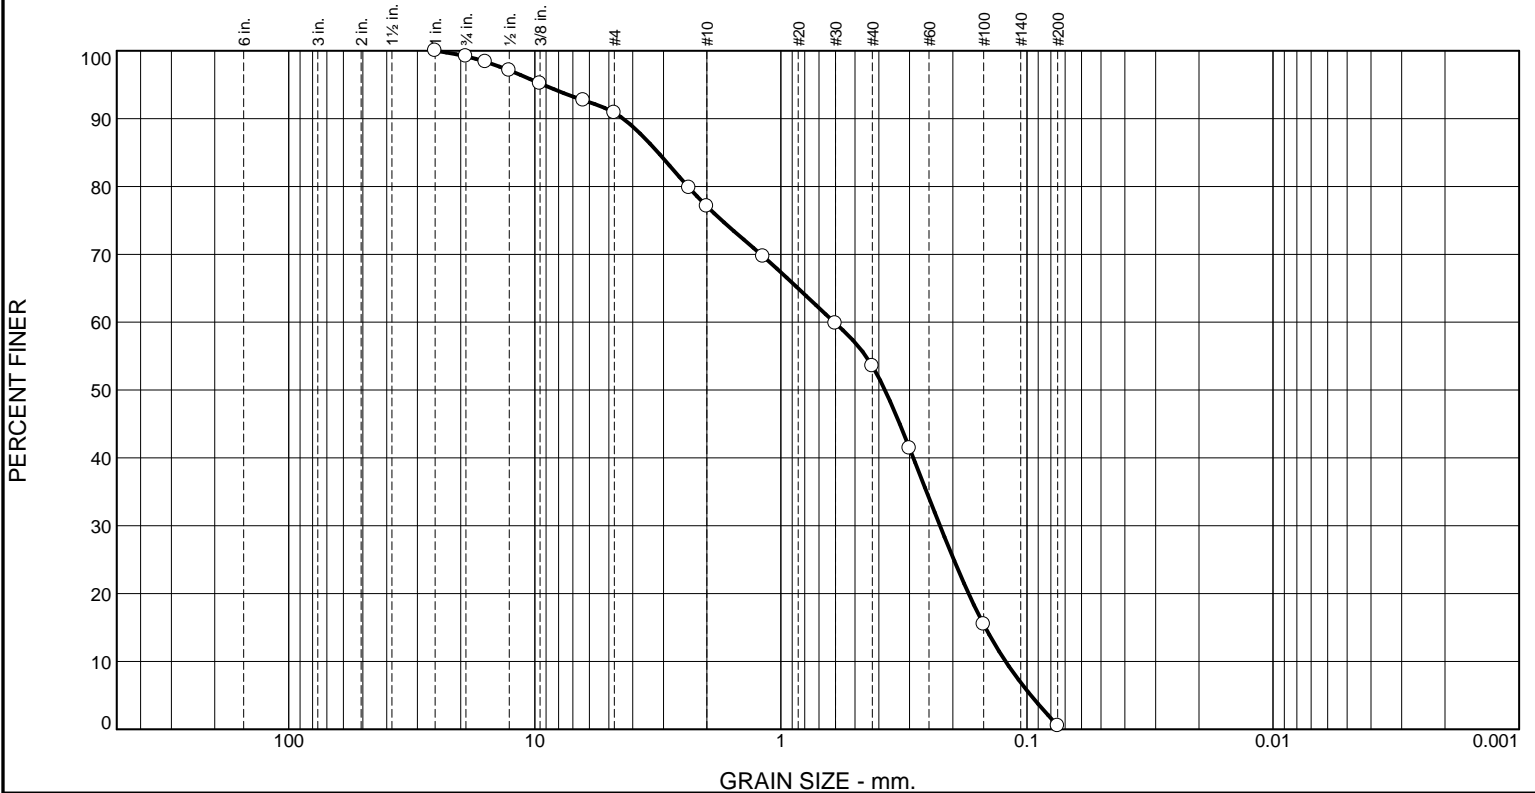
Particle Size Distribution Report

% +3"	% Gravel		% Sand			% Fines	
	Coarse	Fine	Coarse	Medium	Fine	Silt	Clay
0.0	0.8	8.3	13.8	23.6	53.0	0.5

SIEVE SIZE	PERCENT FINER	SPEC.* PERCENT	PASS? (X=NO)
1"	100.0		
3/4"	99.2		
5/8"	98.4		
1/2"	97.1		
3/8"	95.2		
1/4"	92.7		
#4	90.9		
#8	79.8		
#10	77.1		
#16	69.7		
#30	59.8		
#40	53.5		
#50	41.4		
#100	15.5		
#200	0.5

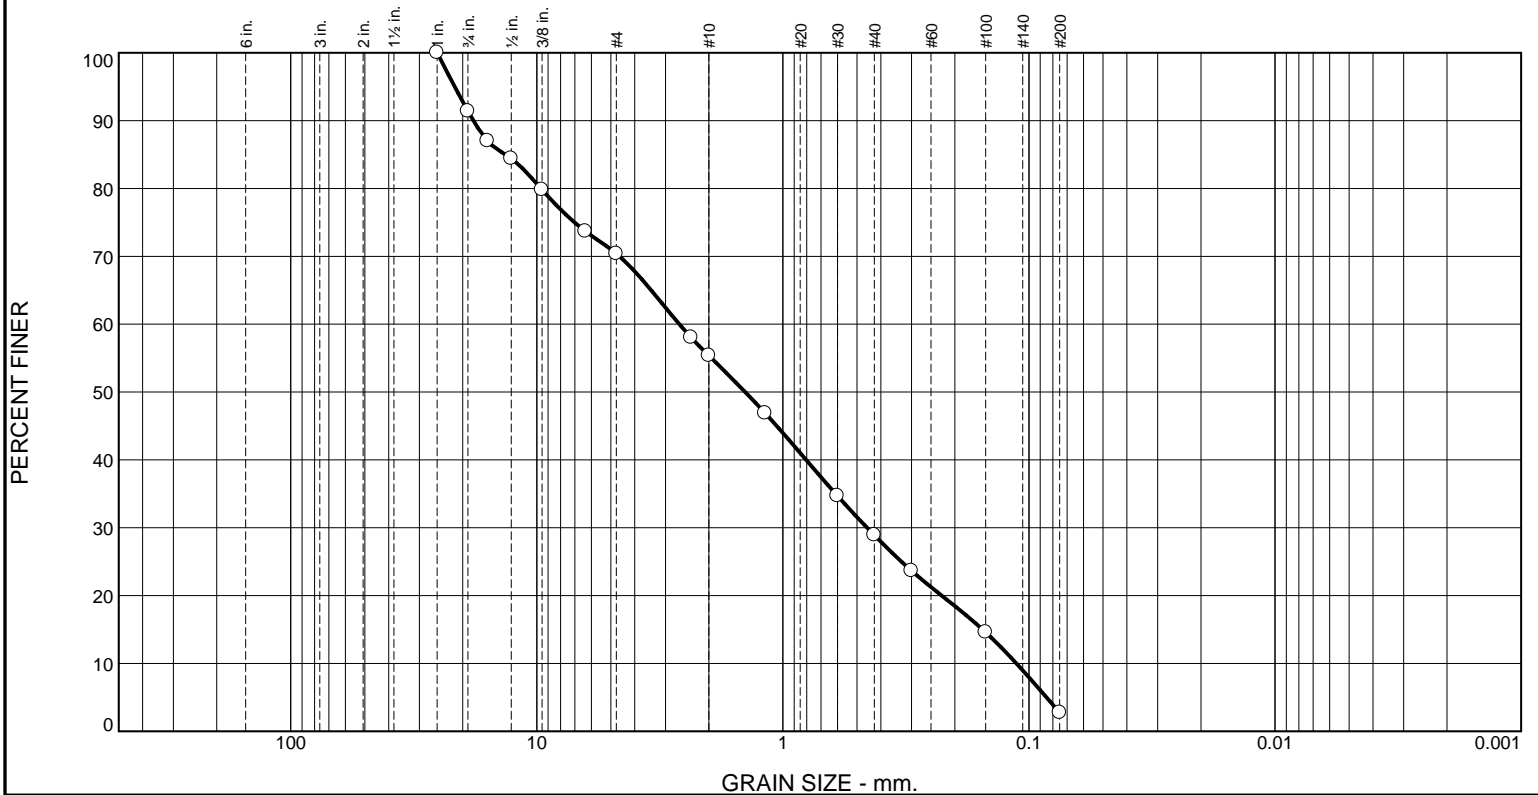
Particle Size Distribution Report

% +3"	% Gravel		% Sand			% Fines	
	Coarse	Fine	Coarse	Medium	Fine	Silt	Clay
0.0	8.6	21.0	15.0	26.5	26.2	2.7

SIEVE SIZE	PERCENT FINER	SPEC.* PERCENT	PASS? (X=NO)
1"	100.0		
3/4"	91.4		
5/8"	87.0		
1/2"	84.4		
3/8"	79.8		
1/4"	73.7		
#4	70.4		
#8	58.0		
#10	55.4		
#16	46.9		
#30	34.7		
#40	28.9		
#50	23.7		
#100	14.6		
#200	2.7

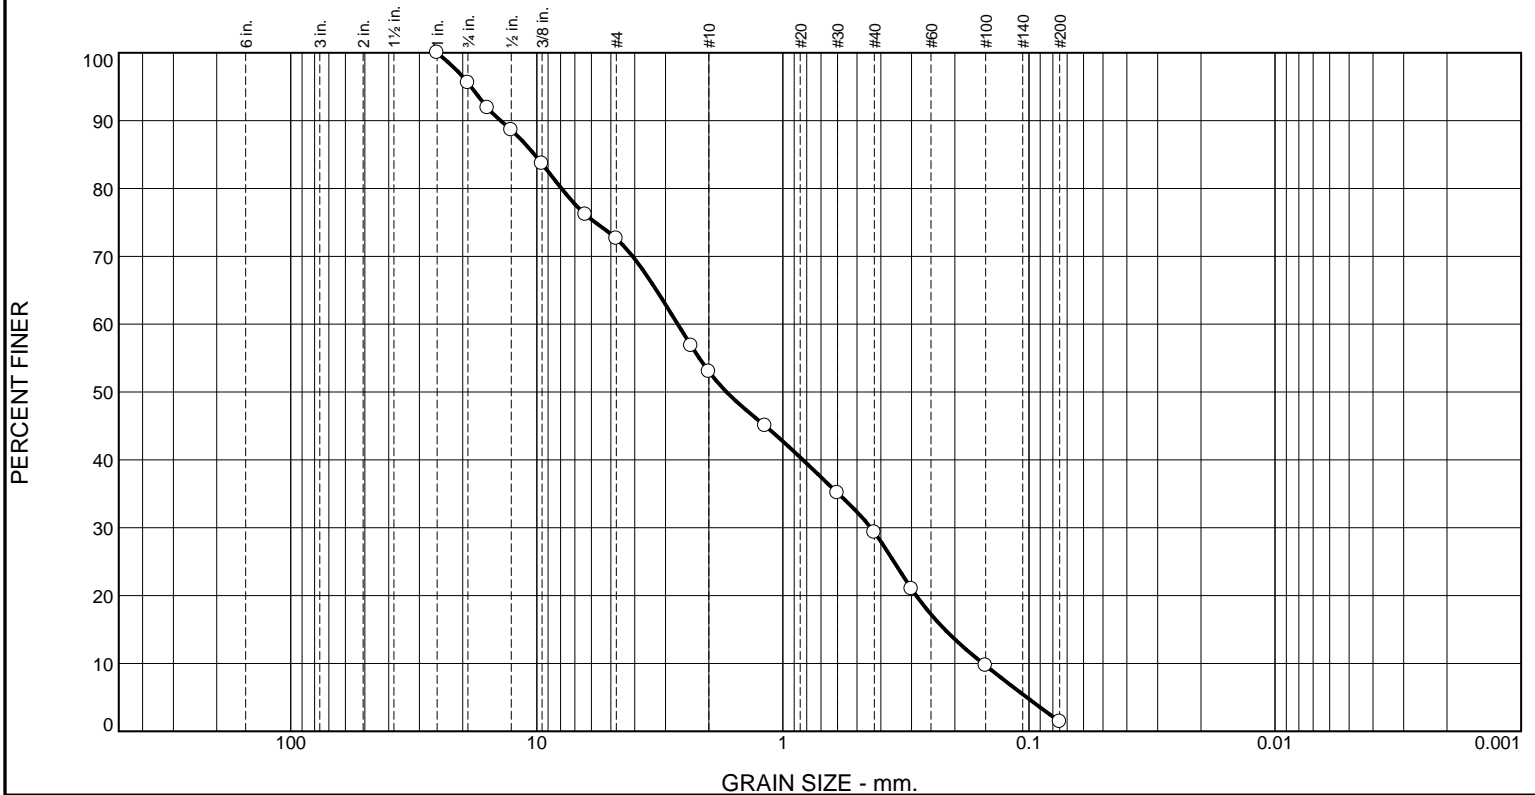
Particle Size Distribution Report

% +3"	% Gravel		% Sand			% Fines	
	Coarse	Fine	Coarse	Medium	Fine	Silt	Clay
0.0	4.4	23.0	19.6	23.7	27.9	1.4

SIEVE SIZE	PERCENT FINER	SPEC.* PERCENT	PASS? (X=NO)
1"	100.0		
3/4"	95.6		
5/8"	91.9		
1/2"	88.6		
3/8"	83.7		
1/4"	76.1		
#4	72.6		
#8	56.8		
#10	53.0		
#16	45.0		
#30	35.1		
#40	29.3		
#50	21.0		
#100	9.7		
#200	1.4

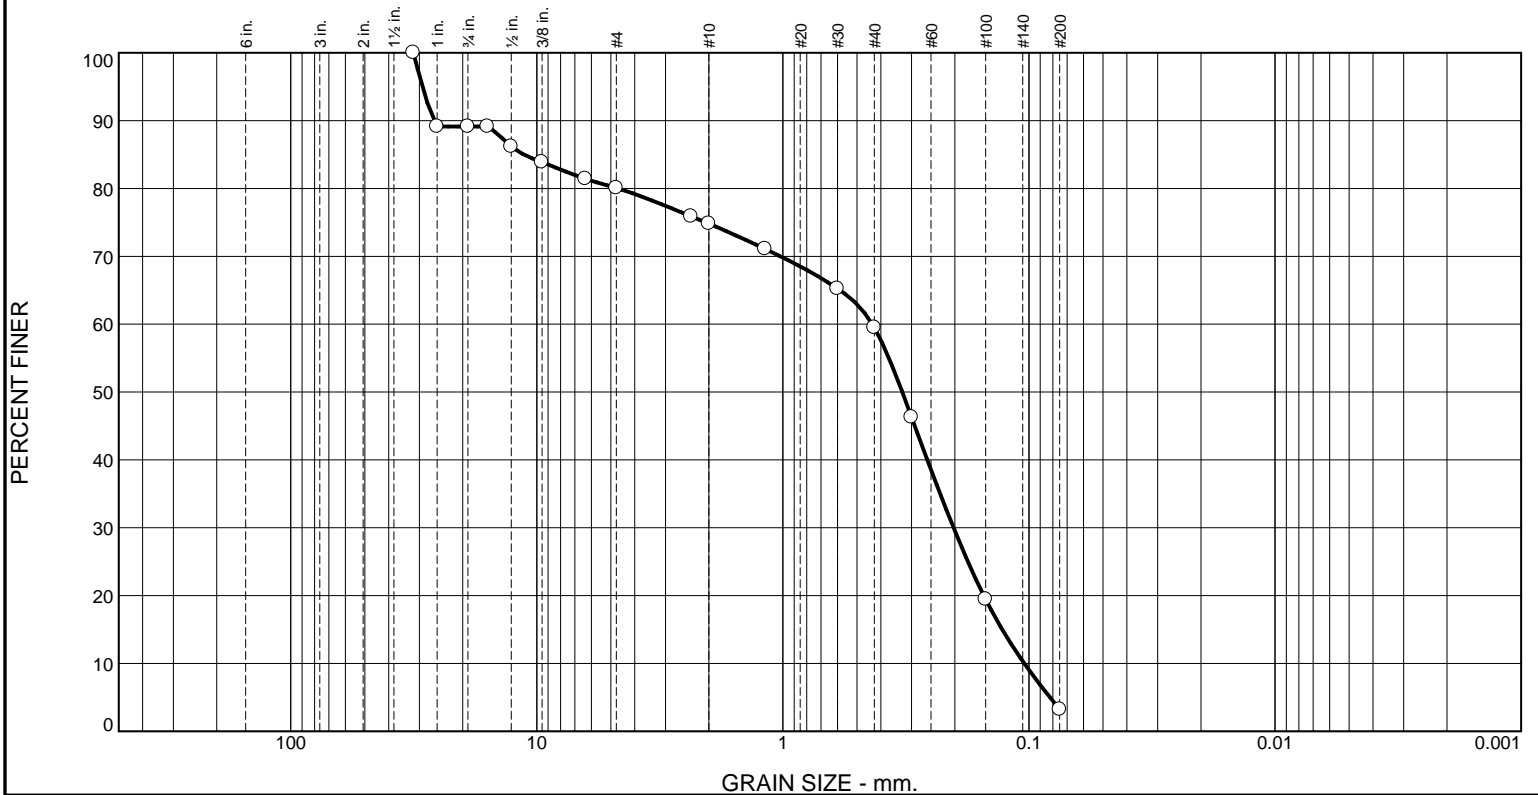
Particle Size Distribution Report

% +3"	% Gravel		% Sand			% Fines	
	Coarse	Fine	Coarse	Medium	Fine	Silt	Clay
0.0	10.9	9.0	5.3	15.3	56.3	3.2

SIEVE SIZE	PERCENT FINER	SPEC.* PERCENT	PASS? (X=NO)
1.25"	100.0		
1"	89.1		
3/4"	89.1		
5/8"	89.1		
1/2"	86.2		
3/8"	83.9		
1/4"	81.4		
#4	80.1		
#8	75.9		
#10	74.8		
#16	71.1		
#30	65.2		
#40	59.5		
#50	46.3		
#100	19.4		
#200	3.2

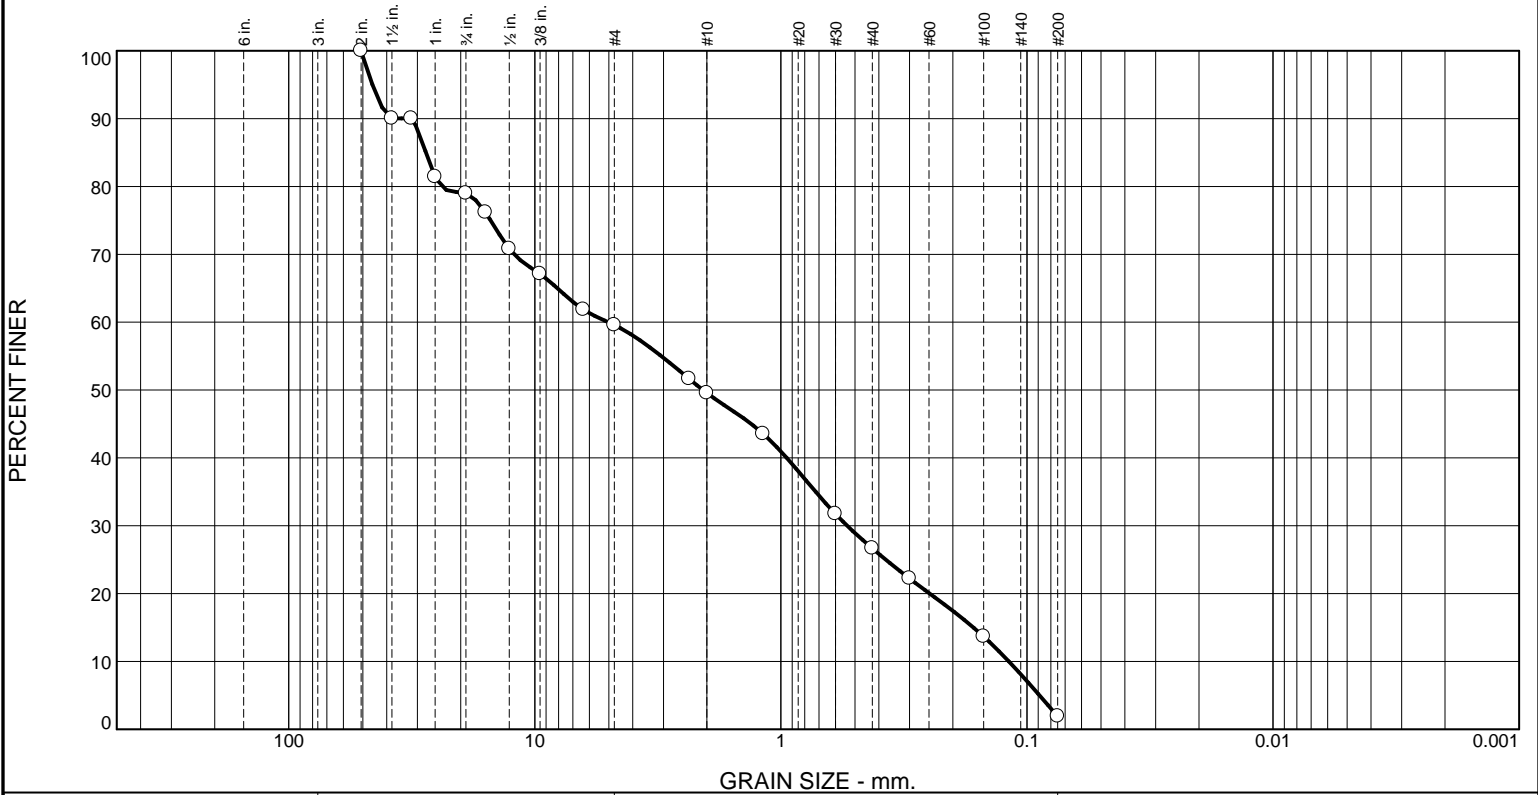
Particle Size Distribution Report

% +3"	% Gravel		% Sand			% Fines	
	Coarse	Fine	Coarse	Medium	Fine	Silt	Clay
0.0	21.0	19.4	10.0	22.9	24.8	1.9

SIEVE SIZE	PERCENT FINER	SPEC.* PERCENT	PASS? (X=NO)
2"	100.0		
1.5"	90.0		
1.25"	90.0		
1"	81.4		
3/4"	79.0		
5/8"	76.2		
1/2"	70.8		
3/8"	67.1		
1/4"	61.9		
#4	59.6		
#8	51.7		
#10	49.6		
#16	43.6		
#30	31.7		
#40	26.7		
#50	22.2		
#100	13.7		
#200	1.9

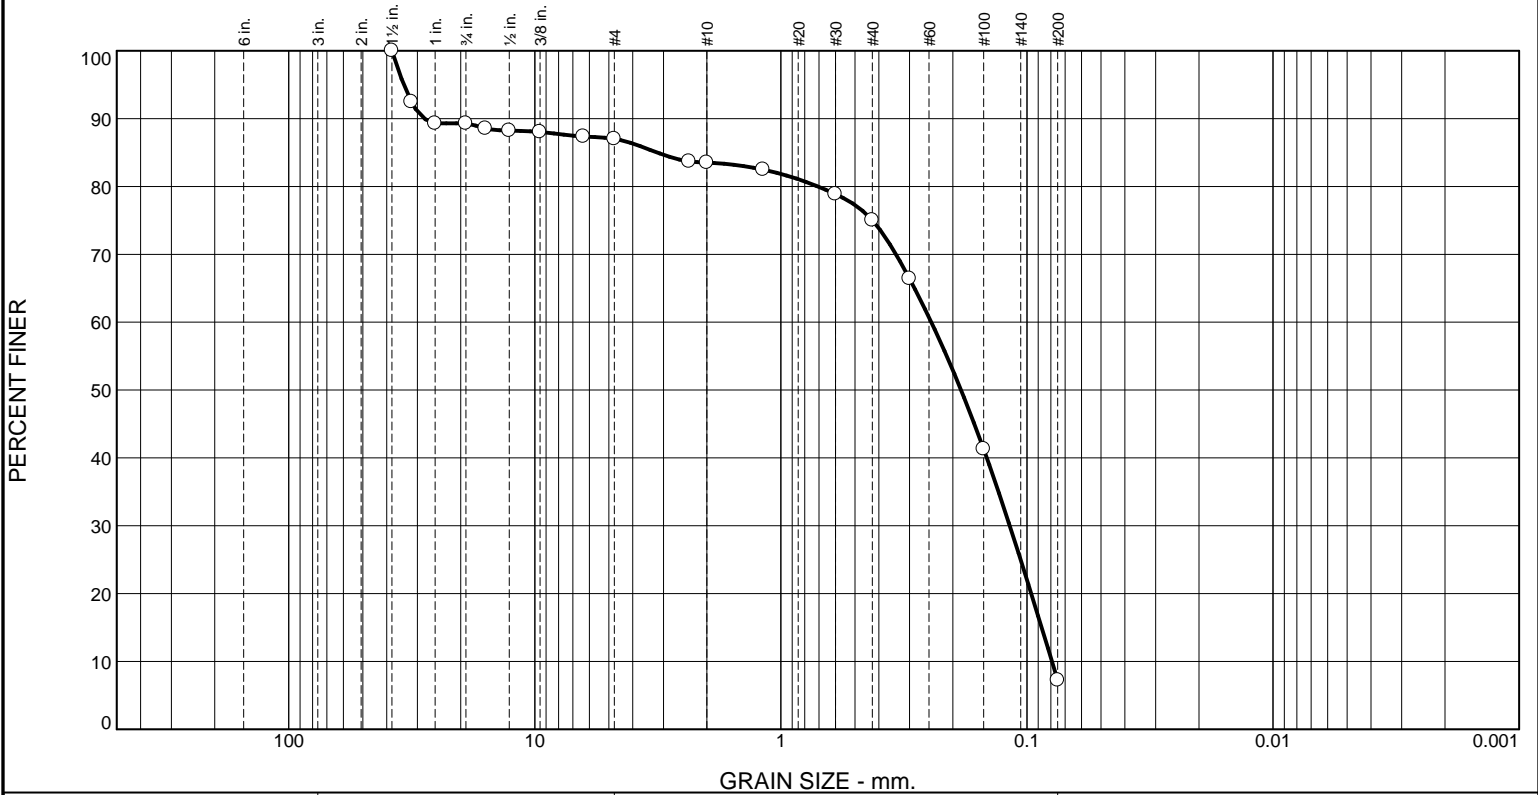
Particle Size Distribution Report

% +3"	% Gravel		% Sand			% Fines	
	Coarse	Fine	Coarse	Medium	Fine	Silt	Clay
0.0	10.7	2.3	3.5	8.5	67.8	7.2

SIEVE SIZE	PERCENT FINER	SPEC.* PERCENT	PASS? (X=NO)
1.5"	100.0		
1.25"	92.5		
1"	89.3		
3/4"	89.3		
5/8"	88.6		
1/2"	88.2		
3/8"	88.0		
1/4"	87.4		
#4	87.0		
#8	83.7		
#10	83.5		
#16	82.5		
#30	78.9		
#40	75.0		
#50	66.4		
#100	41.3		
#200	7.2

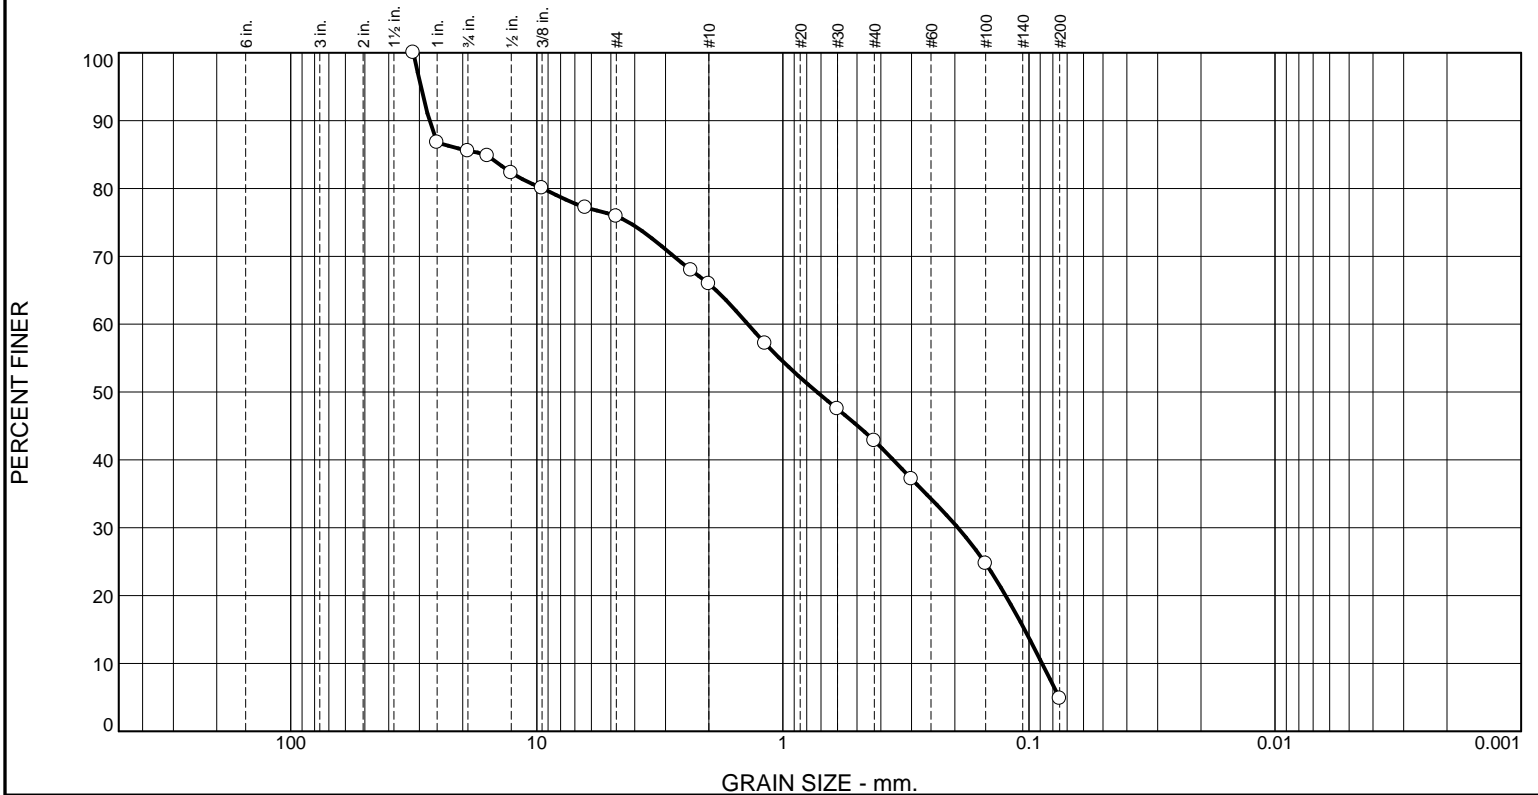
Particle Size Distribution Report

% +3"	% Gravel		% Sand			% Fines	
	Coarse	Fine	Coarse	Medium	Fine	Silt	Clay
0.0	14.5	9.6	9.9	23.2	38.0	4.8

SIEVE SIZE	PERCENT FINER	SPEC.* PERCENT	PASS? (X=NO)
1.25"	100.0		
1"	86.8		
3/4"	85.5		
5/8"	84.8		
1/2"	82.3		
3/8"	80.0		
1/4"	77.2		
#4	75.9		
#8	68.0		
#10	66.0		
#16	57.2		
#30	47.5		
#40	42.8		
#50	37.2		
#100	24.7		
#200	4.8

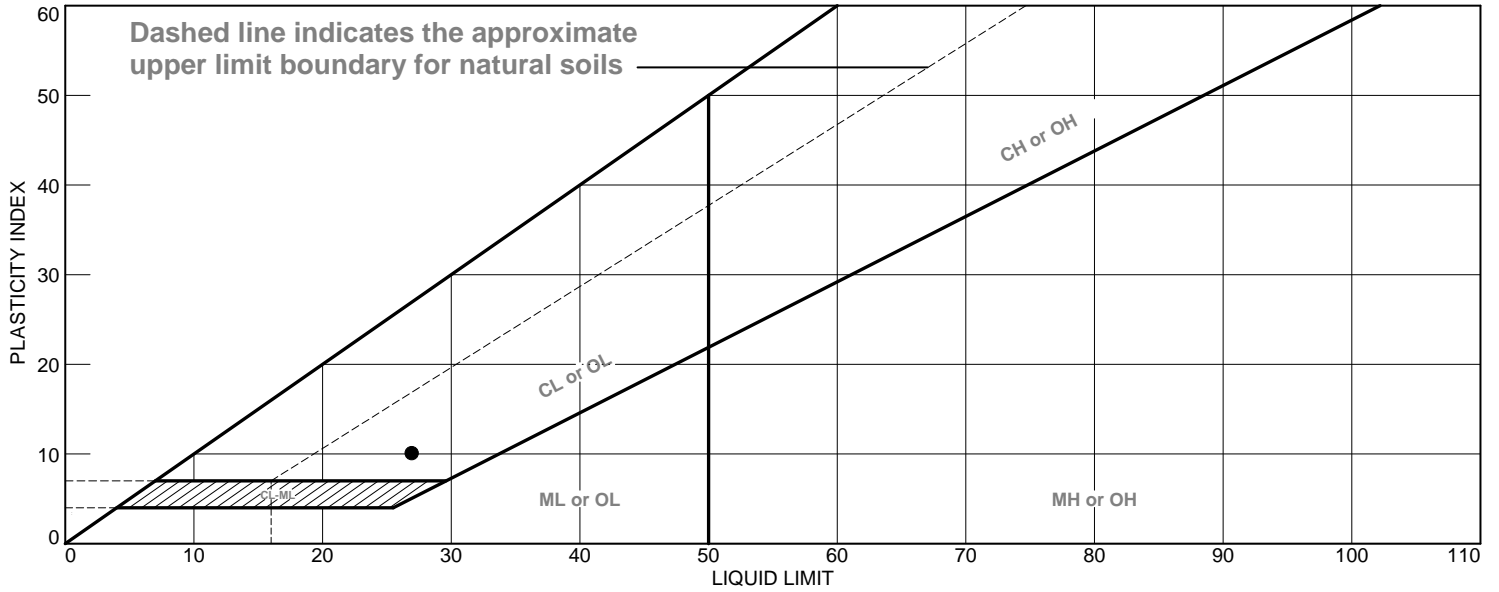
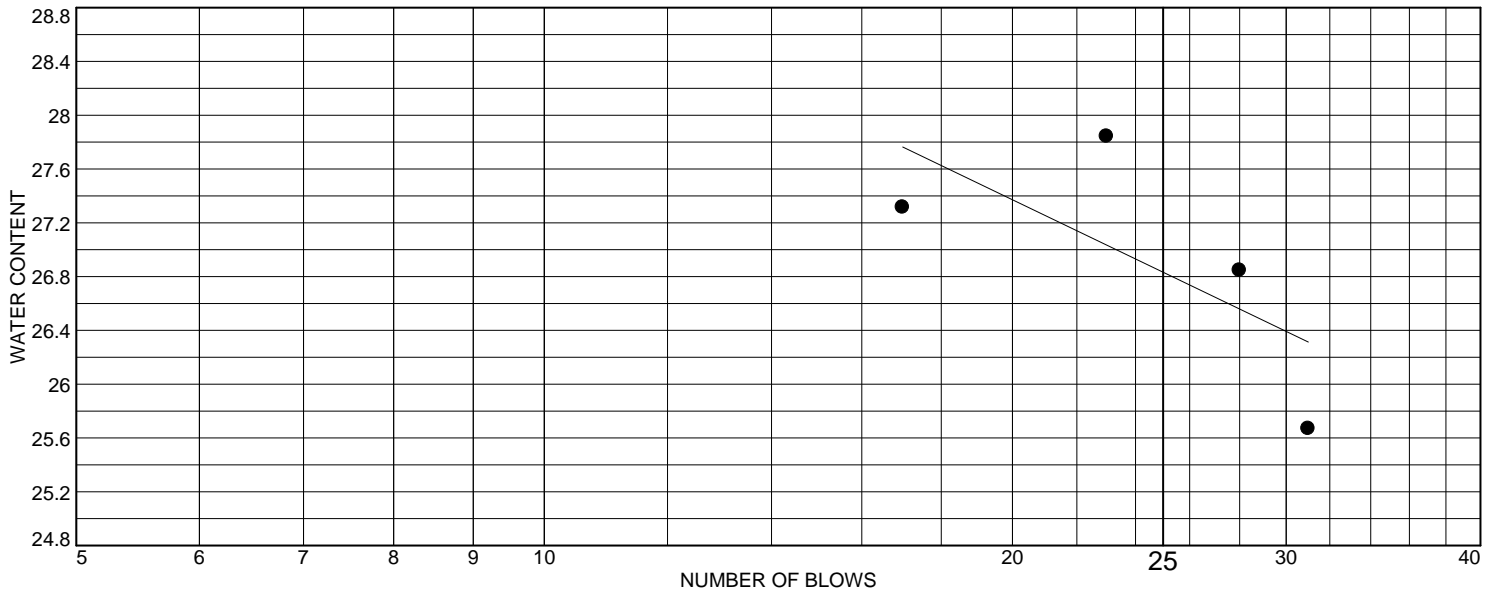
LIQUID AND PLASTIC LIMITS TEST REPORT

MATERIAL DESCRIPTION	LL	PL	PI	%<#40	%<#200	USCS
●	27	17	10

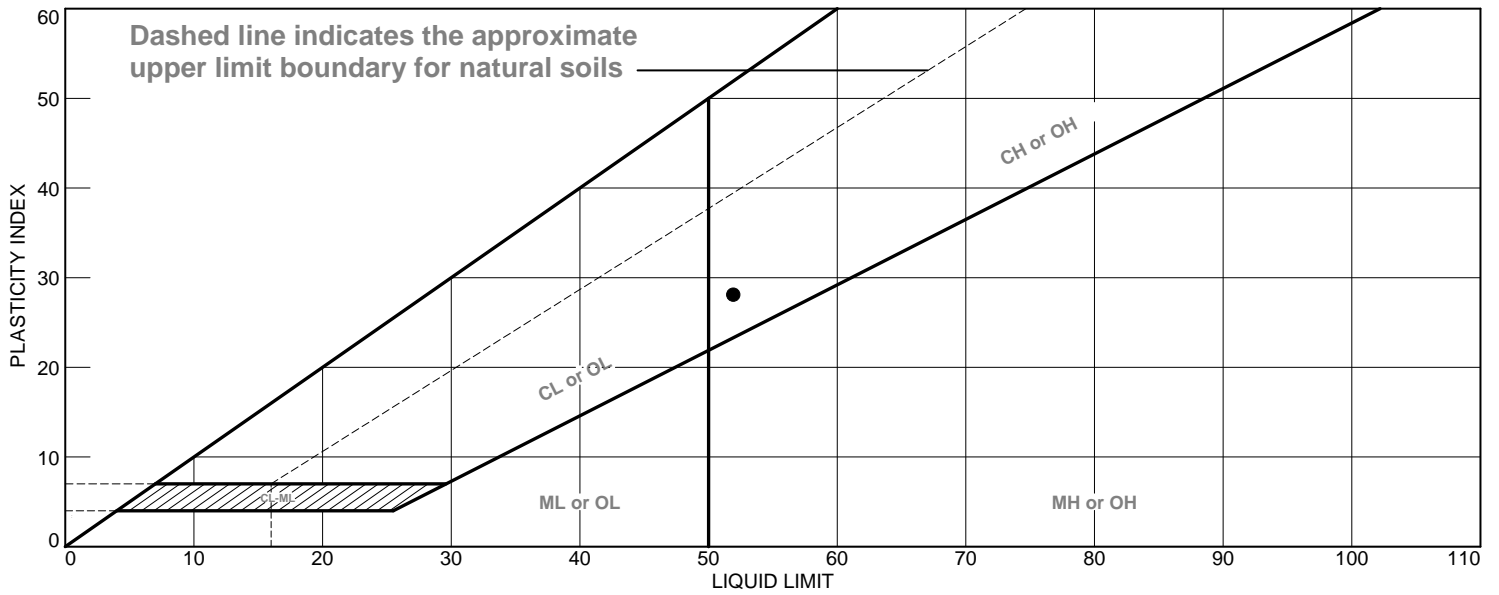
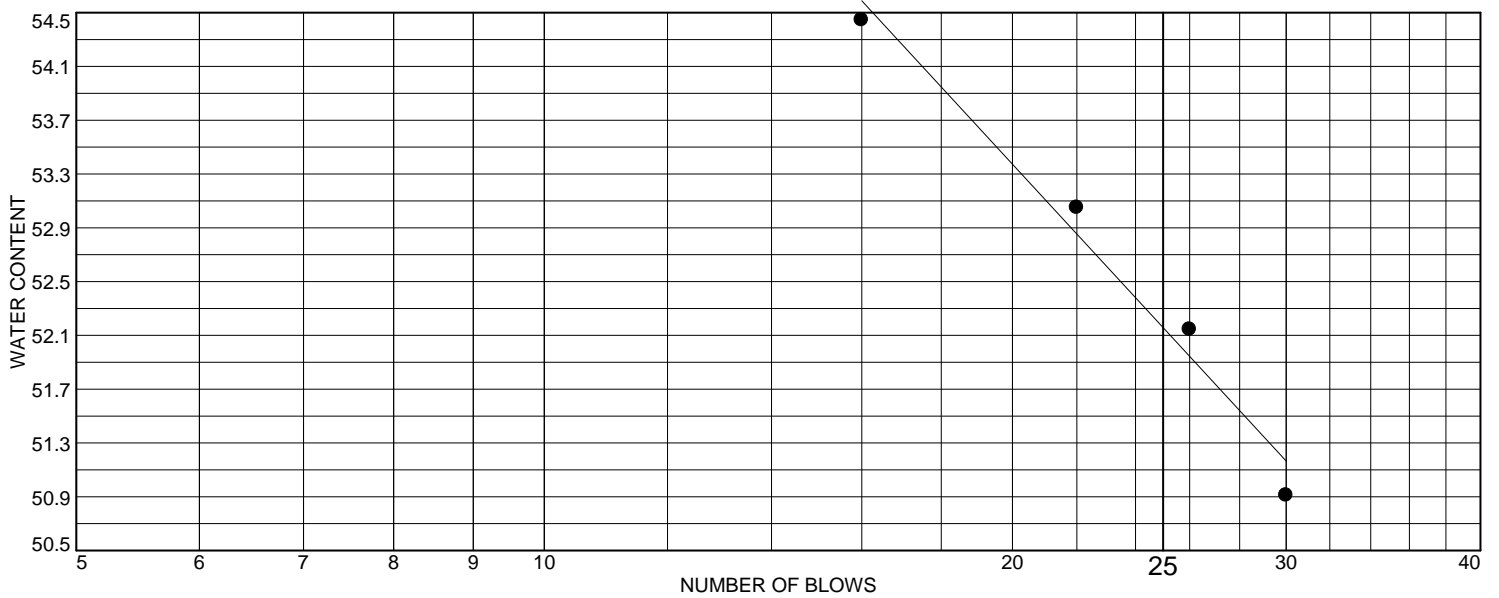
LIQUID AND PLASTIC LIMITS TEST REPORT

MATERIAL DESCRIPTION	LL	PL	PI	%<#40	%<#200	USCS
●	52	24	28

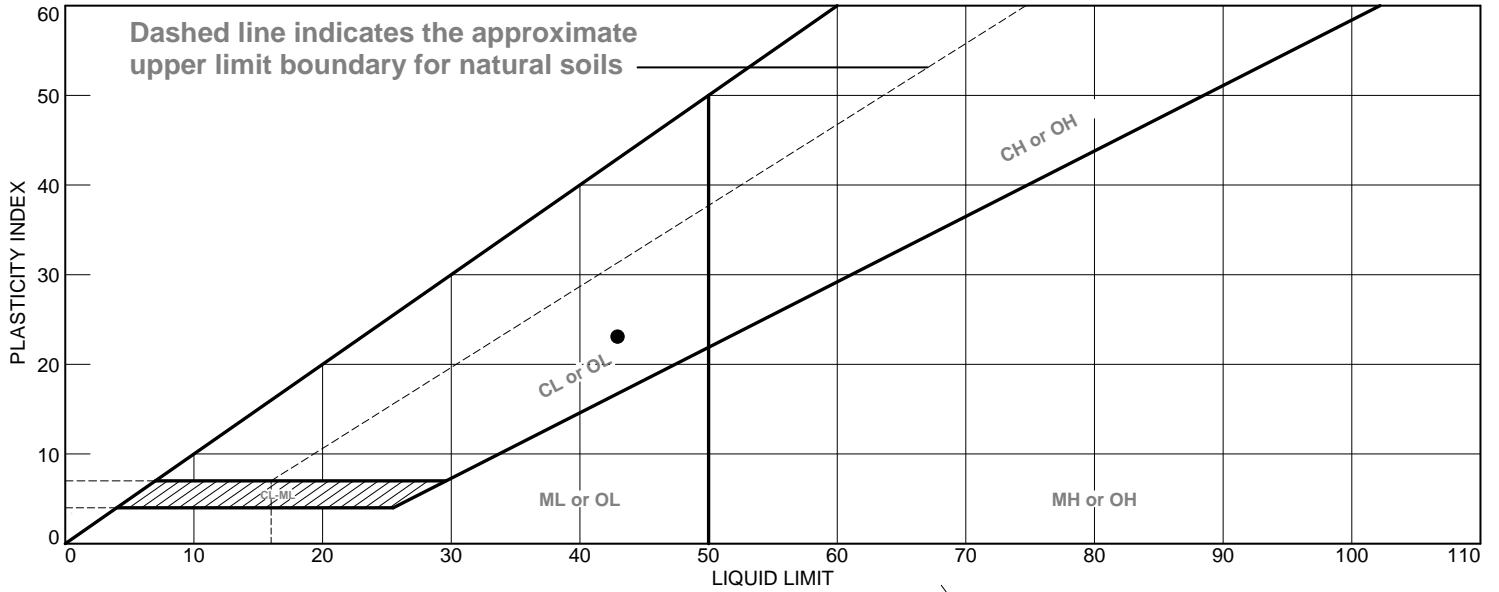
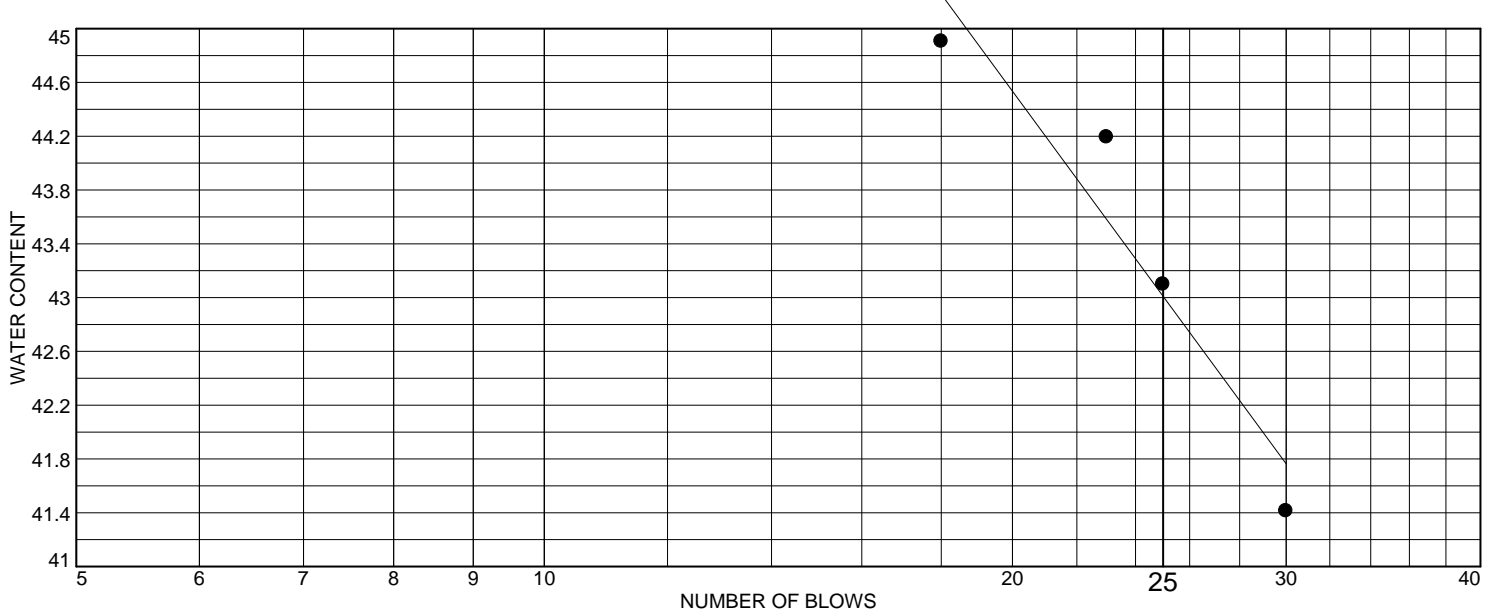
LIQUID AND PLASTIC LIMITS TEST REPORT

MATERIAL DESCRIPTION	LL	PL	PI	%<#40	%<#200	USCS
●	43	20	23

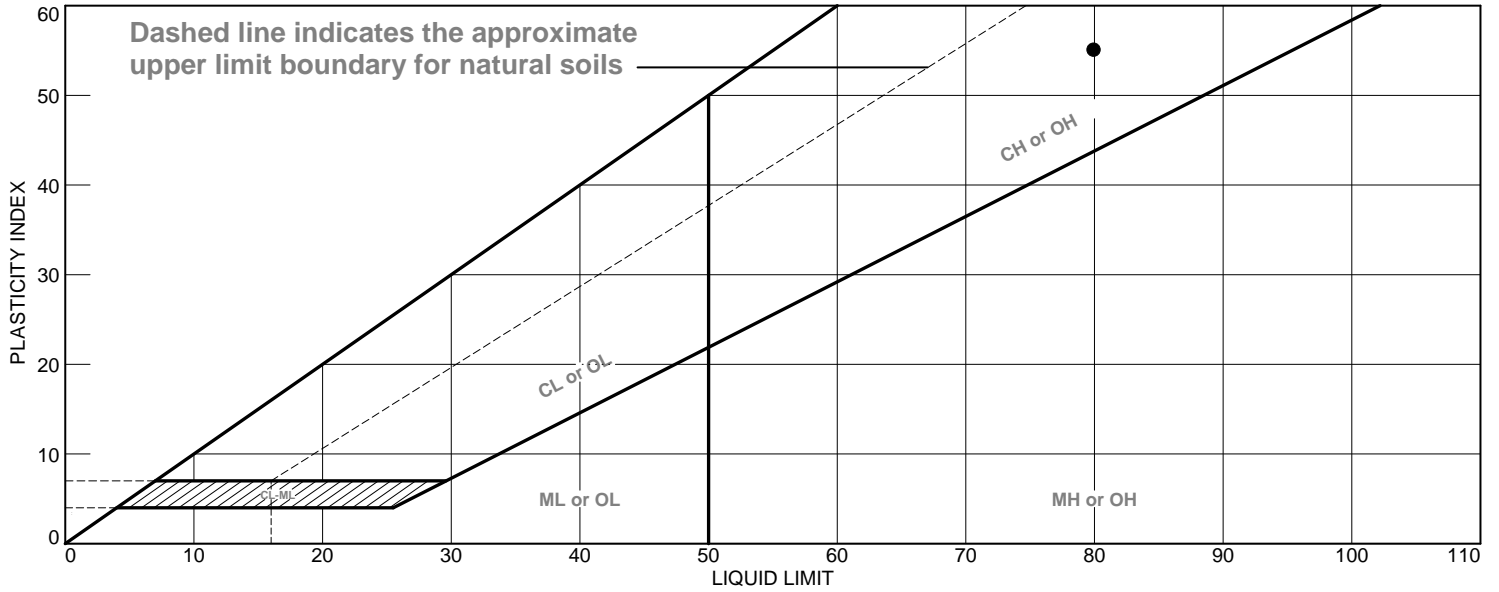
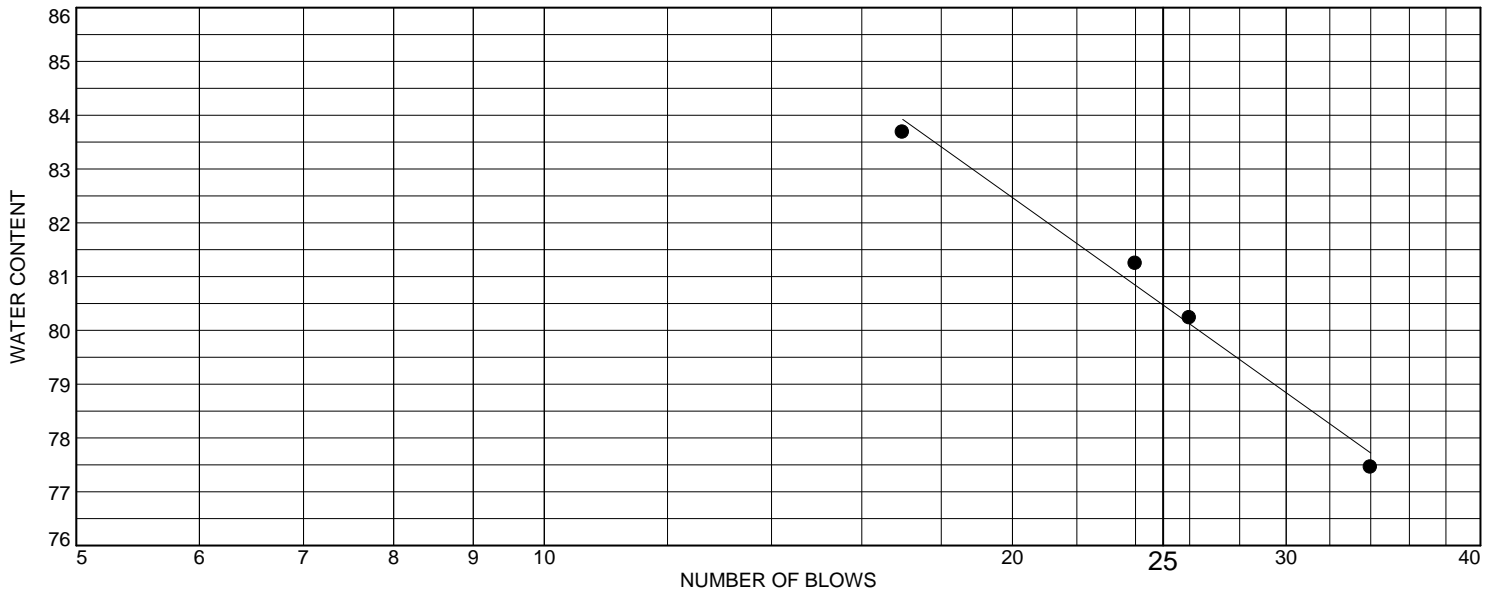
LIQUID AND PLASTIC LIMITS TEST REPORT

MATERIAL DESCRIPTION	LL	PL	PI	%<#40	%<#200	USCS
●	80	25	55

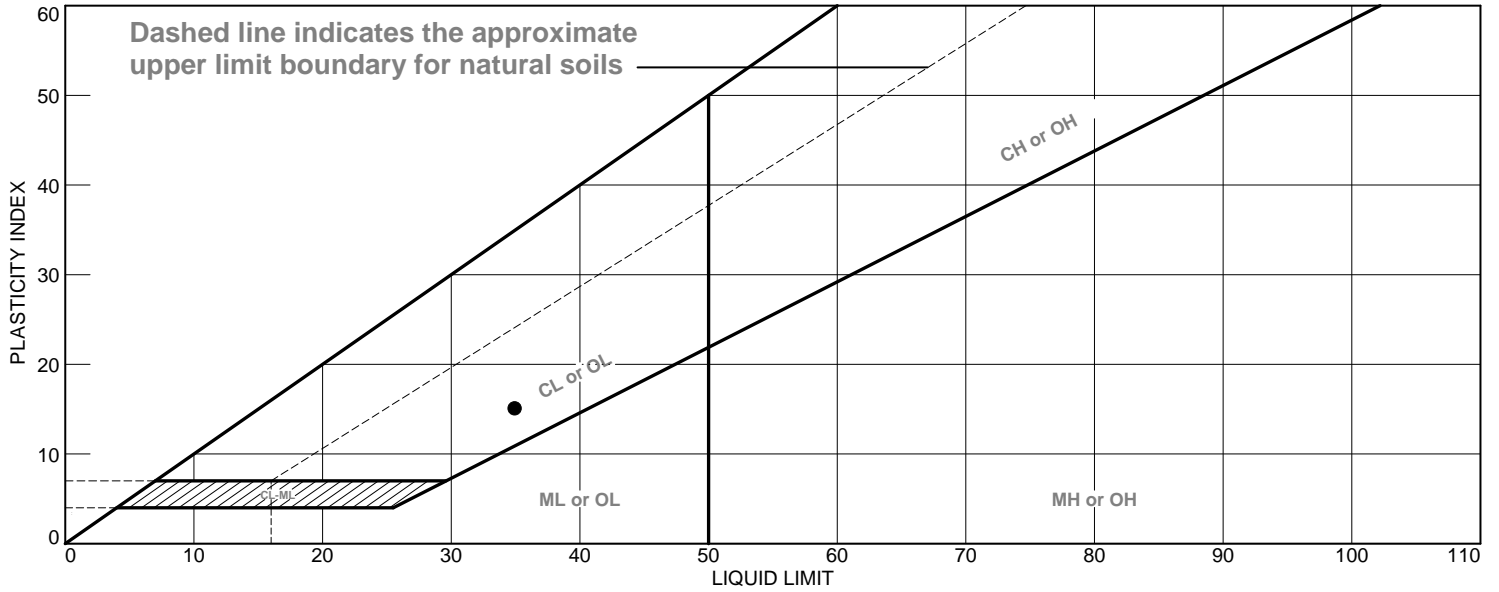
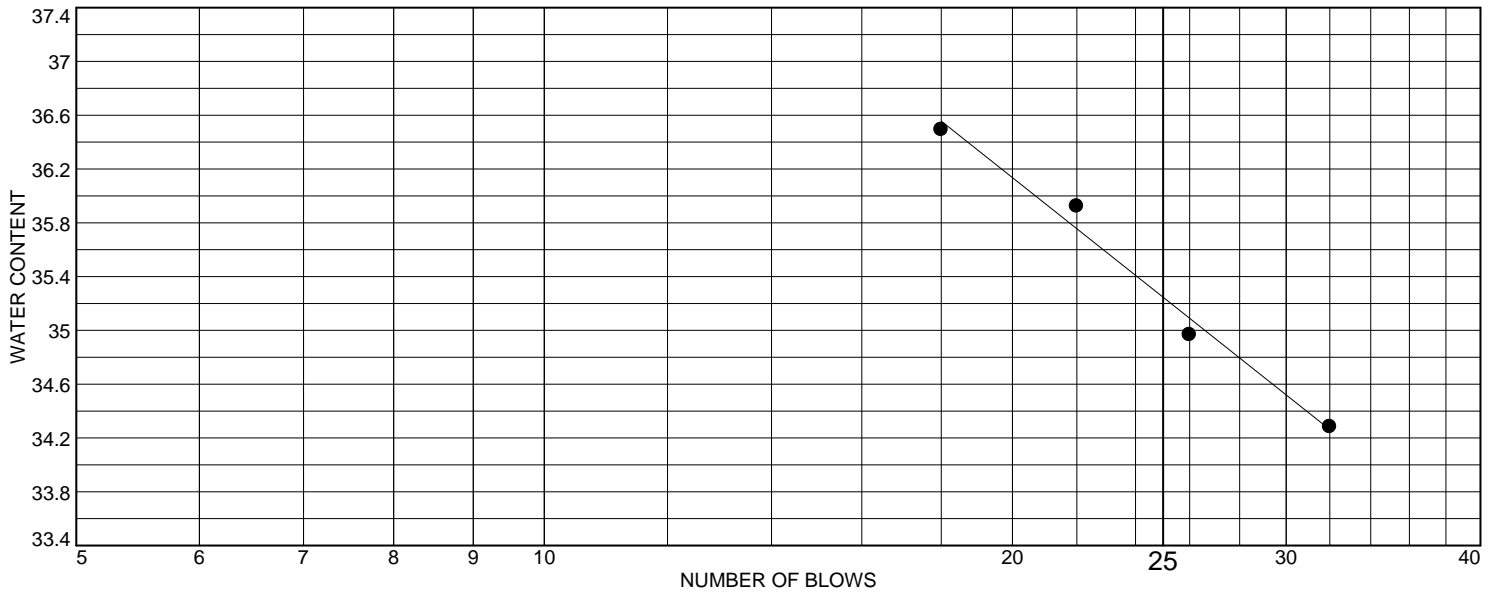
LIQUID AND PLASTIC LIMITS TEST REPORT

MATERIAL DESCRIPTION	LL	PL	PI	%<#40	%<#200	USCS
●	35	20	15

Project No. 242417005 **Client:** AMEC/The Kroger Company
Project: Chehalis Property
Location: TP-16, S-1 **Depth:** 2
Sample Number: 835
Terracon Consultants, Inc.
Mountlake Terrace, WA

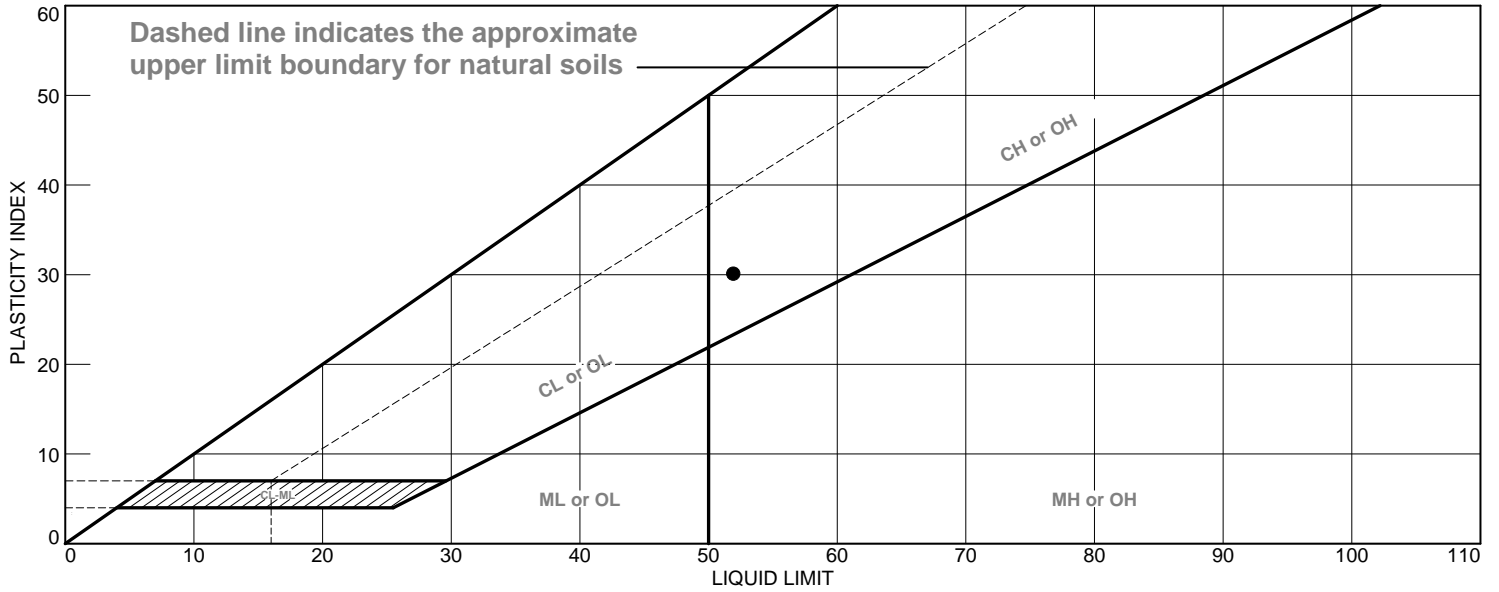
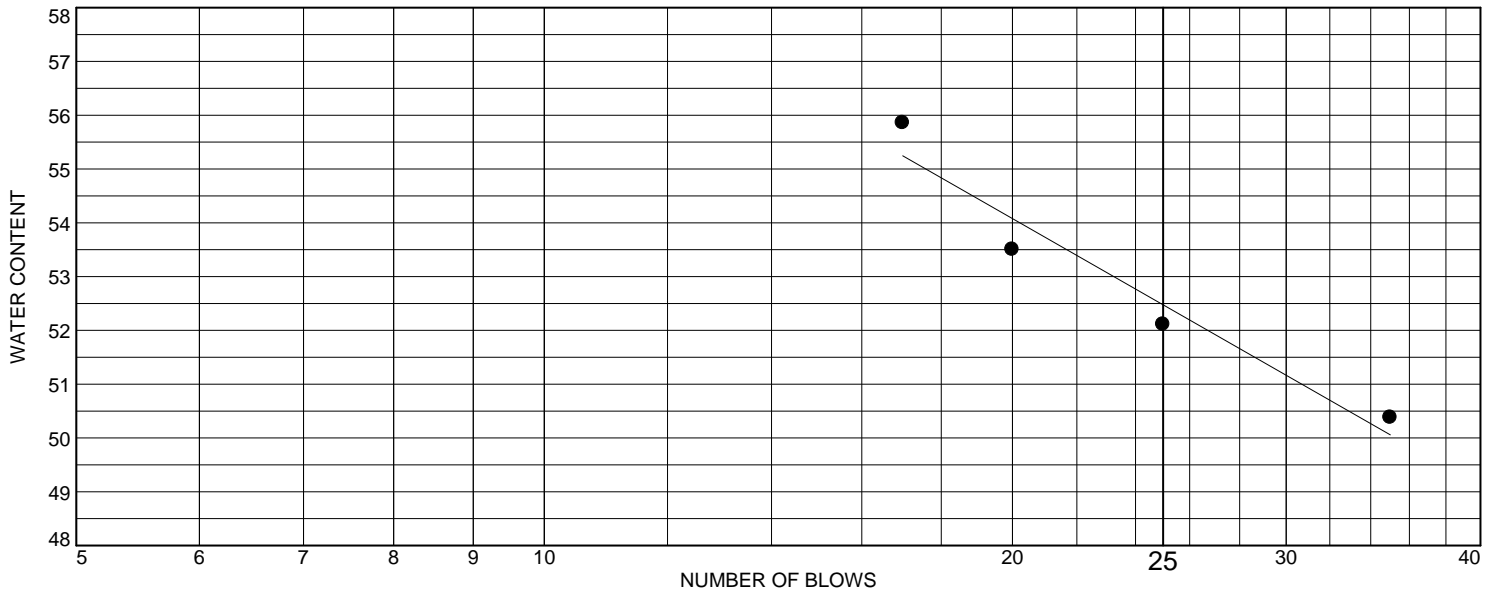
LIQUID AND PLASTIC LIMITS TEST REPORT

MATERIAL DESCRIPTION	LL	PL	PI	%<#40	%<#200	USCS
●	52	22	30
