Critical Areas Assessment  
Corps Reference No. NWS-2019-745  
April 6, 2020

Berwick Creek Flood  
Reduction and Restoration  
City of Chehalis, Washington

Prepared for  
Port of Chehalis  
321 Maurin Road  
Chehalis, Washington 98532  
(360) 748-9365

Prepared by  
Ecological Land Services, Inc.  
1157 3rd Avenue, Suite 220A • Longview, WA 98632  
(360) 578-1371 • Project Number 362.35

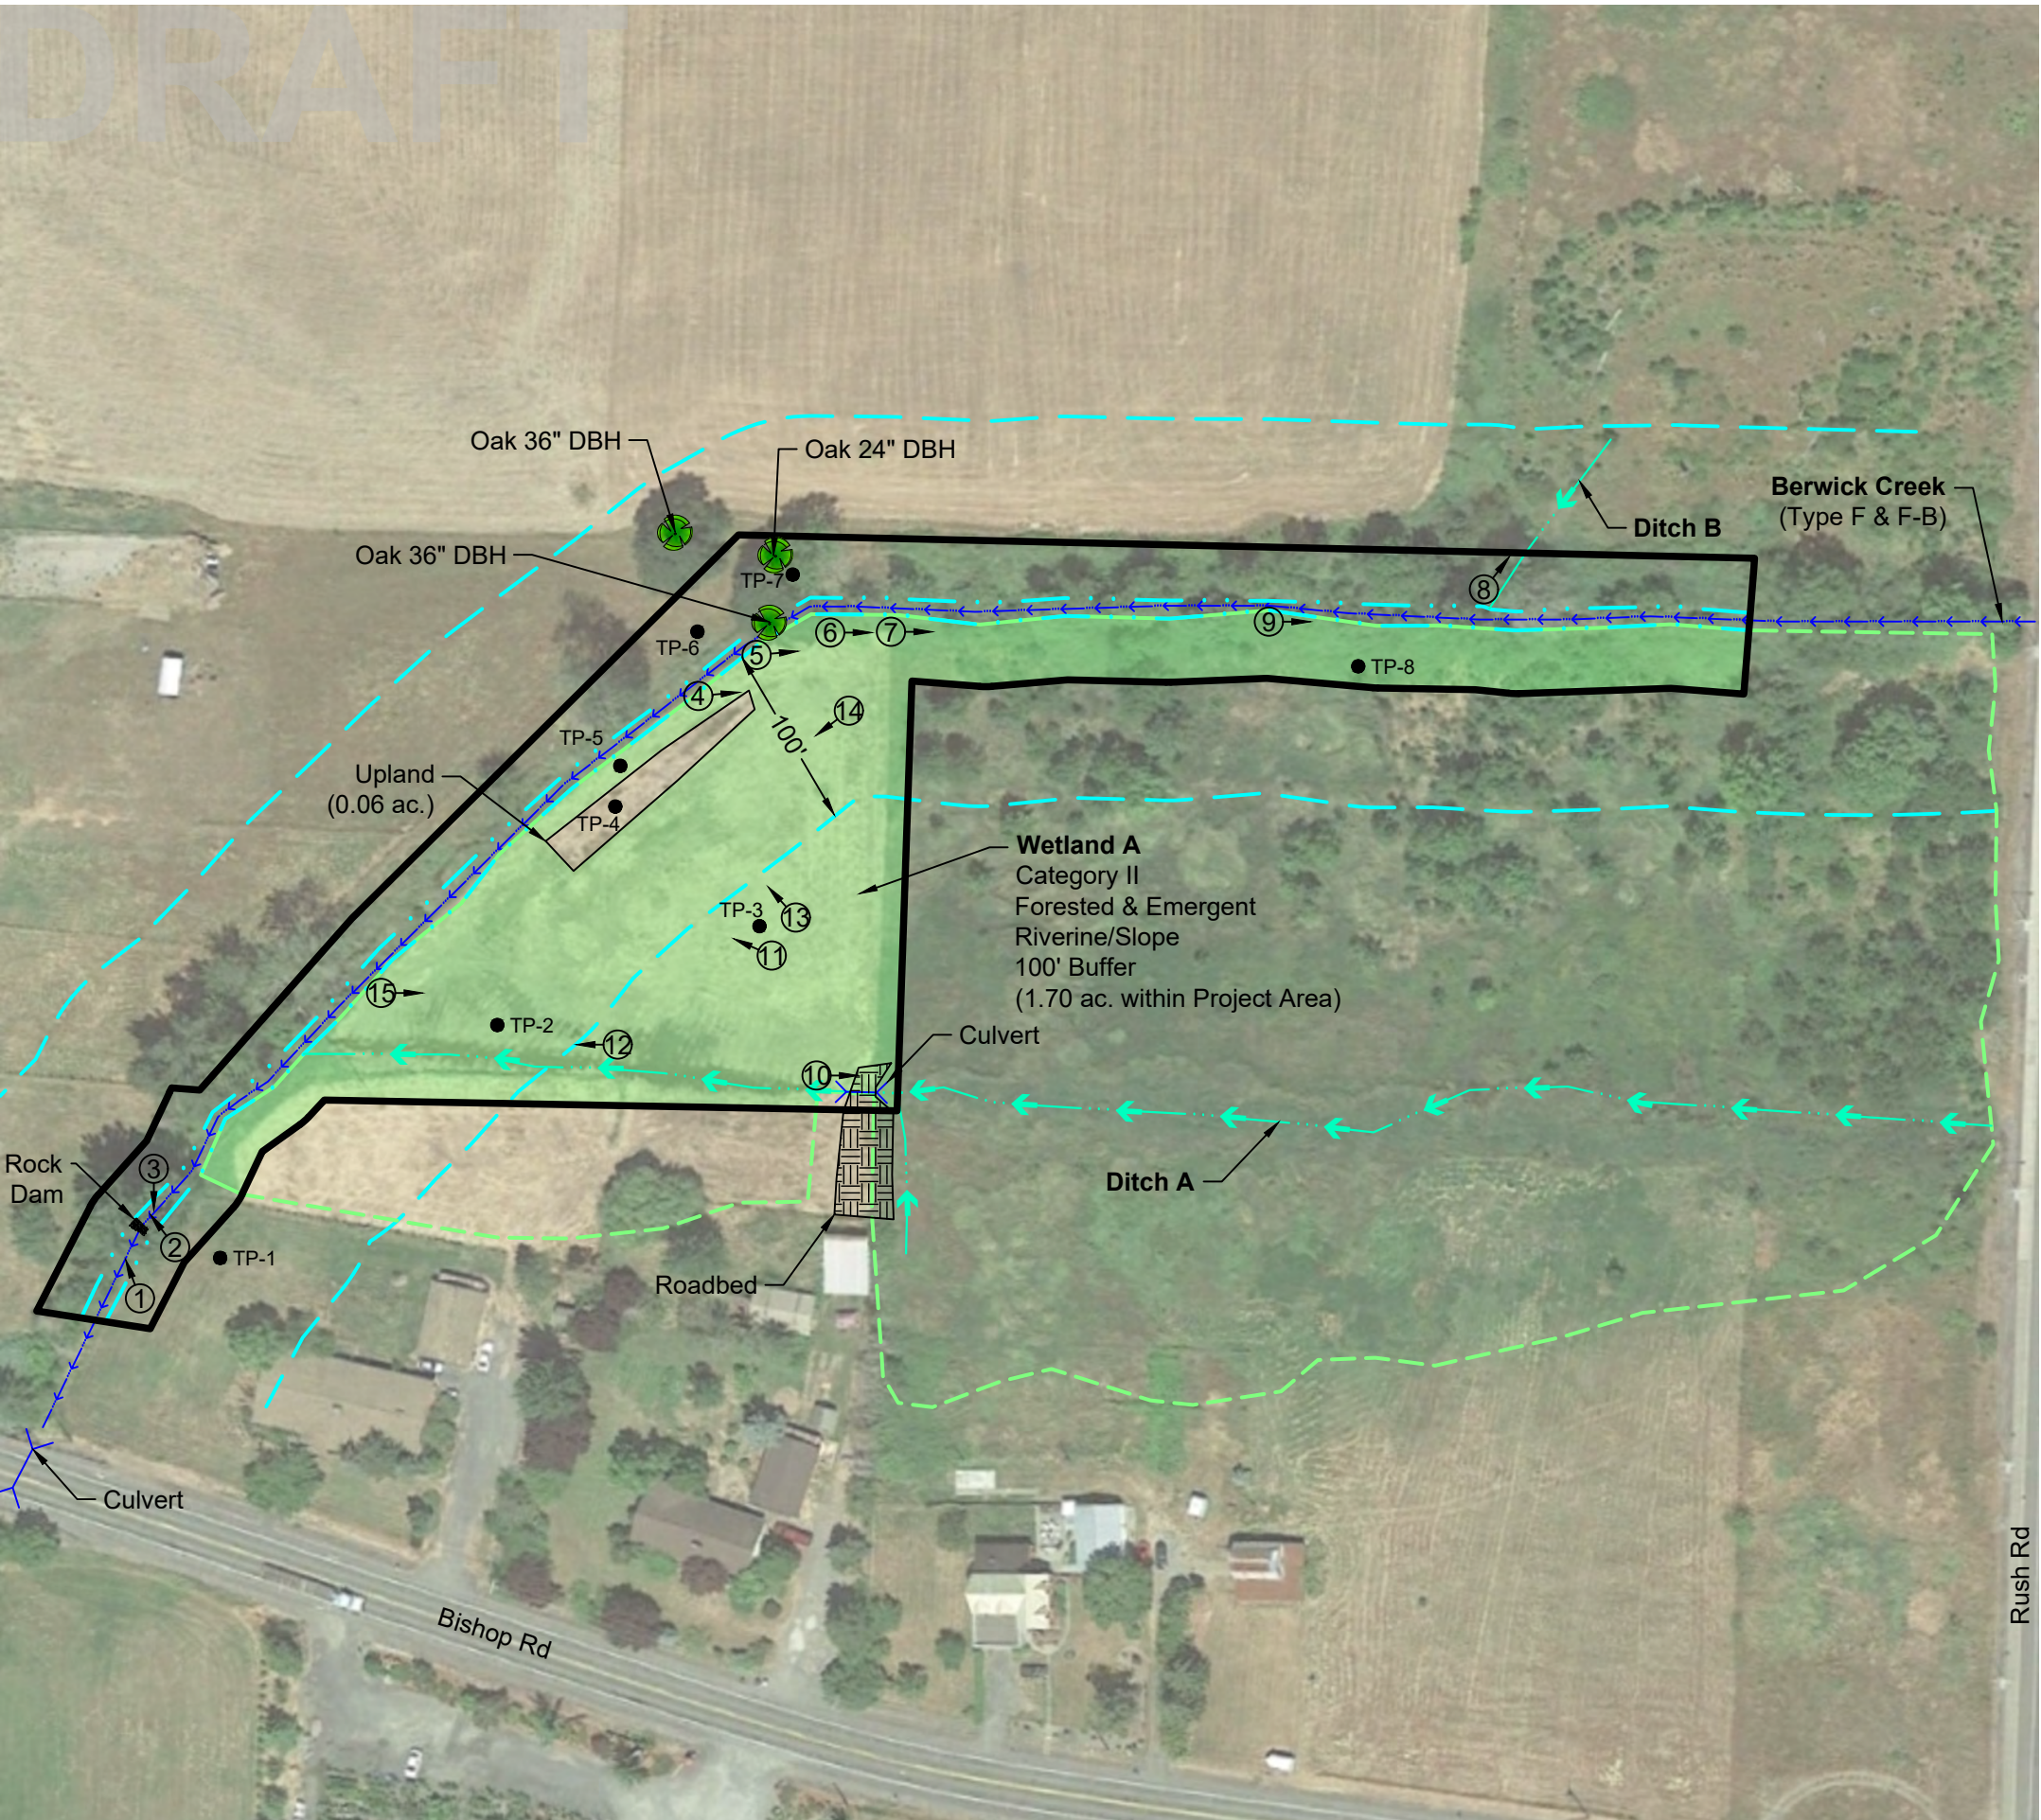
Figure 2  
**EXISTING CONDITIONS**  
 Berwick Creek Flood Reduction and Restoration  
 Port of Chehalis  
 City of Chehalis, Lewis County, WA  
 Section 10 & 15, Township 13N, Range 2W, W.M.

- Project Area (2.79 ac.)
- Wetland Boundary
- Approximate Wetland Boundary (7.29 ac.)
- Stream with Flow Direction
- Ditch with Flow Direction
- OHWM
- Stream Buffer
- Culvert
- Oregon White Oak
- TP-1 Test Plot
- Photopoint

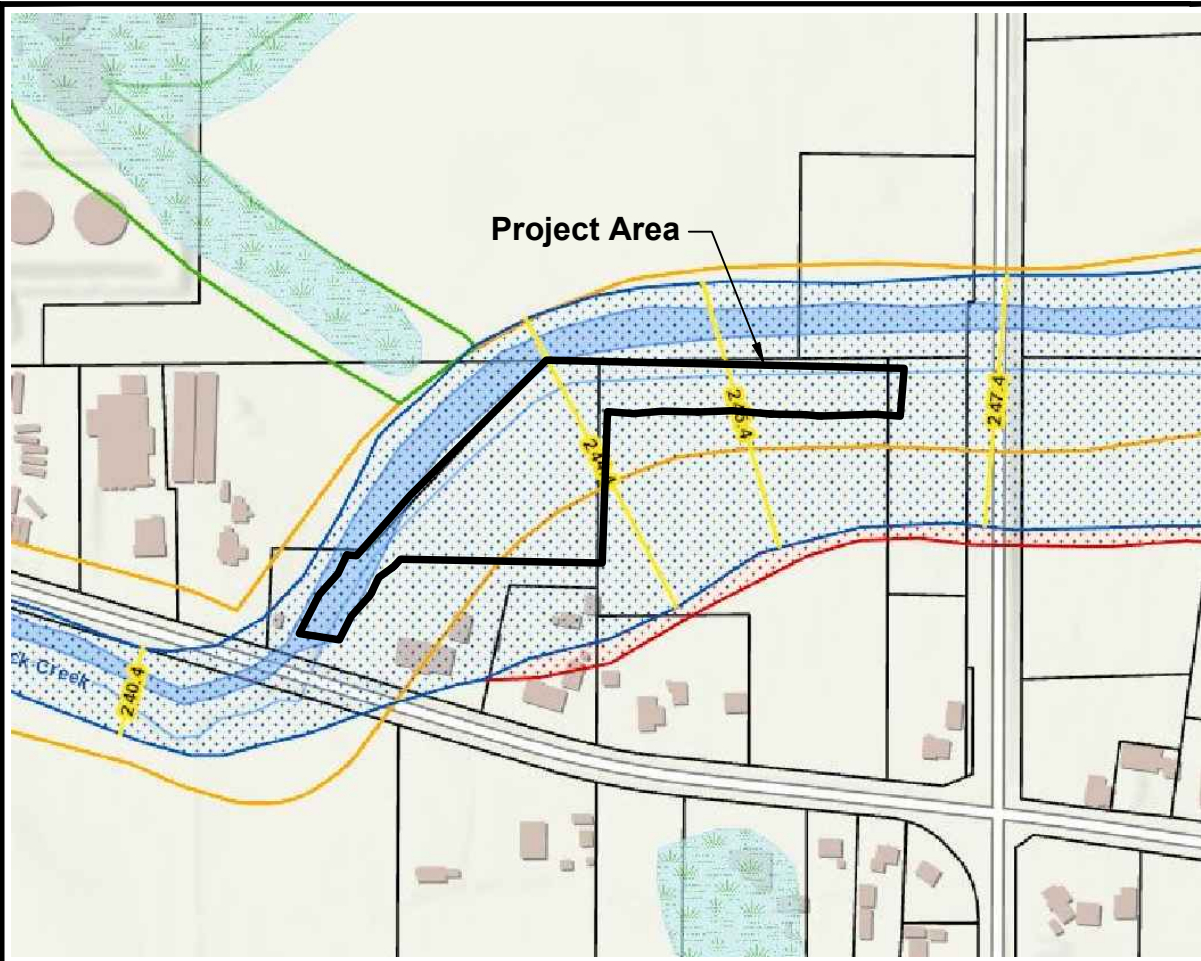
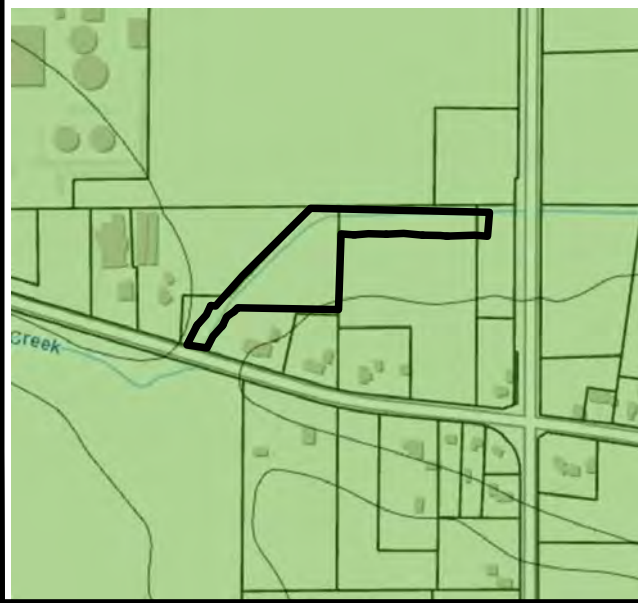
**Figure 3**  
**LEWIS COUNTY CRITICAL AREAS**  
 Berwick Creek Flood Reduction and Restoration  
 Port of Chehalis  
 City of Chehalis, Lewis County, WA  
 Section 10 & 15, Township 13N, Range 2W, W.M.

- Legend:**
- Project Area
  - Floodway
  - 500-Year Flood Area
  - 100-Year Flood Area
  - 150' Shoreline Buffer
  - 150' Stream Buffer (Fish)
  - 75' Stream Buffer (Non-Fish)

- Legend:**
- Hydric Soils

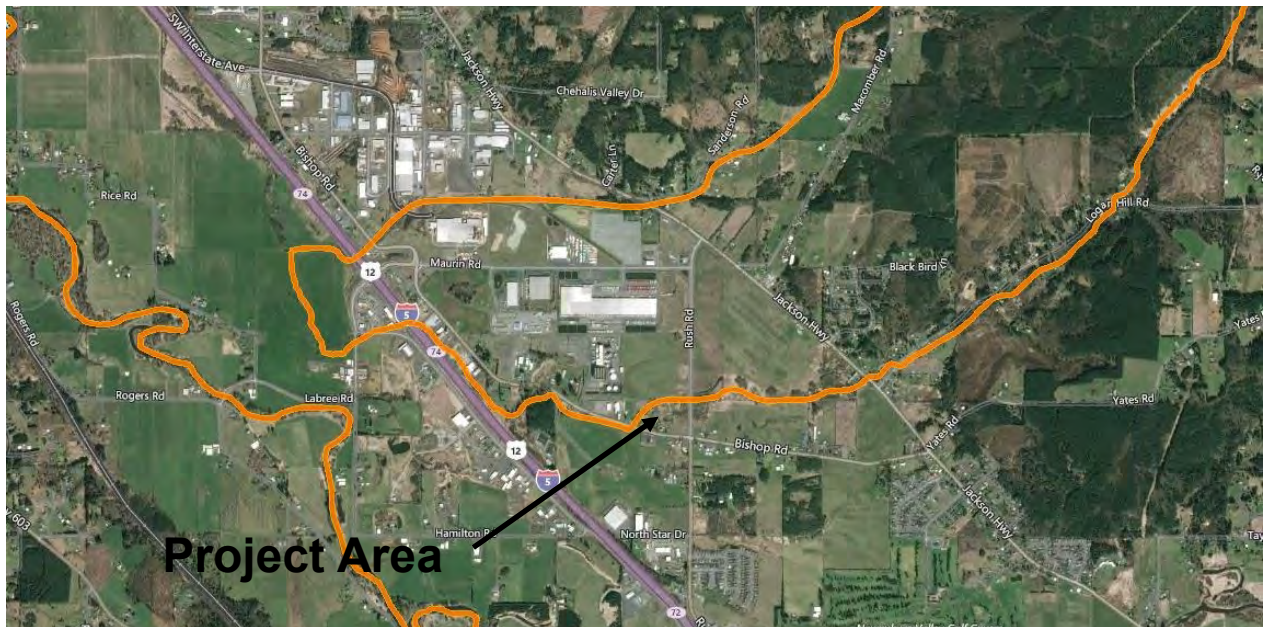
Figure 11  
 303(d) LISTED WATERS & TMDLs  
 Berwick Creek Flood Restoration & Restoration  
 Port of Chehalis  
 City of Chehalis, Lewis County Washington  
 Section 10 & 15, Township 13N, Range 2W, W.M.

**Water Quality Atlas Map - 303(d)**

Orange - Category 4A waters

**Water Quality Atlas Map - TDMLs**

Purple - approved Yellow - in development

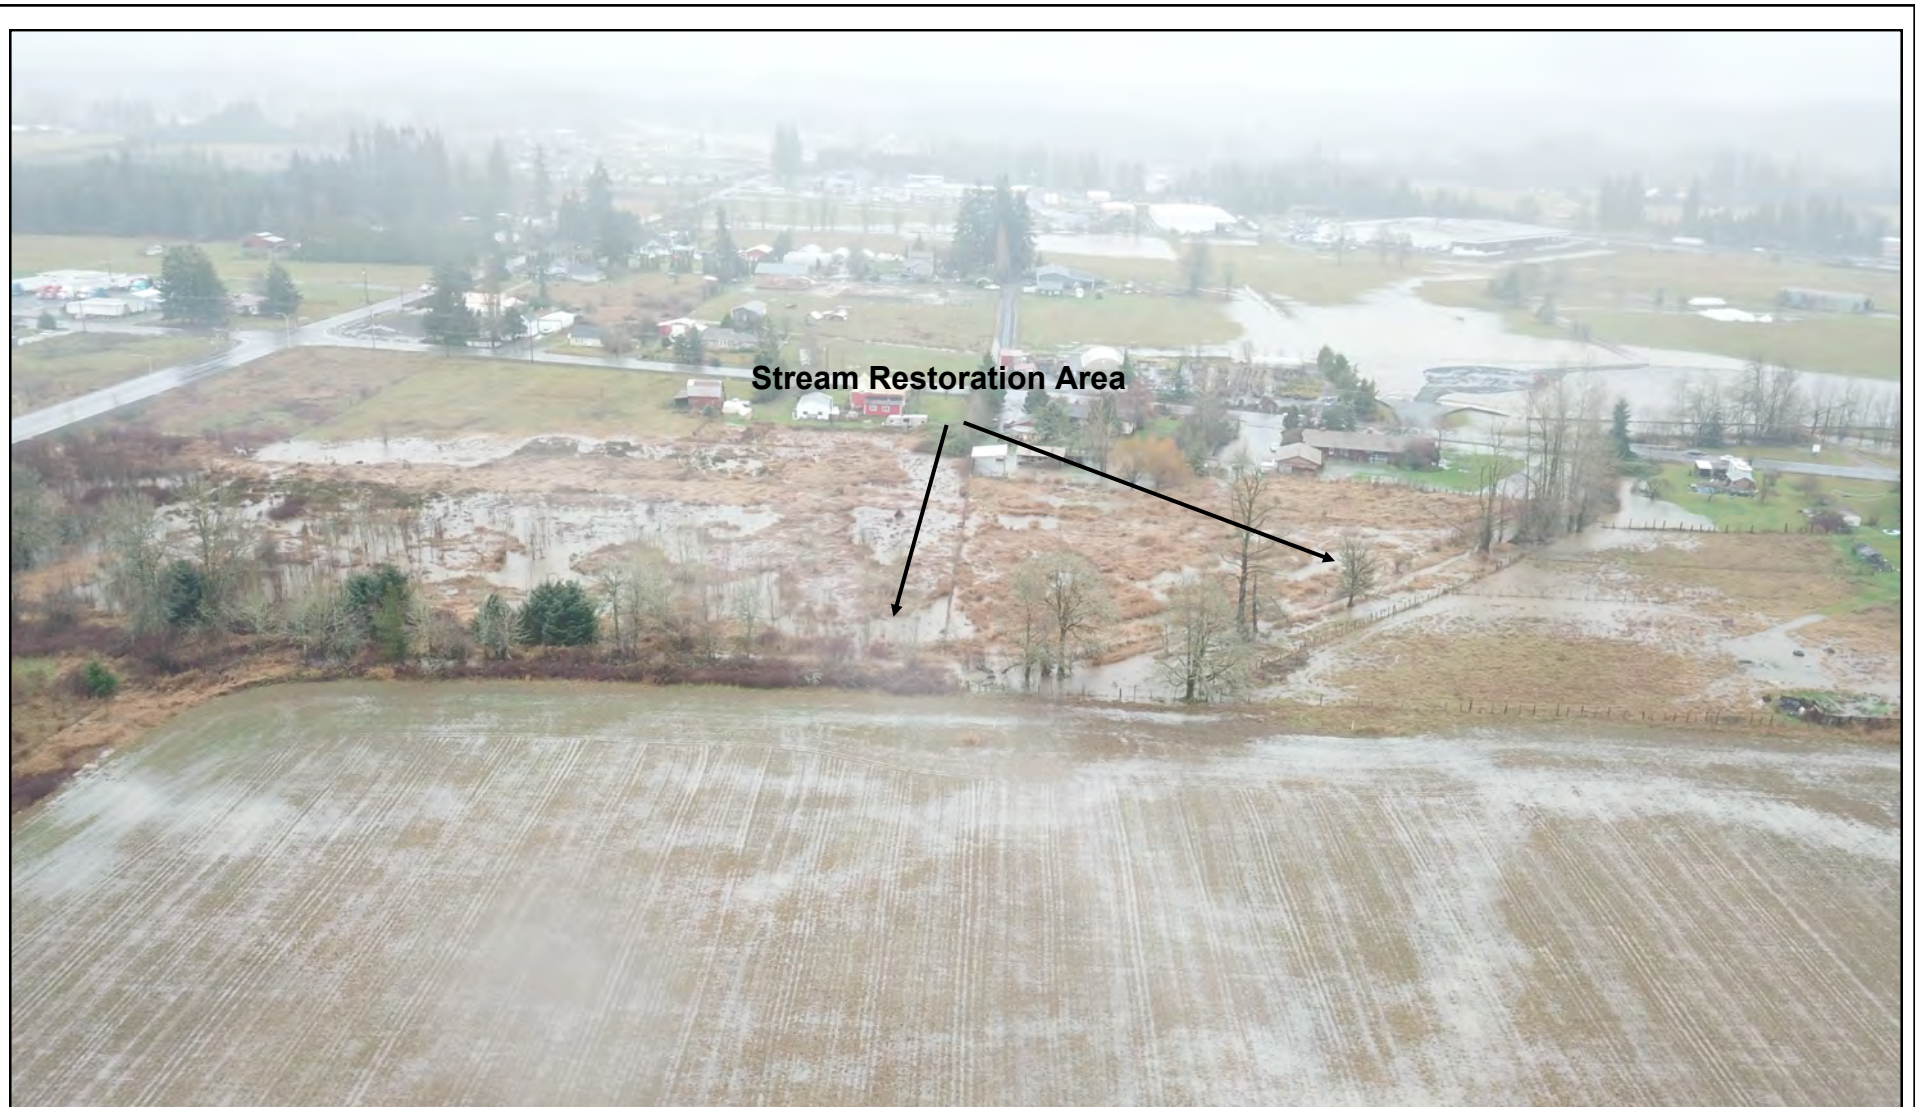
Photoplate 2  
SITE PHOTOS  
Berwick Creek Flood Reduction and Restoration  
Port of Chehalis  
City of Chehalis, Lewis County, Washington  
Sections 10 & 15, T13N, R2W, W.M.

Aerial view south showing extent of flooding, December 2019.

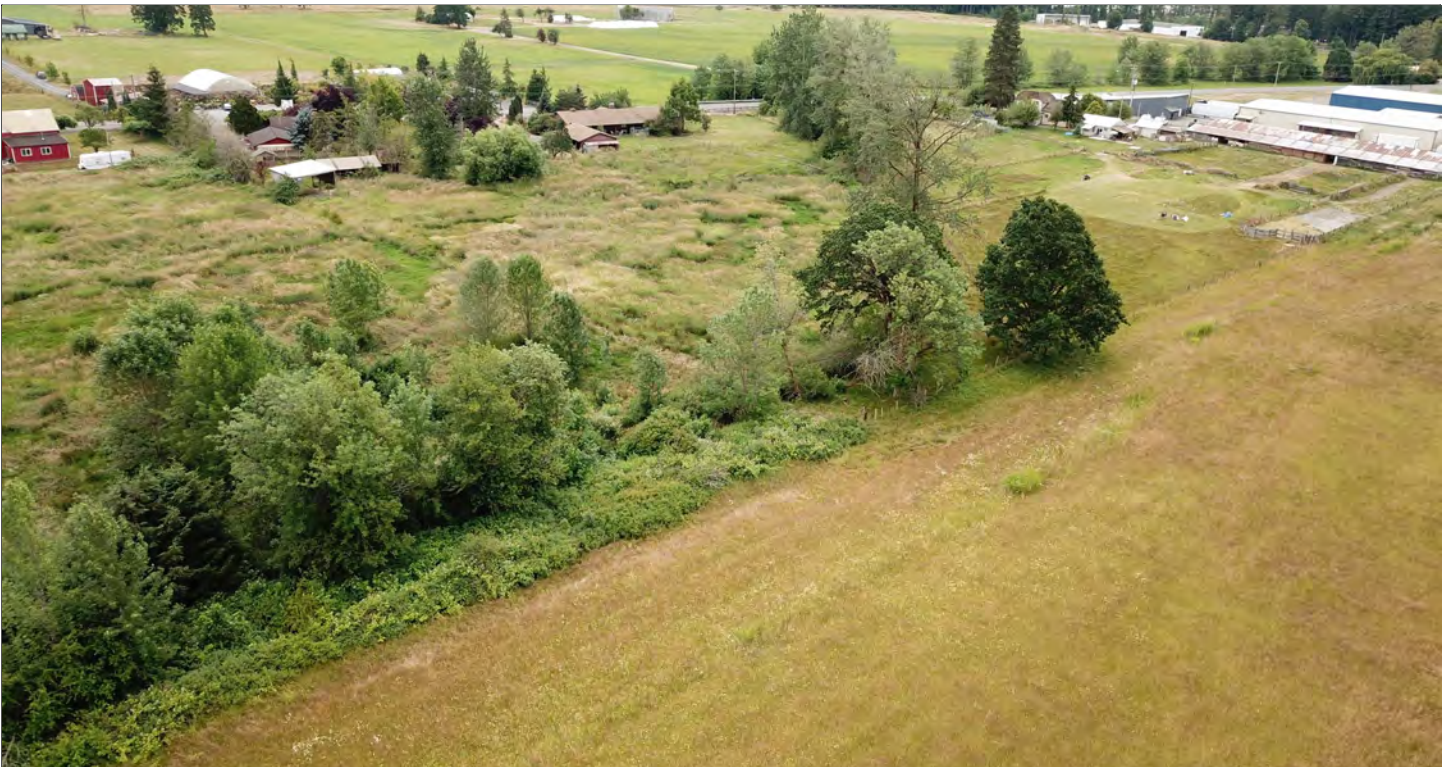
*Above:* View south showing existing vegetation in the riparian corridor. Himalayan blackberry is visible north of the stream. Aerial view June 2018.

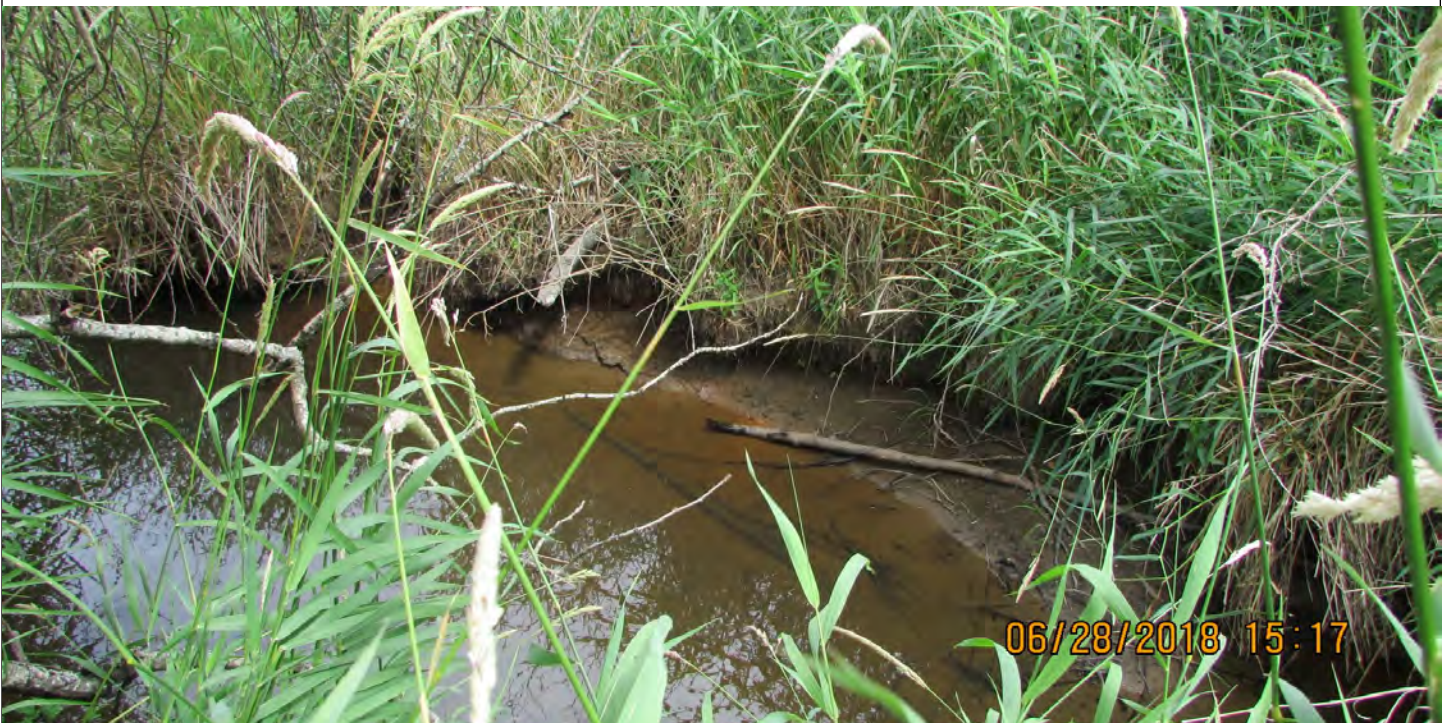
Below: (Photopoint 1) Berwick Creek's existing channel and silty substrate. Reed canarygrass is a prominent herbaceous plant in the riparian zone.

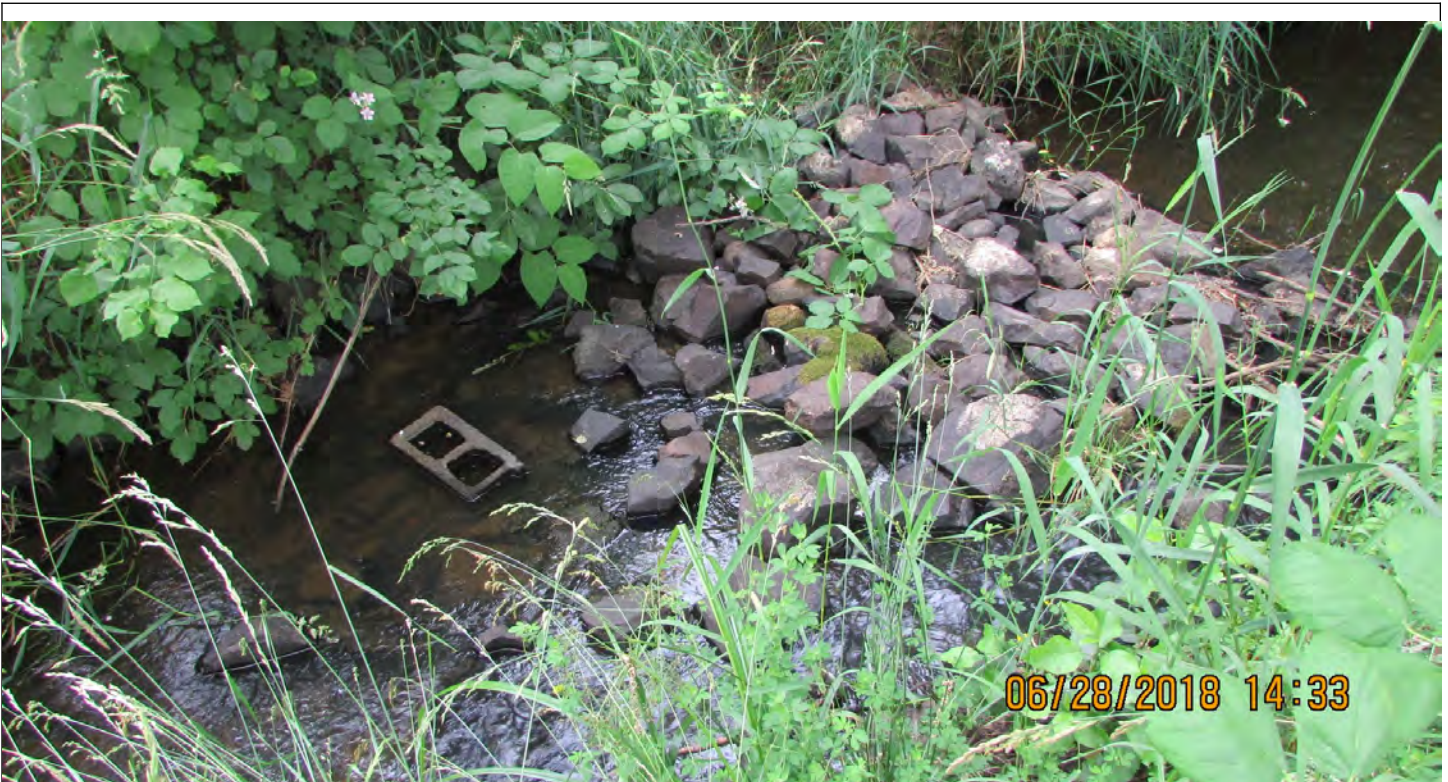
Above: (Photopoint 2) rock "dam" and other debris clogging Bewick Creek's channel.

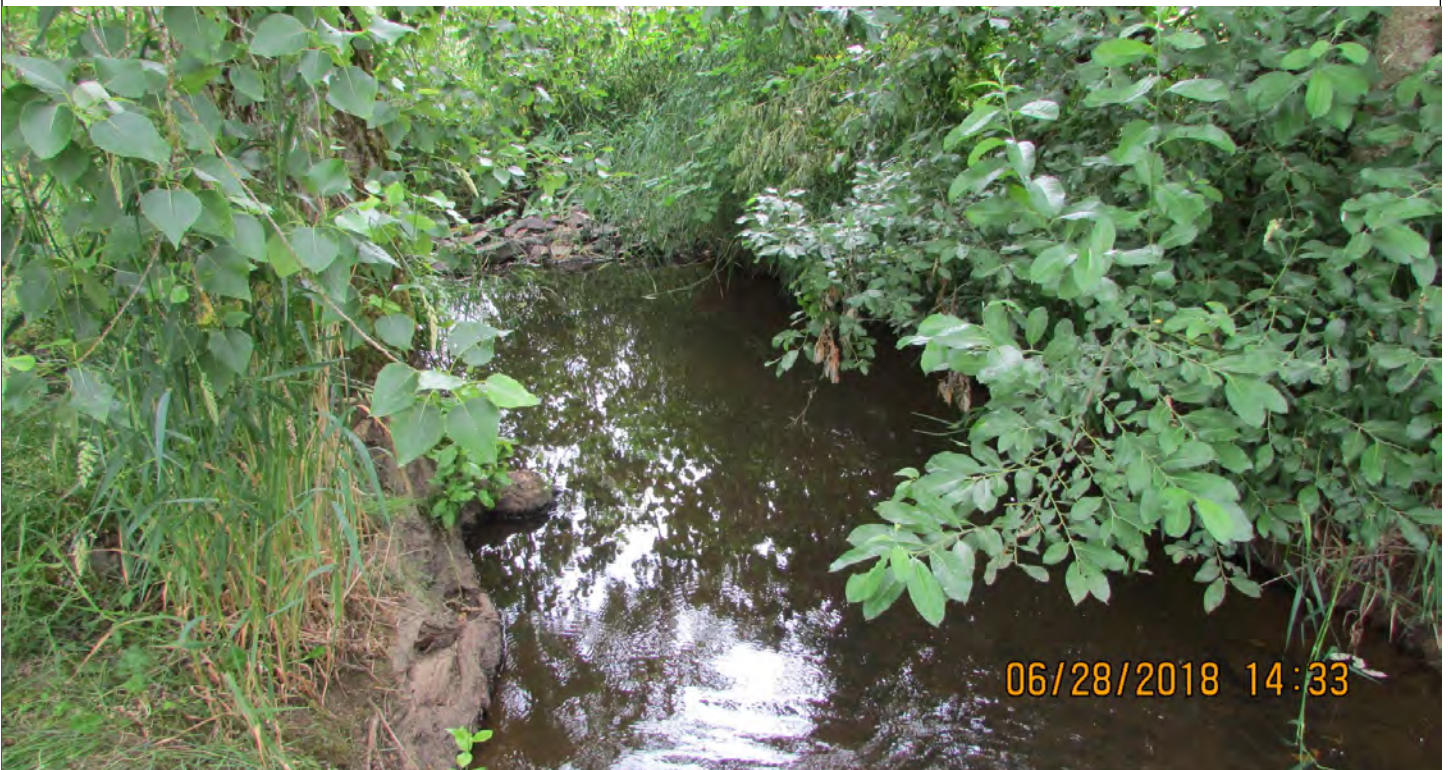
Below: (Photopoint 3) View south upstream of rock "dam".

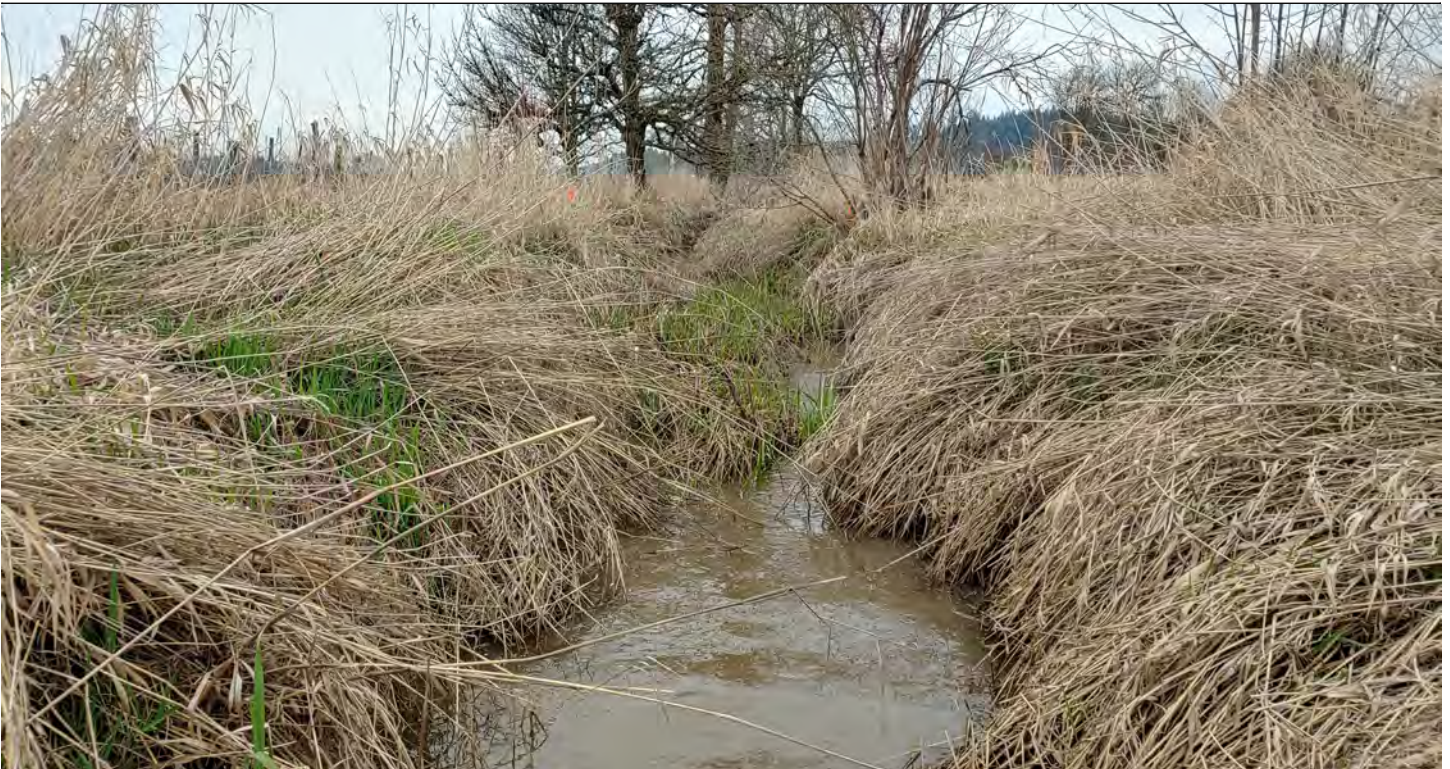
*Above:* (Photopoint 4) View east showing existing stream channel and surrounding vegetation, March 2019.

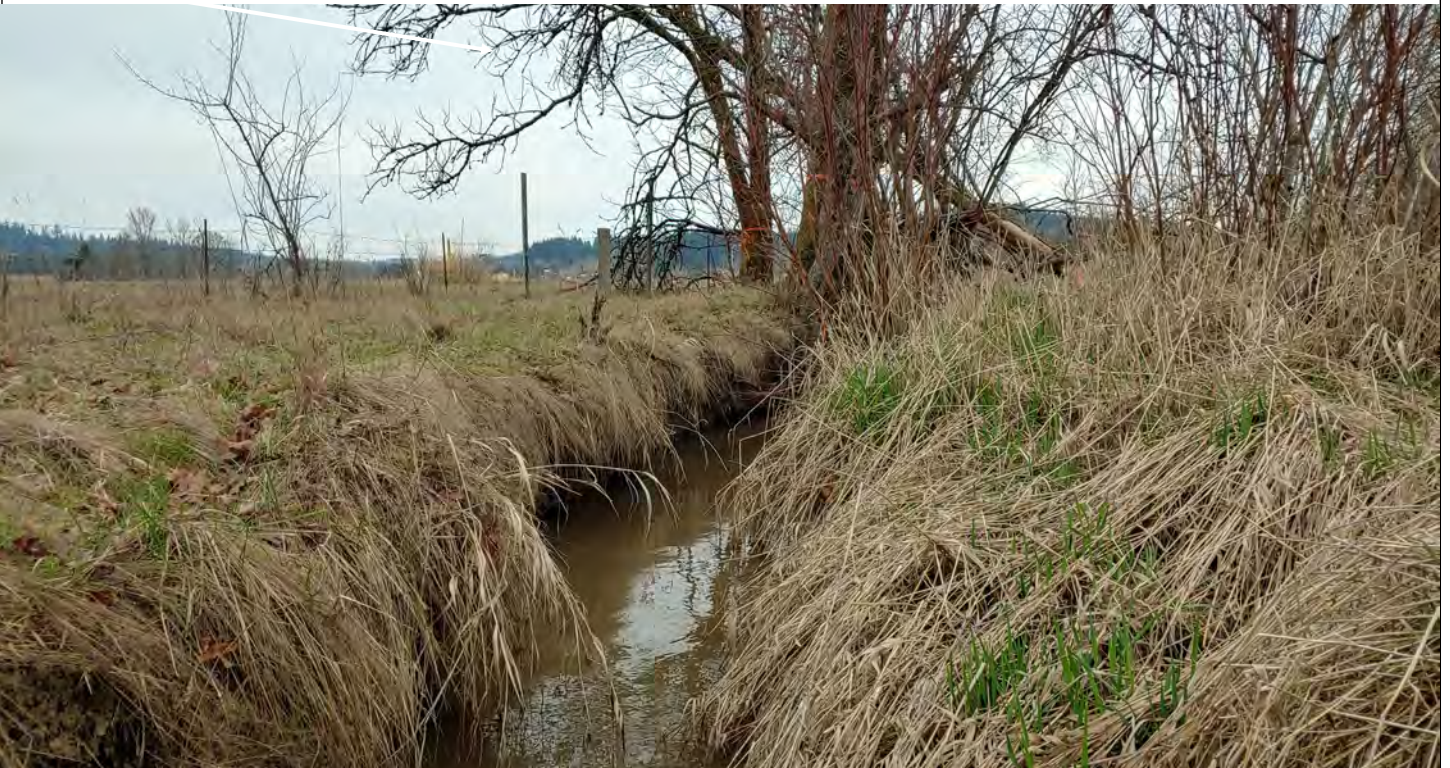
*Below:* (Photopoint 5) View east showing existing stream channel and surrounding vegetation. Oregon white oaks, with orange flagging, are visible in the center, March 2019.

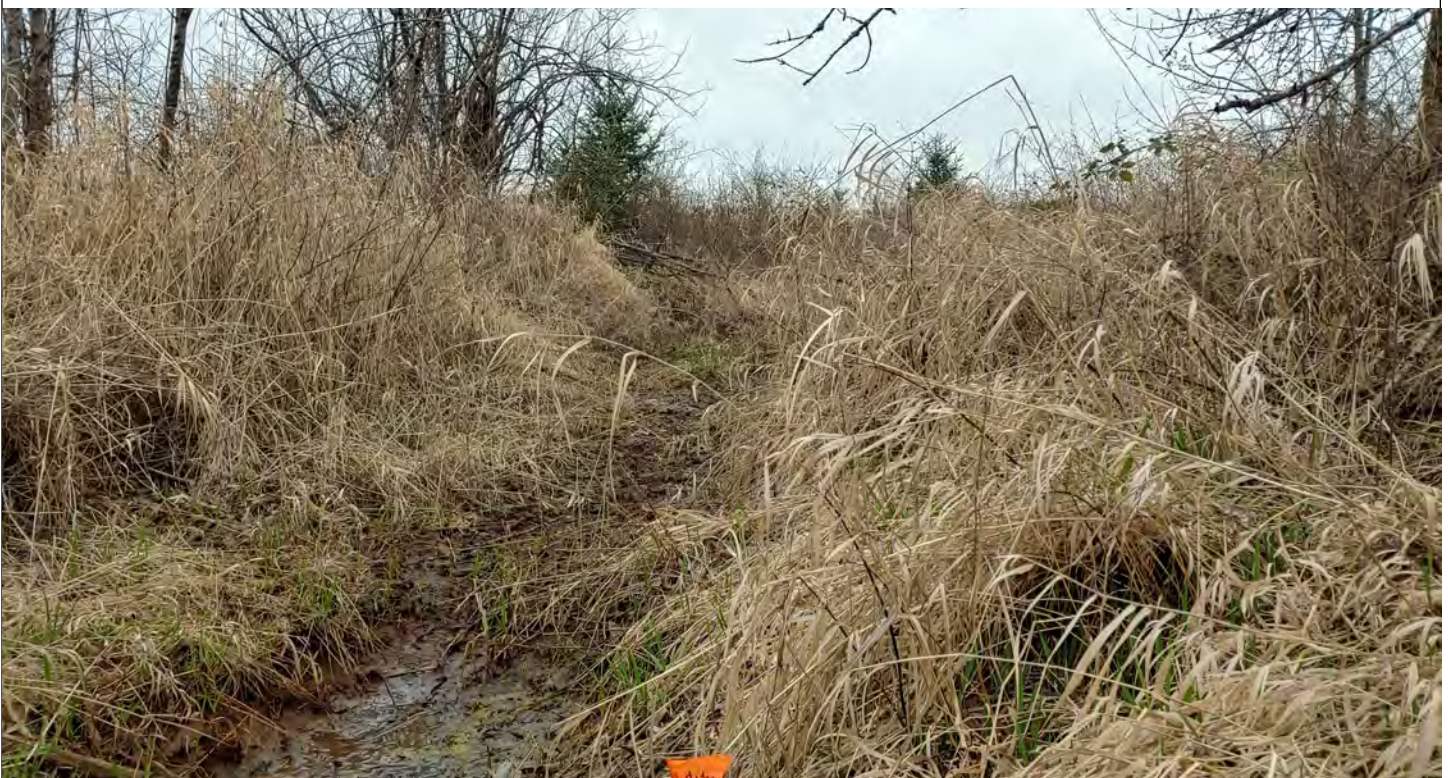
Above: (Photopoint 8) View northeast showing Ditch B, March 2019.

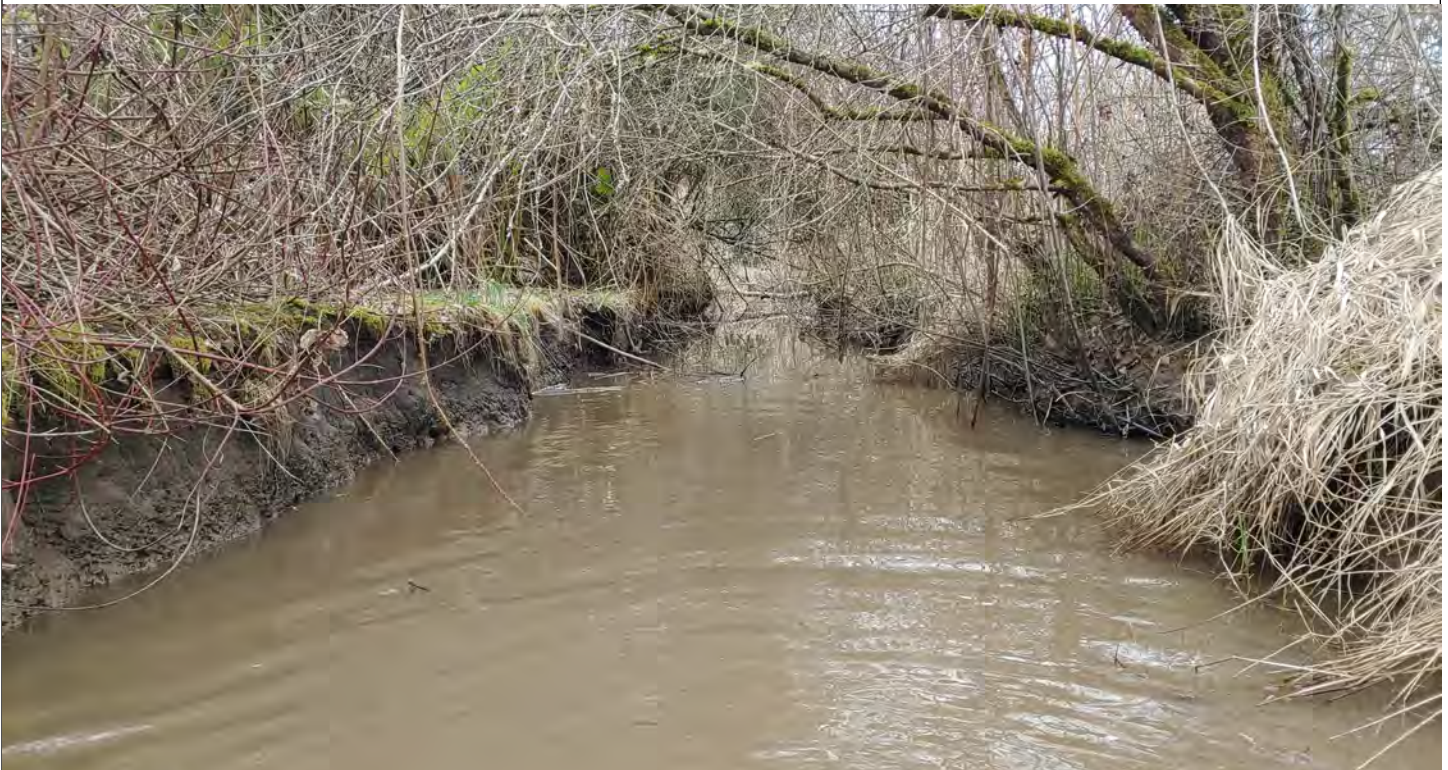
Below: (Photopoint 9) View east showing incised stream channel, March 2019

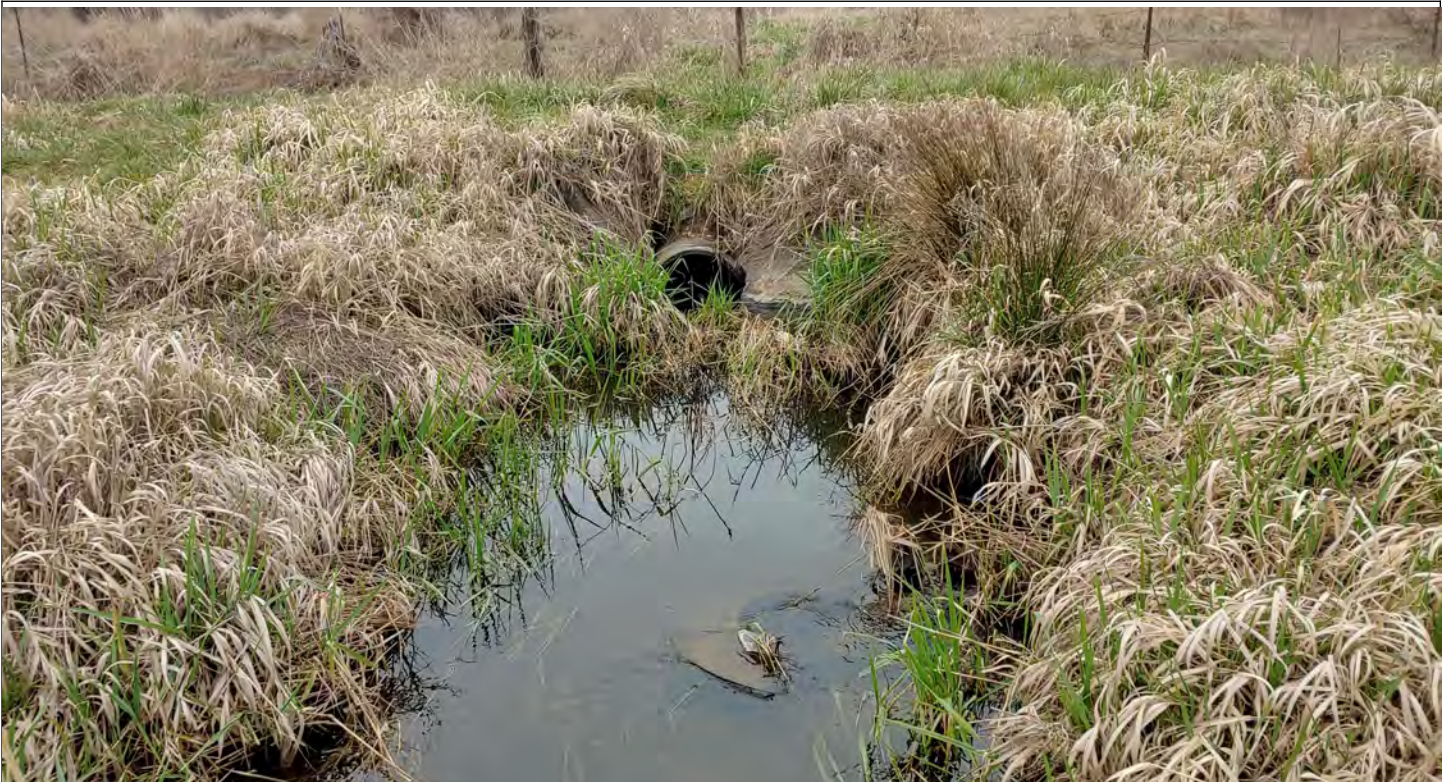
*Above:* (Photopoint 10) View east showing Ditch A and crossing with culvert, March 2019.

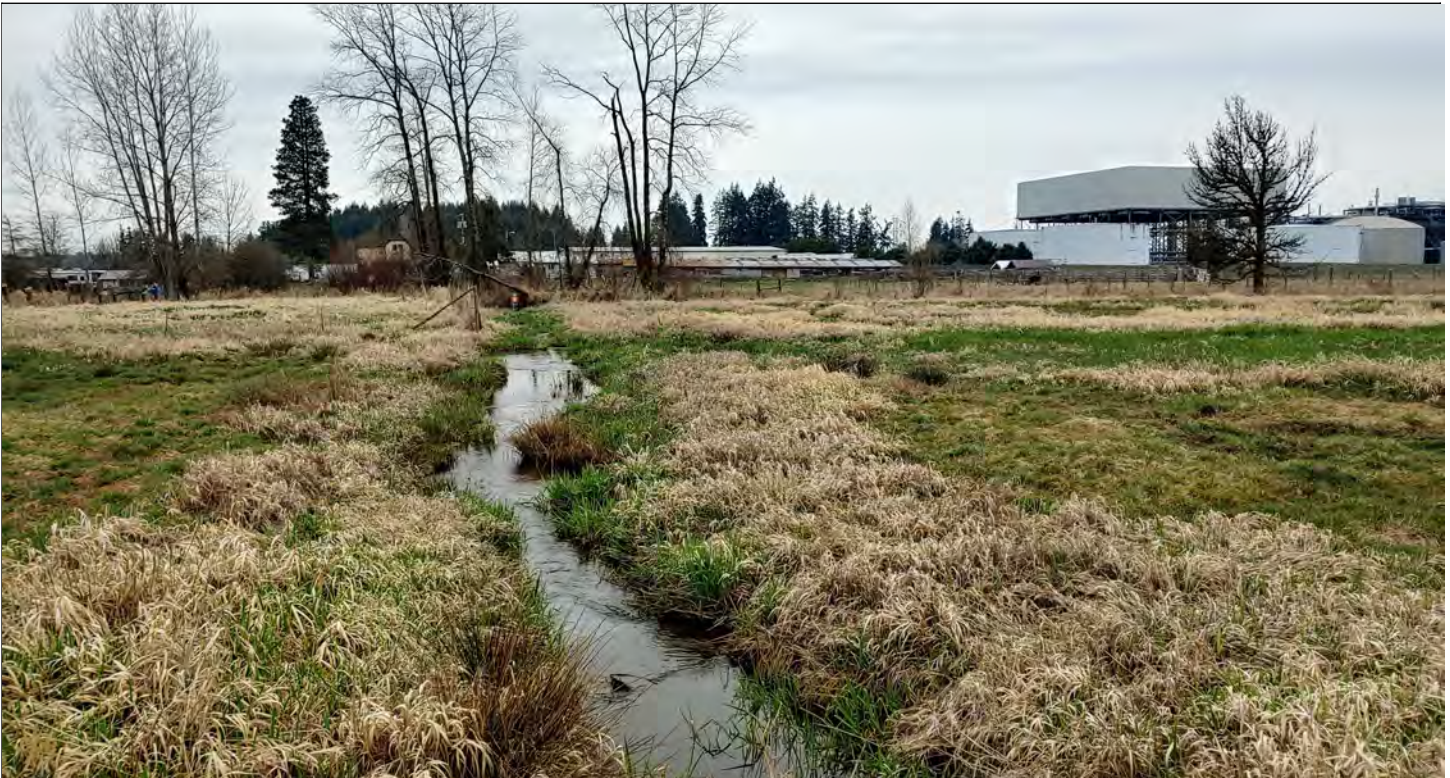
*Above:* (Photopoint 12) View west showing Ditch A. Berwick Creek is in the background, March 2019.
