Geotechnical Report

Twin Transit

**1820 N. National Avenue
Parcels 005605100003 & 005605100004
Chehalis, Washington 98532**

PTI Project # 200004

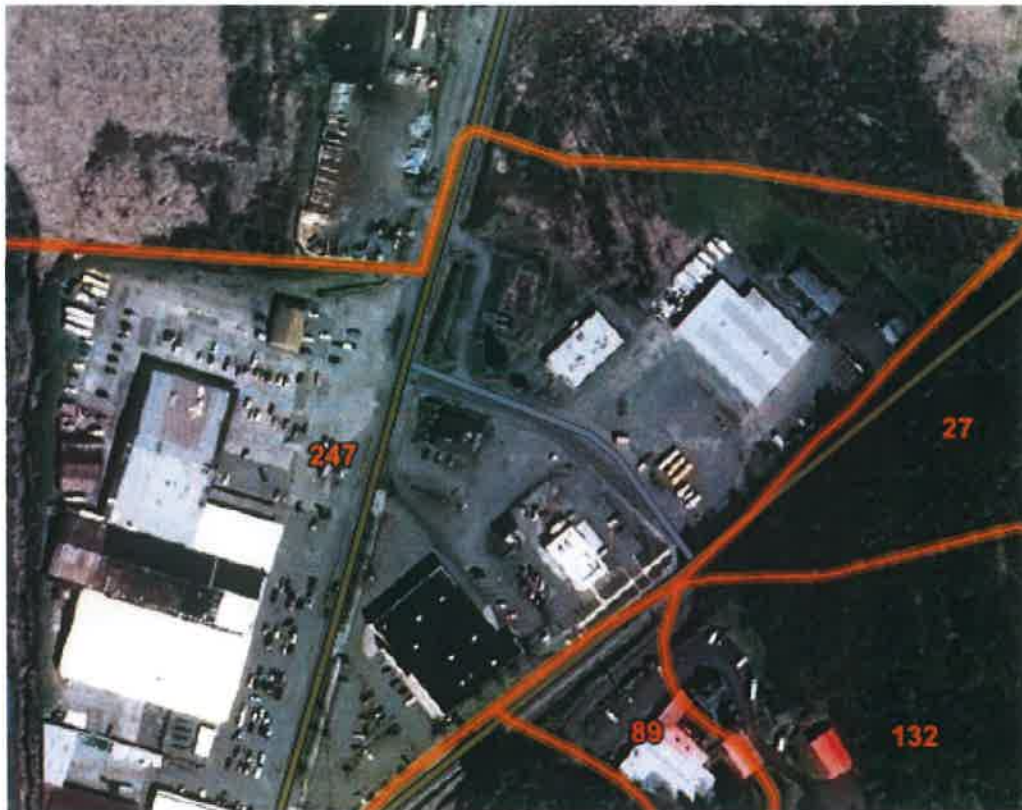
Soil Survey From USDA Natural Resources Conservation Service

According to the “Soil Survey of Lewis County,” by the United States Department of Agriculture, Soil Conservation Service, the site soils are described as Xerorthents, spoils, 247. The soil designations are depicted in the aerial photograph below, and descriptions are provided in Appendix B of this report.

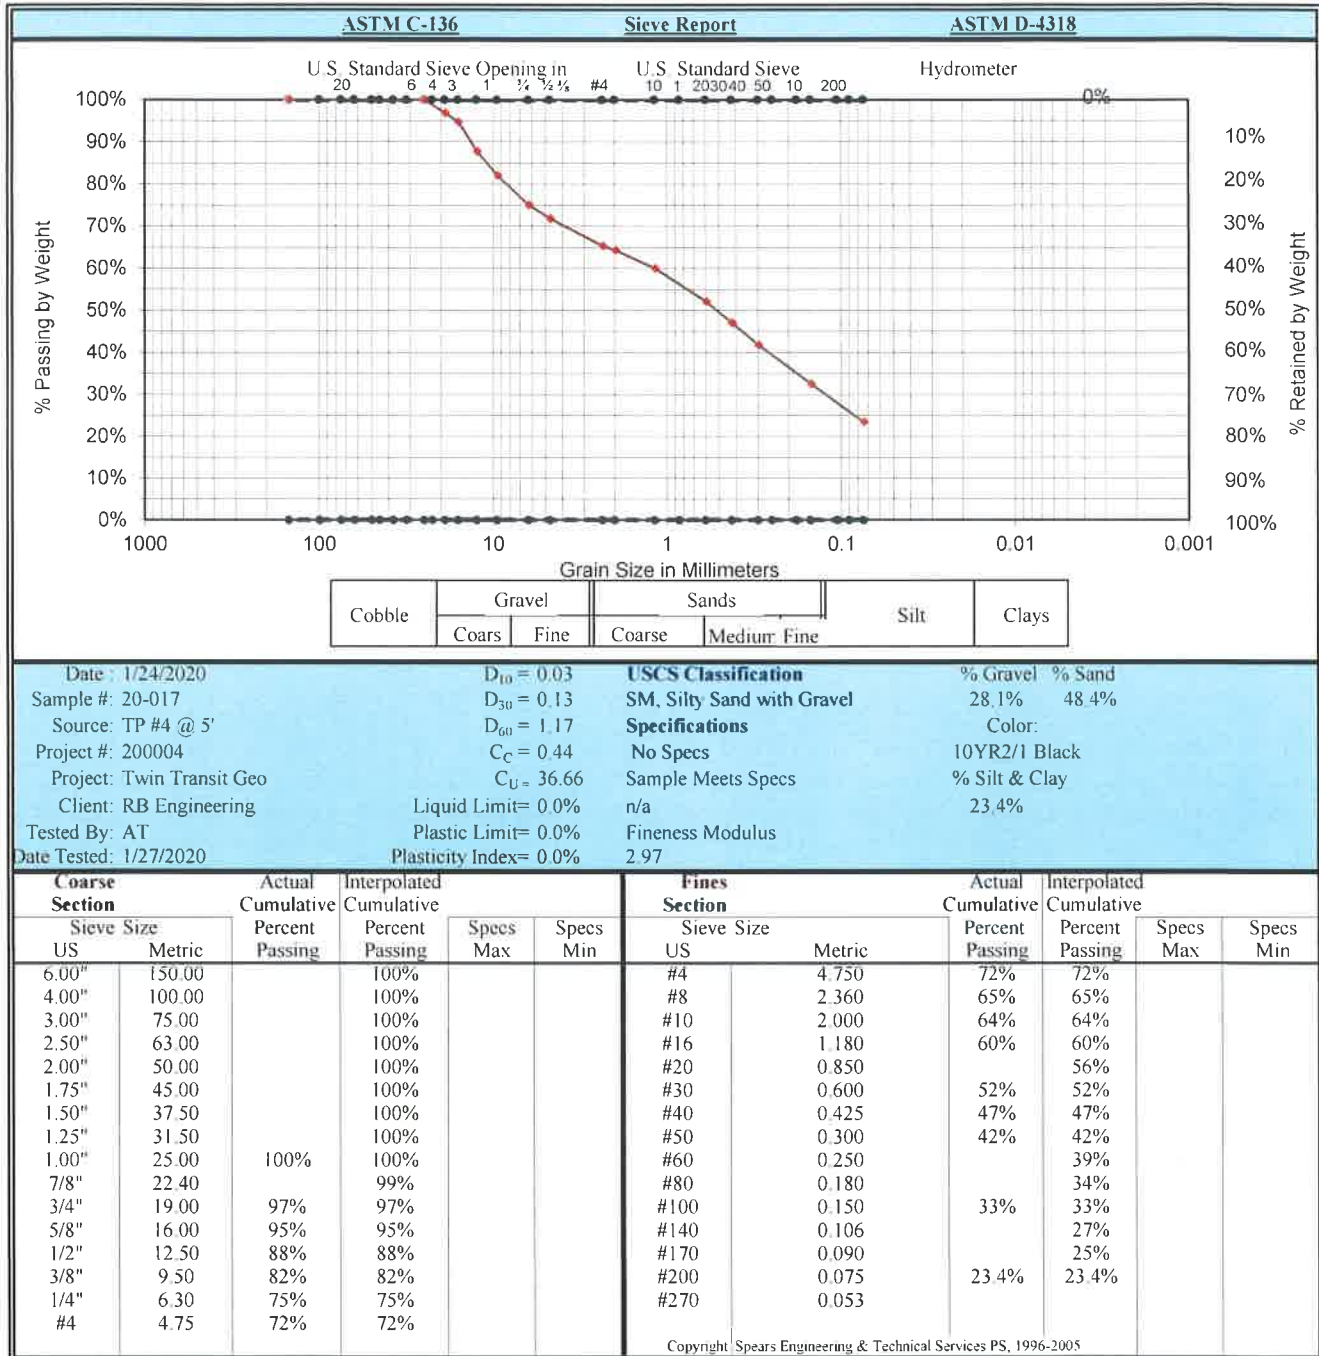
Comments: Moisture content - 20.1%

The results from the sieve analysis, performed by PTI, are provided in Appendix C of this report. The moisture content tests are shown on our soil logs in Appendix B.
