RUSSELL
DEVELOPMENT LLC.

Aquatic Assessment

215 N Hamilton Road
PARCEL #017896002000, 017896006015, 017896006001

Re: Aquatic Assessment - 215 N Hamilton Road, Parcels 017896002000, 017896006015,
017896006001

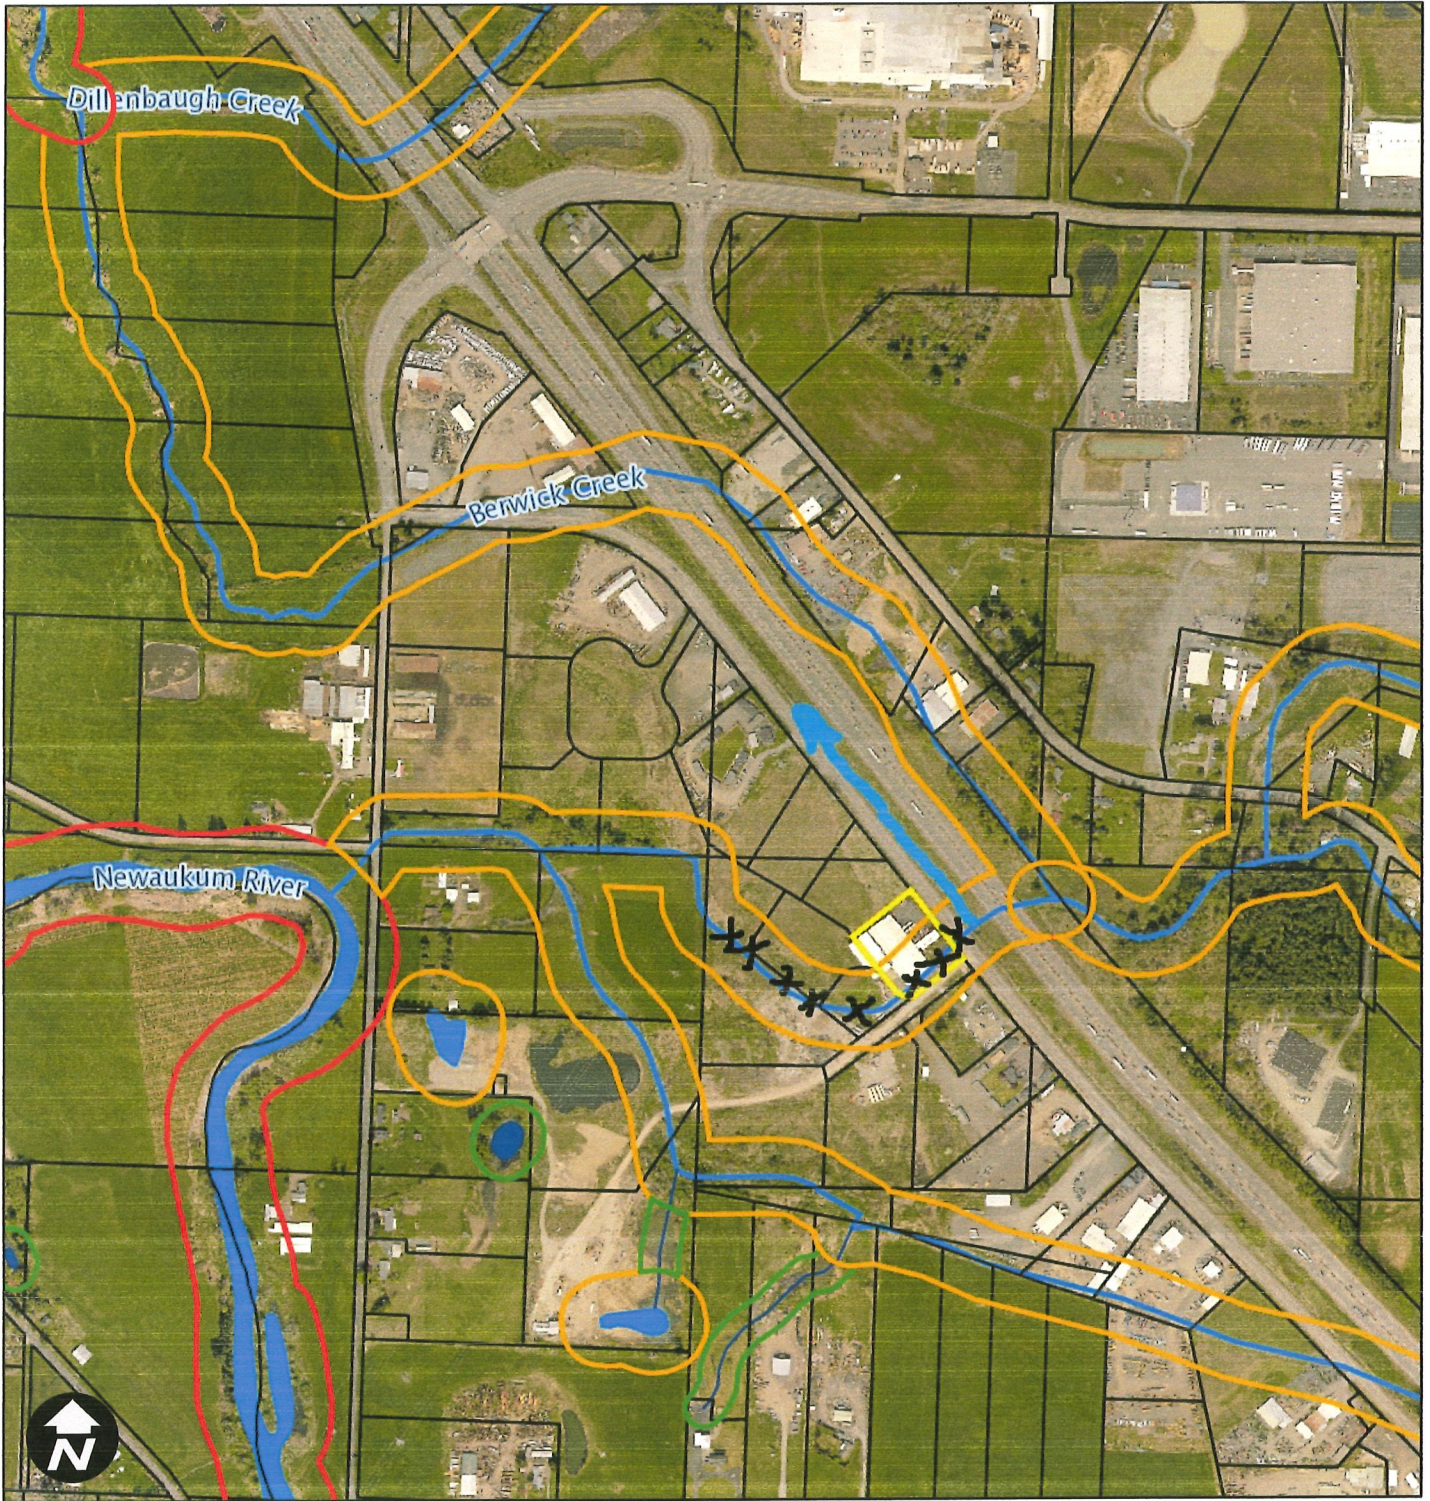
Lewis County GIS Web Map

Parcel 017896002000 (site of Stihl NW) fronts Hamilton Road and Interstate 5, with parcels 017896006015 and 017896006001 located behind the existing building. A stem of Berwick creek appears to approach and cross under I-5 from the east. Once in the median, this stem of Berwick creek turns north and runs for approximately 1200' where it rejoins Berwick Creek.

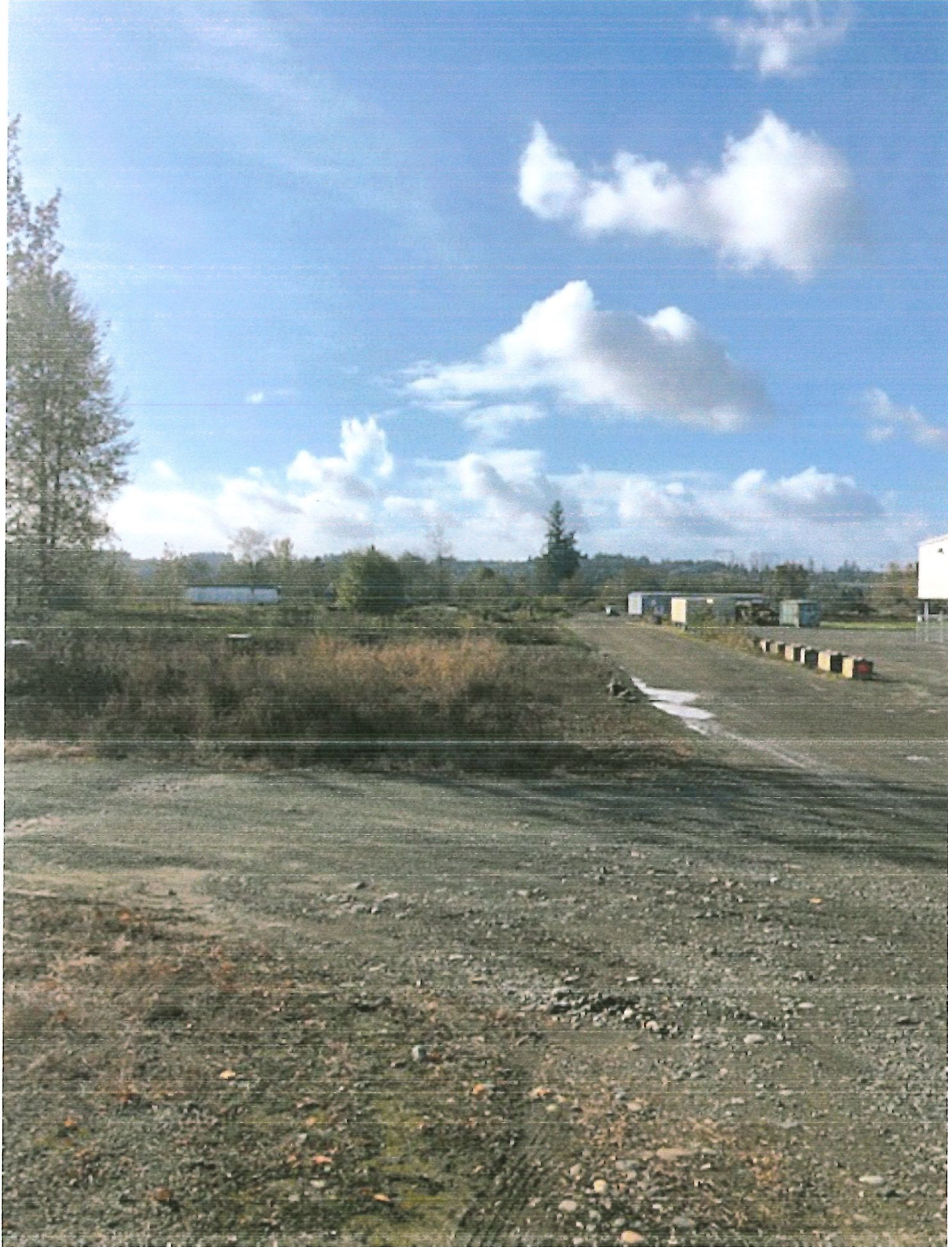
This view is looking North into the NW corner of the parcels of interest. The corner stake is visible, and it is clear that the ditch terminates into the NW corner where there is no outlet.

The existing ditch on the west border of these three (3) parcels has no means for water to flow into it on the SW corner of the property and no exit on the NW corner of the property. The ditch serves no function and can be abandoned and filled without any adverse ecological effects.

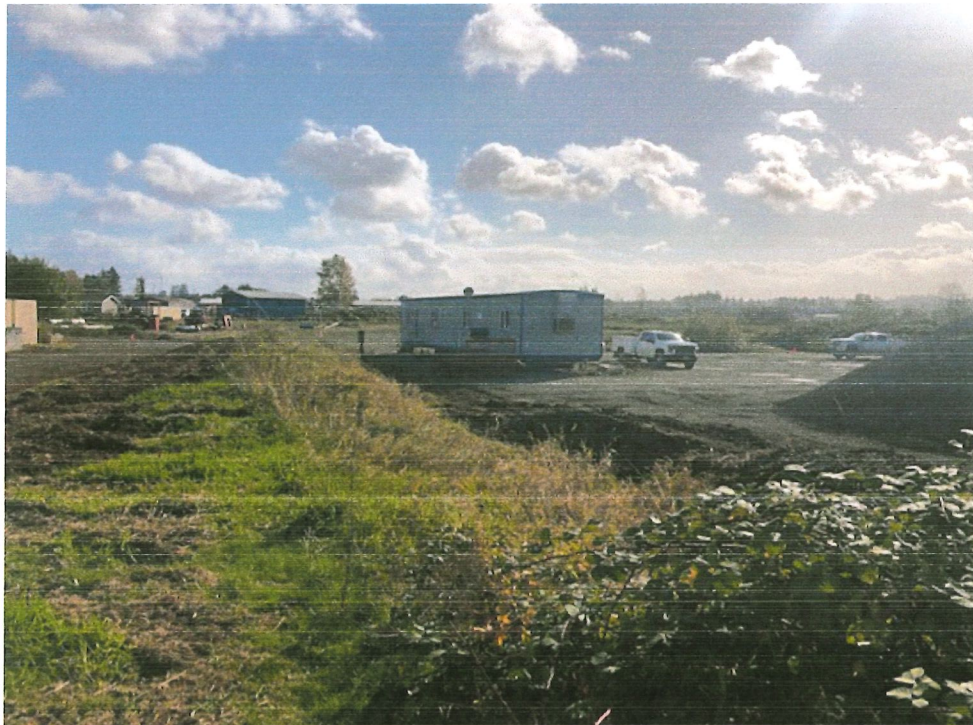
View from Hamilton Road west up the south property line. No evidence of Type F stream is visible.

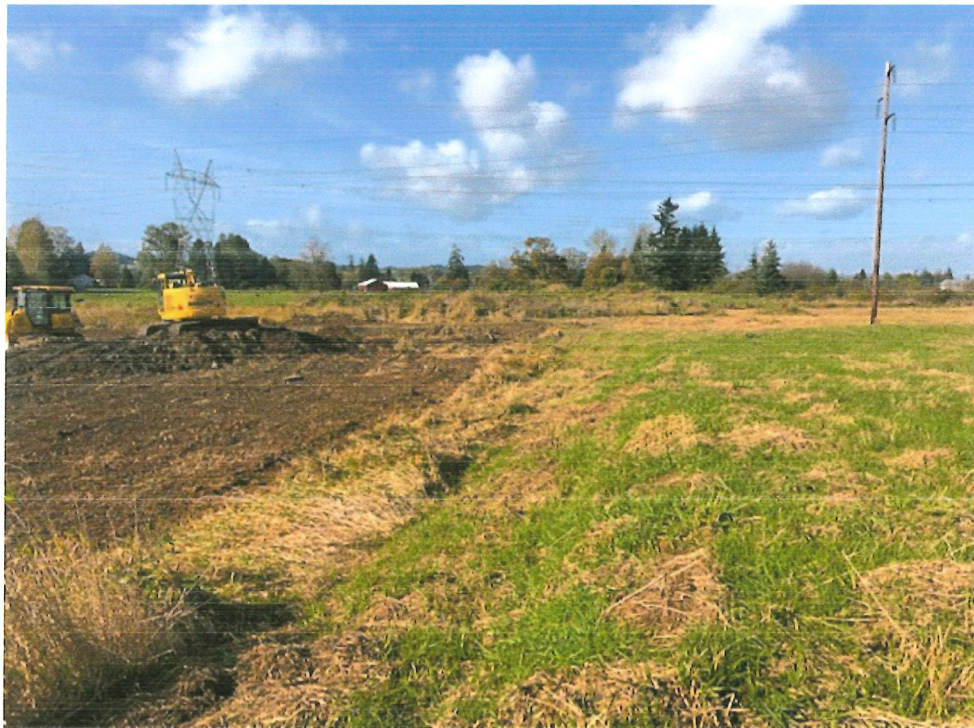
Site inspection also revealed remnants of a historical ditch located on the west side of the parcels listed, running from the SW corner to the NW corner, but this ditch begins at the edge of a road and empties into a low spot of ground in the NW corner. There is not inlet or outlet flow from this ditch. The undefined ditch currently divides the Stihl NW parcels listed and their industrial neighbor to the west. This ditch can be abandoned and filled as it serves no ecological or useful function.

View south along the west property line. The remnants of this ditch begin and end along this west property line. There is no evidence of any type of stream.

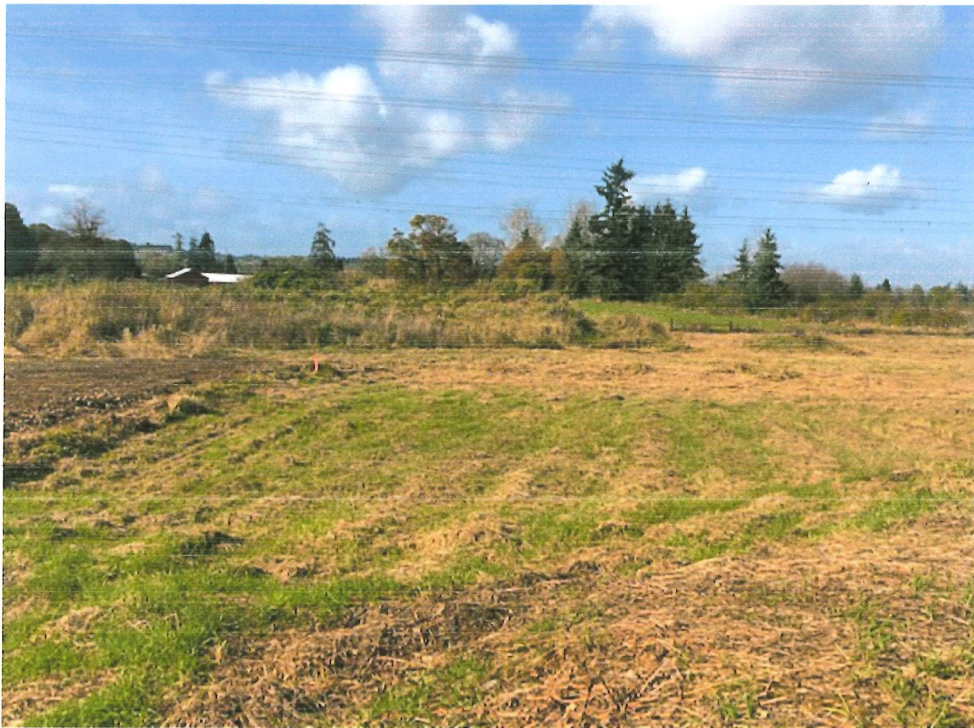
North view along the west property line. There is not inlet or outlet to this in defined ditch.
