HABITAT ASSESSMENT & RIPARIAN BUFFER ENHANCEMENT PLAN

September 17, 2020

Jesus Name Pentecostal Church
Lewis County, Washington

Prepared by
Ecological Land Services
1157 3rd Avenue, Suite 220A • Longview, WA 98632
(360) 578-1371 • Project Number 3091.01

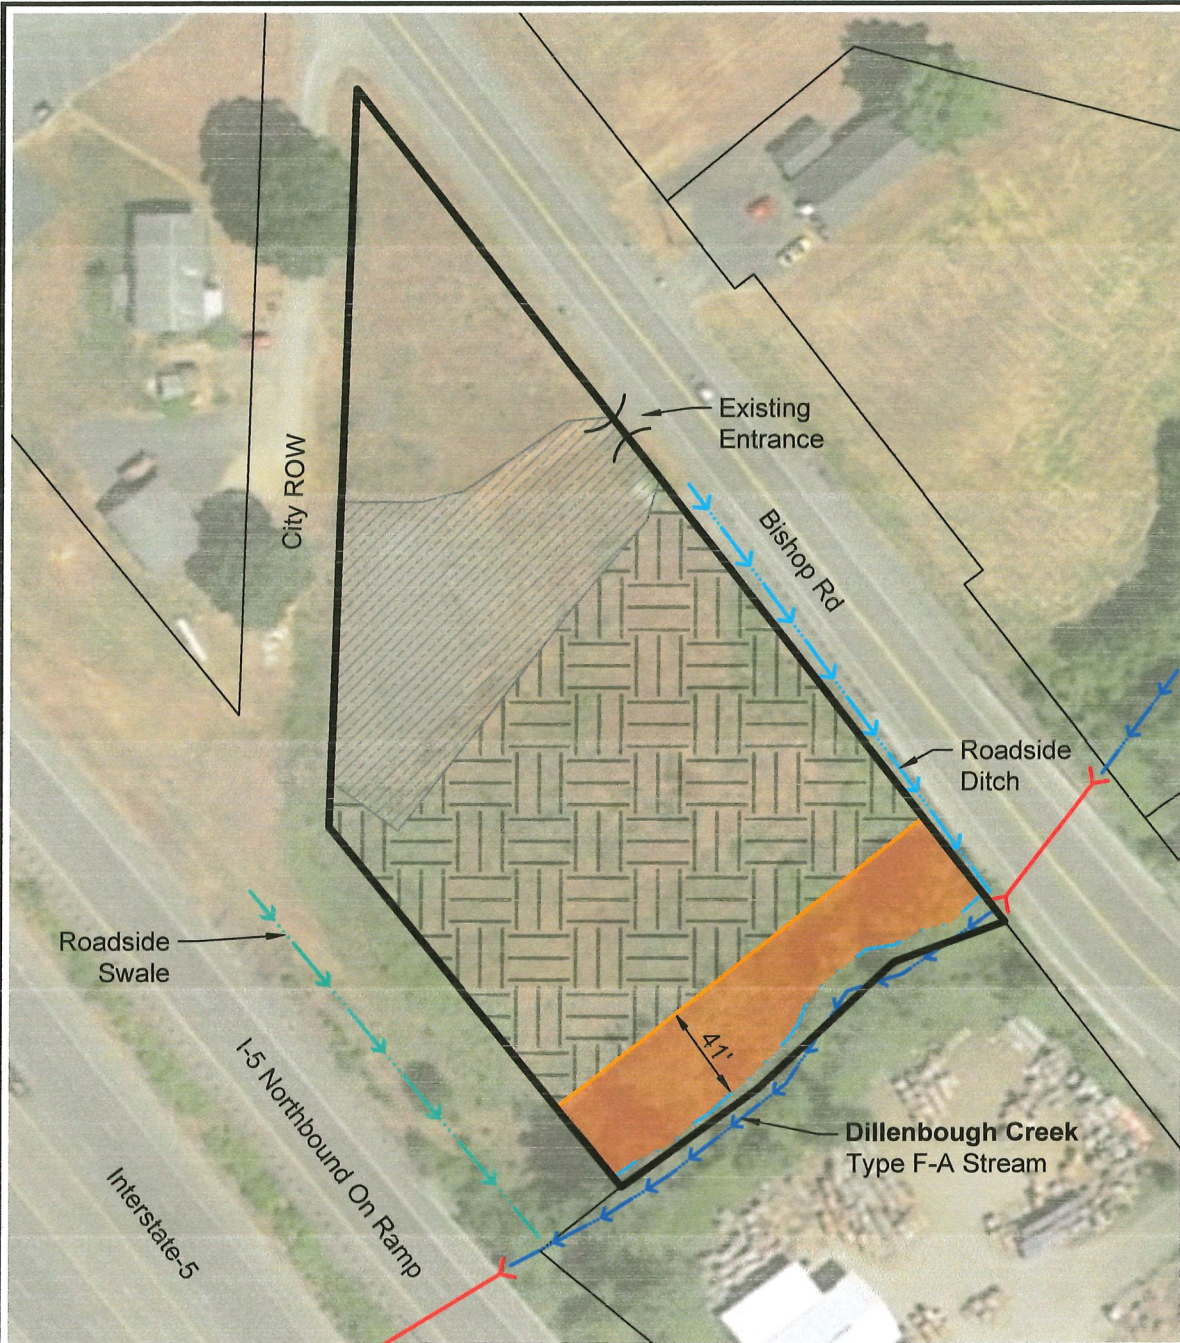
Figure 2
EXISTING CONDITIONS MAP
 JNPC Habitat Assessment
 Shannon Burgess
 Chehalis, Lewis County, Washington
 Section 9, Township 13N, Range 2W, W.M.

- LEGEND:**
- Site Boundary
 - Parcel Boundary
 - OHWM
 - Stream with Flow Direction
 - Swale with Flow Direction
 - Roadside Ditch with Flow Direction
 - Existing Fill
 - Existing Gravel Surface
 - Edge of Fill
 - Riparian Buffer
 - Culvert

- NOTE(S):**
1. Aerial from Google Earth™.
 2. OHWM was mapped by an ELS Biologist using a hand-held GPS unit with submeter accuracy.

The subject property is bordered on the southwest by Interstate 5 (I-5) and on the northeast by Bishop Road. The church and pastor's personal residence is located northwest of the site just beyond an unimproved City right-of-way (ROW). Dillenbaugh Creek forms the southeastern boundary of the property. The majority of the site was filled and levelled in 2006 with only the northernmost portion sloping from the northeastern corner towards the City ROW. In 2009, approximately 13,500 square feet of the site was further filled with gravel which was placed from the existing driveway along Bishop Road to the City ROW.

According to CMC 17.25.030(B)(2), Type F-A streams have a standard designated 150-foot buffer. The CMC also recognizes that buffers shall not extend across “hardened surfaces” due to these areas being functionally and effectively disconnected from the stream in 17.24.030(C). In this case, the existing fill area onsite extends to the top of the slope, effectively functionally isolating the buffer. The existing functionally isolated buffer averages approximately 45 feet from the OHWM.

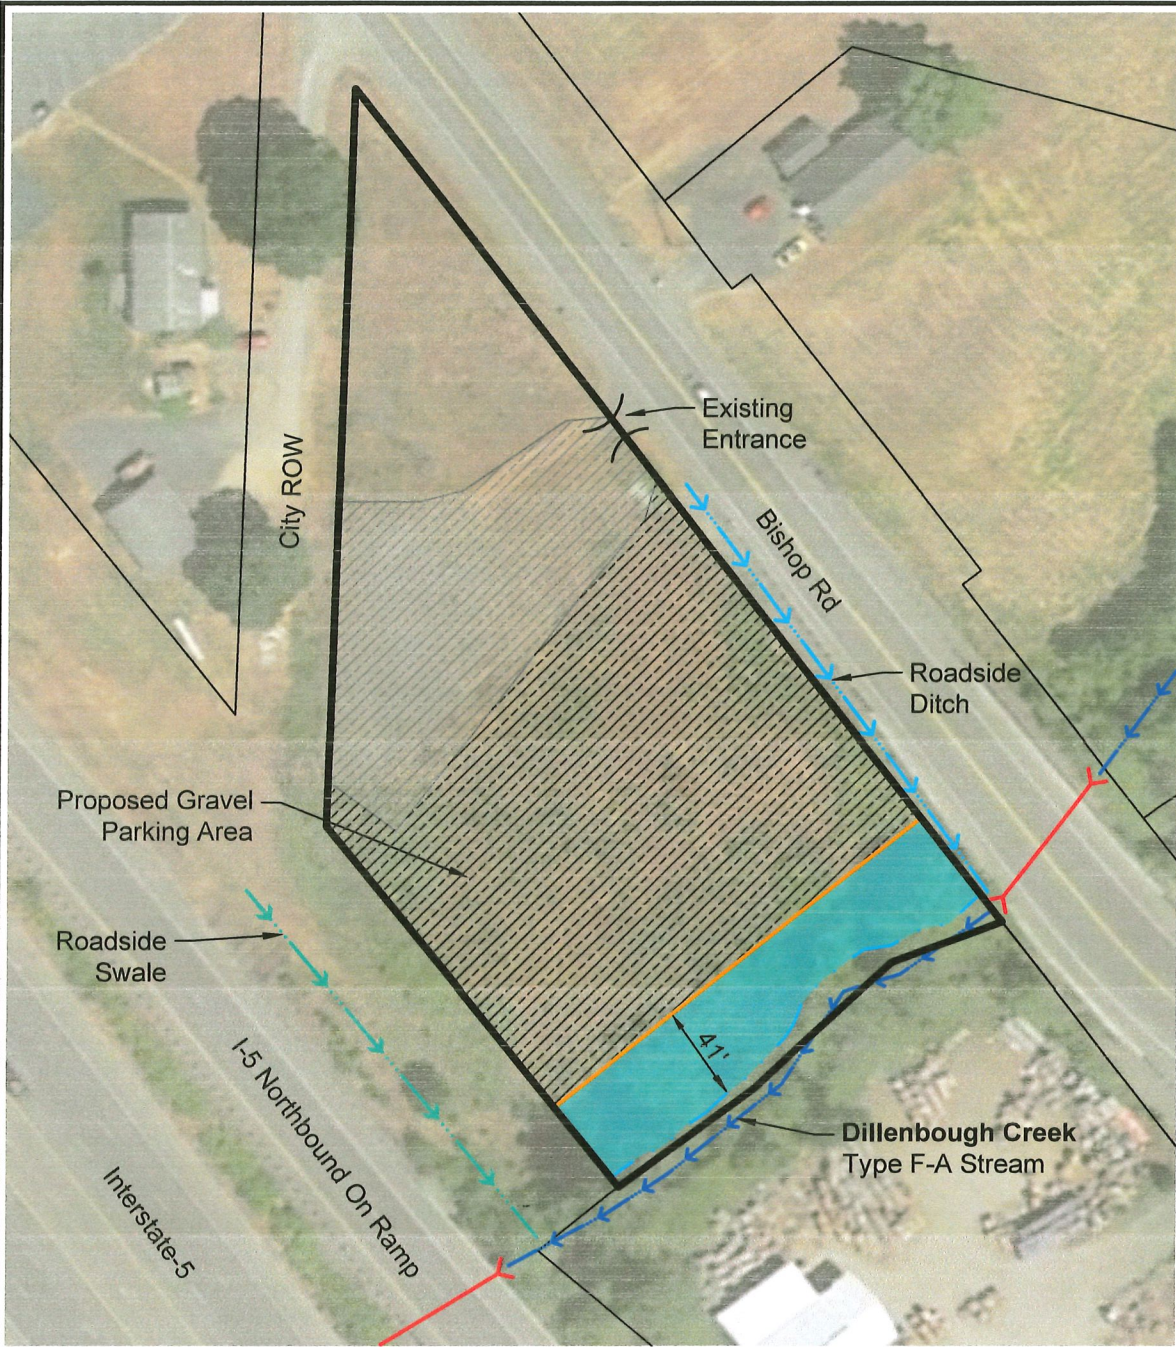
Figure 3
PROPOSED CONDITIONS MAP
 JNPC Habitat Assessment
 Shannon Burgess
 Chehalis, Lewis County, Washington
 Section 9, Township 13N, Range 2W, W.M.

- LEGEND:**
- Site Boundary
 - Parcel Boundary
 - OHWM
 - Stream with Flow Direction
 - Swale with Flow Direction
 - Roadside Ditch with Flow Direction
 - Existing Gravel Surface
 - Edge of Fill
 - Riparian Buffer Enhancement Area (0.17 ac.)
 - Proposed Gravel Parking Area
 - Culvert

- NOTE(S):**
1. Aerial from Google Earth™.
 2. OHWM was mapped by an ELS Biologist using a hand-held GPS unit with submeter accuracy.

Construction activities will consist of the addition of approximately 660 cubic yards of gravel over top of the existing fill pad to create an additional parking area for church services and activities. The existing northern riparian buffer of Dillenbaugh Creek will be enhanced via removal of garbage and state and county-listed noxious weeds to allow the native vegetation to become denser to create better protection of the stream and riparian functions.

The goal of the enhancement plan is to create an increase in ecological function of the riparian buffer onsite. The northern riparian buffer is functionally isolated by the existing compacted fill (hardened surface) and only extends for approximately 45 feet from the OHWM of Dillenbaugh Creek. The remaining 0.17 acres of buffer will be enhanced via removal of garbage and state and county-listed noxious weeds. The removal of state and county-listed noxious weeds will reduce inter-species competition and allow the native vegetation to become more dense to create better protection of the stream and riparian functions.

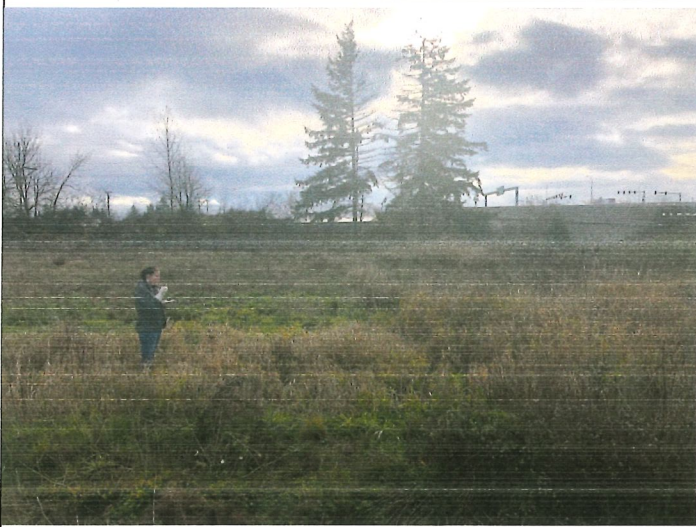
Photo 1

Photo taken from the existing gravel pad in the central portion of site facing south towards Dillenbaugh Creek. I-5 can be seen in the right of the frame.

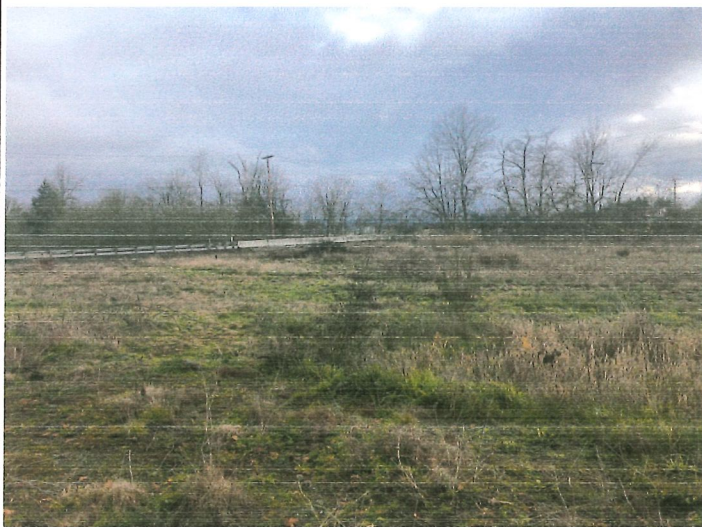
Photo 2

Photo taken from approximately same location as Photo 1, facing southeast. Bishop Road can be seen in the left of the frame.

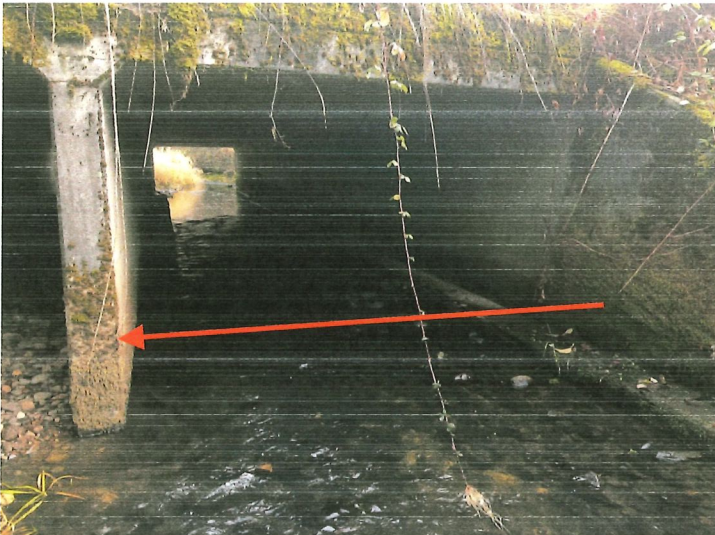
Photo 3

Photo taken from the easternmost point on the site facing northeast through the box culvert under Bishop Road. The OHWM can be seen along the culvert walls in the form of water staining. The red arrow denotes the OHWM.

ELS conducted a site visit on November 15, 2019 to collect measurements and photographs, observe site conditions, and determine the western OHWM of the unnamed stream onsite. The northern OHWM of Dillenbaugh Creek located in proximity to the construction area was determined using standard methodology as described in the Washington State Department of Ecology (Ecology) manual: *Determining the Ordinary High Water Mark on Streams in Washington State* (Olson and Stockdale 2010). The main indicators used to determine the OHWM was the water stain along the culverts located under Bishop Road and I-5.

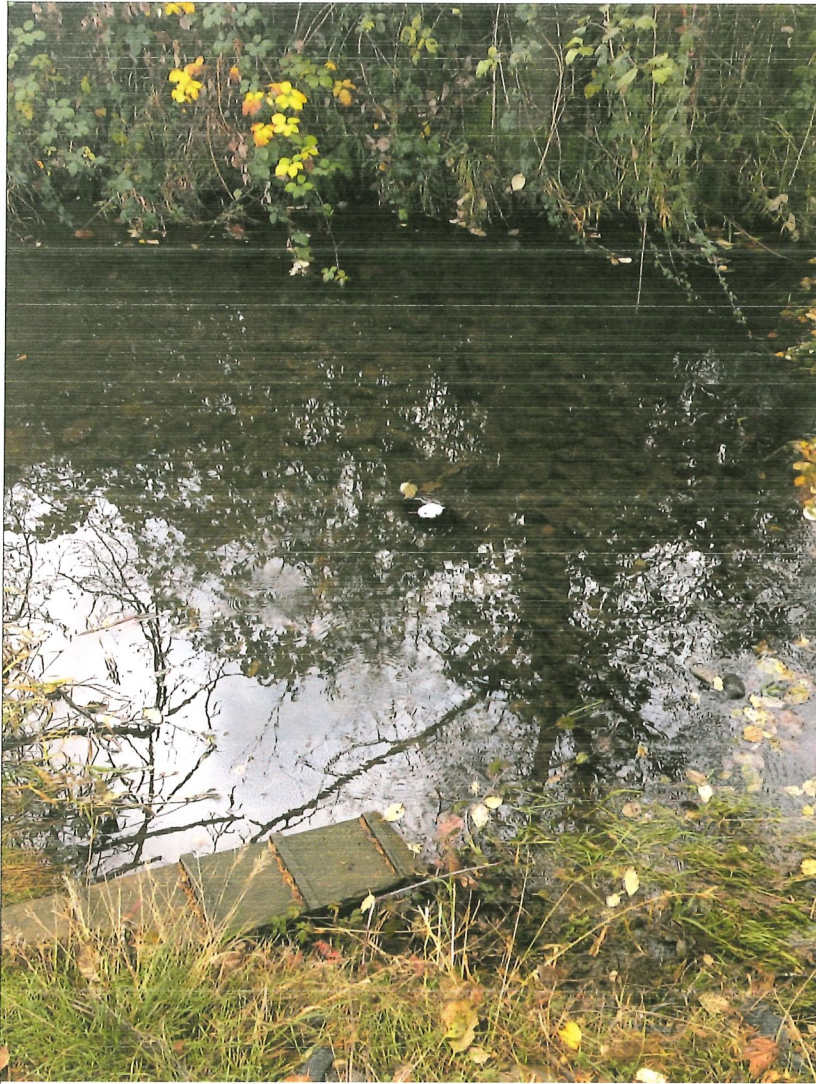
Photo 4

Photo taken from the approximately same location as Photo 3 facing across Dillenbaugh Creek. Note the presence of garbage and Himalayan Blackberry.

The area southeast of the existing fill slopes moderately for approximately 45 feet down to Dillenbaugh Creek, a fish-bearing perennial stream with a defined channel greater than 10 feet which according to CMC 17.25.020(A)(2), makes it a Type F-A Water. The streambed substrate was composed of rocky rubble containing pebbles to small boulders. The creek has a defined bed and steep banks with overhanging vegetation. Garbage piles are present within the riparian buffer onsite due to transient activity.

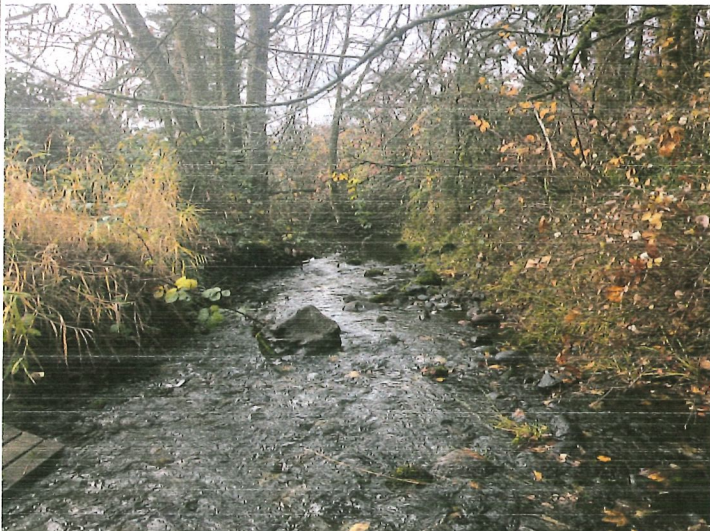
Photo 5

Photo taken from the southernmost point on the site facing upstream along Dillenbaugh Creek. Note the presence of garbage and reed canarygrass.
