Stormwater Site Plan

WSECU CHEHALIS
Chehalis, WA

July 2021

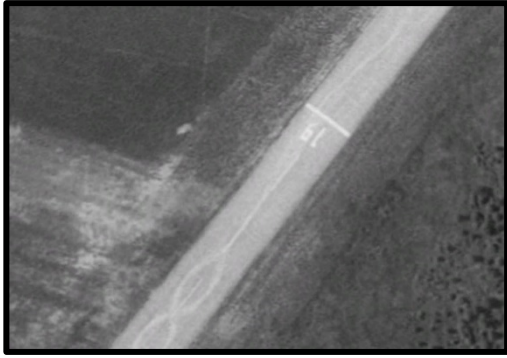
Figure 1: Existing Conditions (1990)

The subject site is +/- 2.74 acres in size. Topography within the property is generally flat throughout sloping to the south at slopes between 0 and 5%. The site was an airport landing strip until sometime in 1990 and 2003 when a neighboring development removed half of the air strip. By 2005, the remaining air strip was removed and a larger development to the north, Home Depot, was built along with NW Louisiana Ave and NW Arkansas Way and has sat largely unchanged since then. Vegetation appears to be minimal, with some grasses. No developments have been added since then. See the figures below.

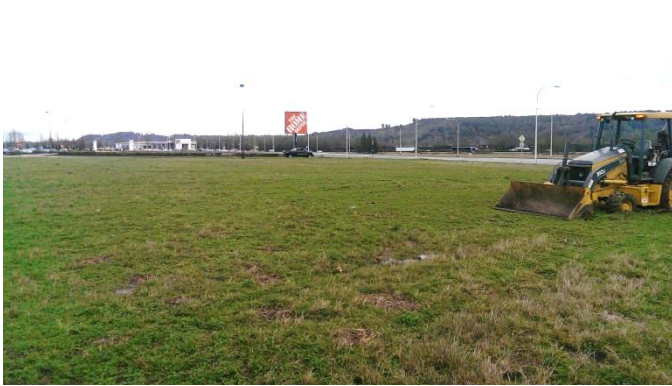
Photo 1. Looking East near West Corner of site

Most of the project site is nearly cleared of vegetation and covered with up to 10 feet of imported undocumented fill material from raising the site to current grade. The project site is relatively flat and gently slopes to the southeast. No significant cut or retaining structures are anticipated. However, relatively significant fill activities (around 2 to 4 feet or more across the site) are proposed due to prior flood elevations.

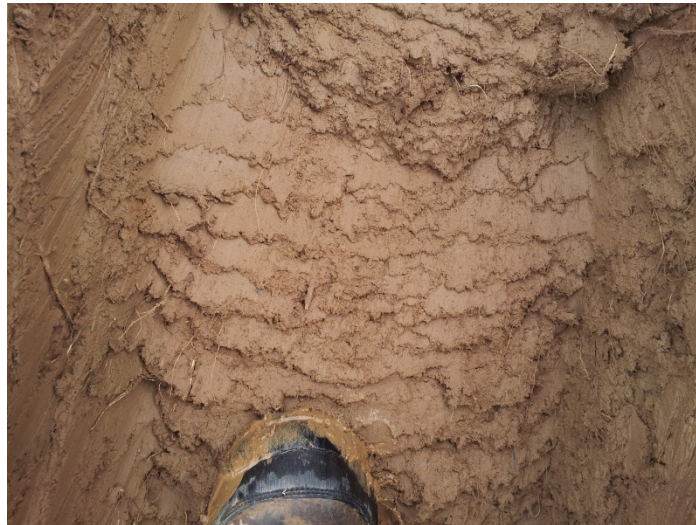
Photo 3. Typical surface fill soil.

Fill – ML / SM: An undocumented fill layer up to 10 feet thick covered the site. The fill material was generally a brown to orange-brown silt with sand to sand with silt and minor gravel. The fill material was generally in a very loose to loose condition with varying moisture content.

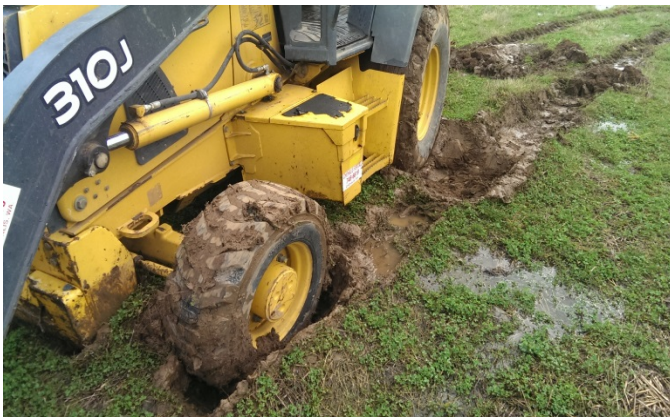
Photo 4. Excavation Equipment stuck in Soft Surficial Soil

We investigated the site on March 5, 2014, by attempting to excavate test pits, conducting hand augers, and advancing three penetration tests using a Wildcat Dynamic Cone Penetrometer (DCP) manufactured by Triggs Technologies, Inc. Test pit excavation was very limited due to the soft and slippery surficial soil conditions (equipment buried itself in the soft soil and had to be towed out).

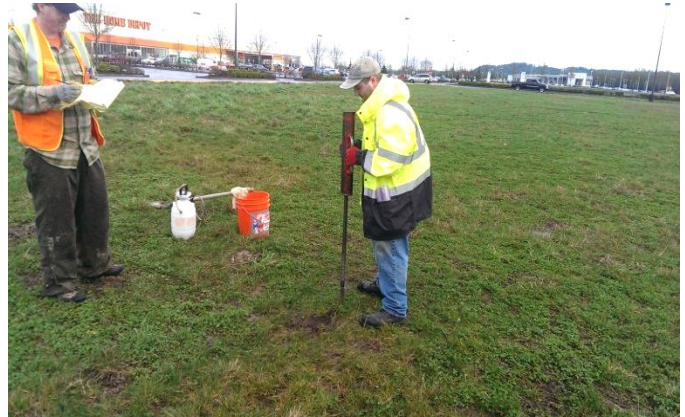
Photo 5. DCP Testing at DCP location P-1

The Wildcat DCP was utilized to determine the current bearing capacity of the soils. Blow counts were recorded for 10 centimeter increments as a 35-pound weight was dropped a distance of 15 inches. The DCP testing continued until groundwater was encountered and blow counts leveled off. Using a Triggs proprietary spreadsheet, the blow counts were then converted to resistance in kilograms per square centimeter (kg/cm^2), standard penetration blow counts (N'), and consistency descriptions. Our DCP logs are located in Appendix C of this report.
