Loowit Consulting Group, LLC

RE: Addendum to Jackson Villa 4 Project – Chehalis, WA.

Loowit Consulting Group, LLC (LCG) has completed an addendum to the critical areas report for Jackson Villa 4 – Lakewood Investors, LLC – in Chehalis, WA. The purpose of this addendum is (1) address comments from City of Chehalis letter dated June 16, 2021 and (2) document conditions of a seepage area on top of verified fill material in the northern portion of the subject site.

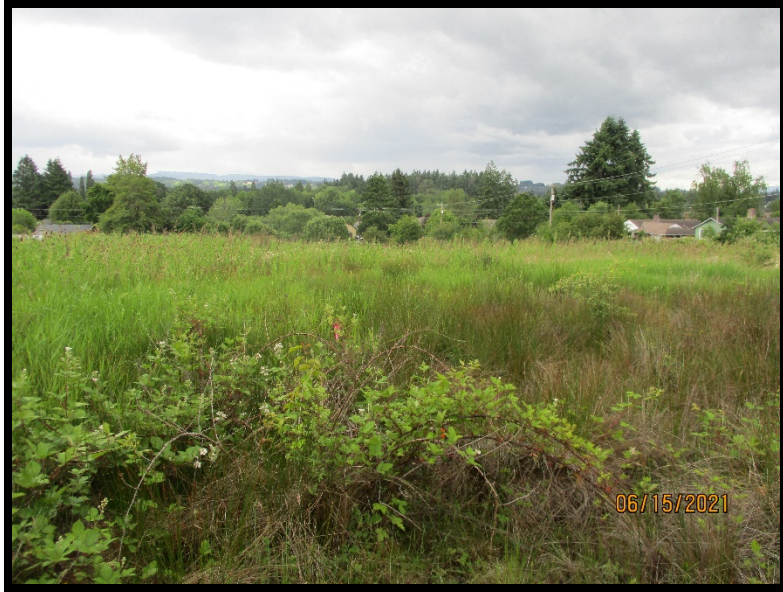
Photograph 1: Seepage area on top of document fill material.

The seepage area is approximately 40 feet wide by 95 feet long (1300 sq ft) and dominated by reed canary grass, teasel, and soft rush. Soils are non-homogenous fill material to a depth of 1 to over 10 feet below ground surface. Hydrology is 100% seepage from the upslope road fill beneath Hosanna Lane. Several hand auger holes along transects through the area confirmed the presence of imported fill and a single data point within the seepage area is attached.

The seepage area is obviously the result of seepage water entering the subject site from seepage originating from upslope ditches along Hosanna Lane which in turn flows beneath the road surface and discharges upslope of the subject site. If this drainage issue was corrected, the seepage area within the northern portion of the subject site would disappear.

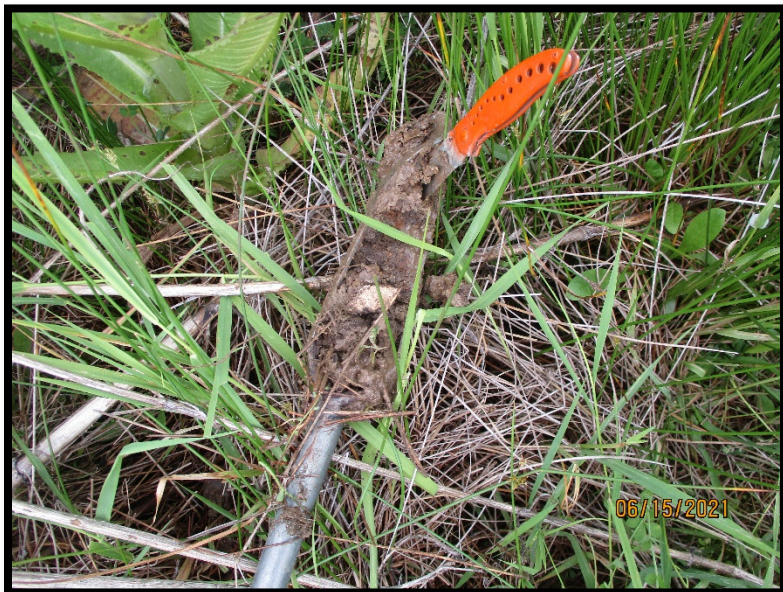
The fill material has been well documented by the geotechnical engineers and civil engineers involved with developing the site into residential housing. The fill material is quite diverse including clays, silts, angular gravel, round gravel, boulders, concrete, asphalt, bricks, organic material, cans, bottles, and miscellaneous other debris (Photograph 2).

Photograph 2: Soil core from 15 to 18 inches below ground surface. Unconsolidated clays and silts with visible organic material, charcoal, angular rock, brick, etc. White material in center of the photograph is a piece ceramic coated pipe or similar material. Auger hit refusal at 20 inches, likely concrete based on chunks of concrete on the surface.

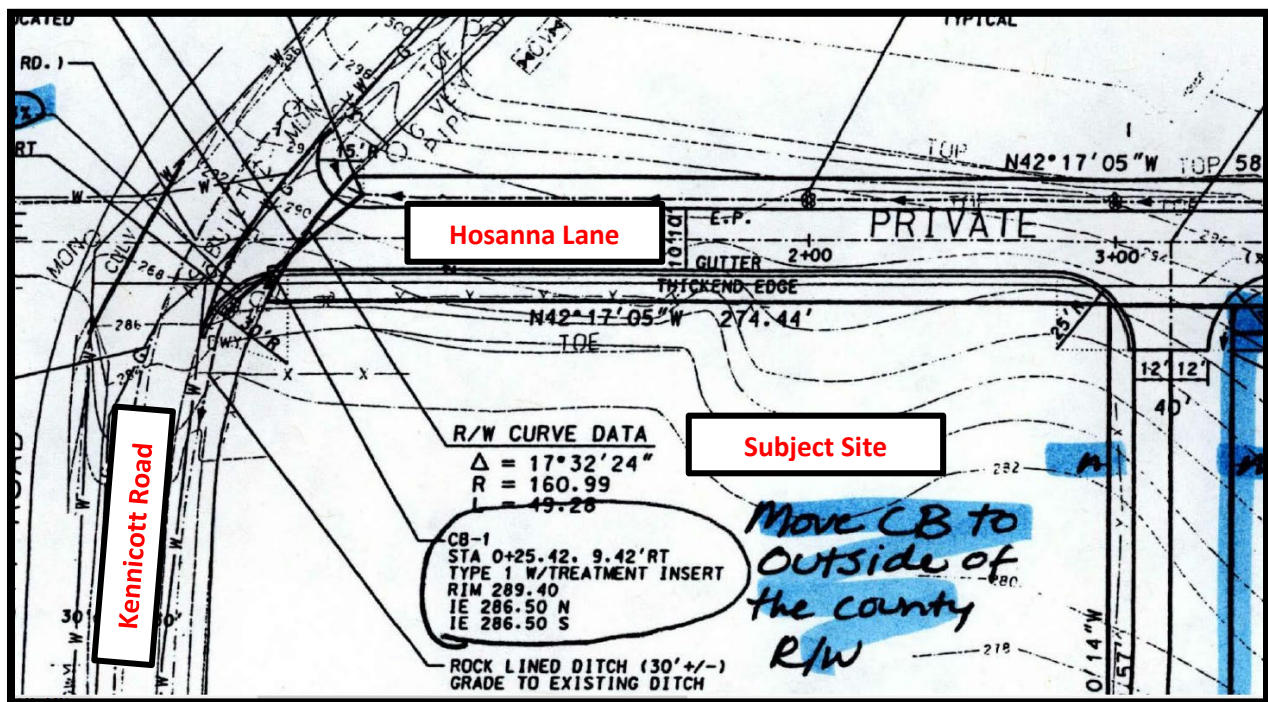
During 2004/2005, Hosanna Lane was designed, approved and constructed within a 40-foot right of way to provide access to three residential lots approved under Short Plat SP-03-0029. Hosanna Lane was constructed along the northern edge of the subject site including storm water runoff collection ditches and a buried utility corridor along the southern edge of the street (see below).

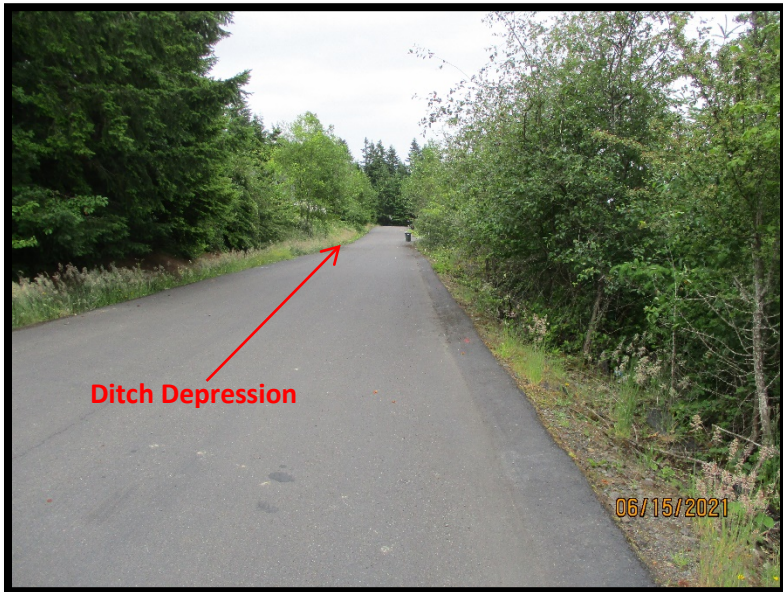
When Hosanna Lane was constructed, a minimum of 10 inches of crushed gravel was used as base material to which four inches of asphalt was placed to provide an all-weather driving surface. A V-shaped ditch was also constructed on the north side of Hosanna Lane to collect and convey runoff away from the road surface (see below). Unfortunately there is a prominent depression (Photograph 3) in the V-shaped ditch that allows water to pond, seep through the road sub-base gravel and leak onto the subject site creating an artificial seepage area on top of existing fill material. Further evidence of saturated conditions under Hosanna Lane is very prominent settlement cracks directly above the area where seepage water is enter the subject site (Photograph 4).

Photograph 3: Looking east along Hosanna Lane with subject site to the right. The V-shaped ditch to the left has a prominent depression opposite the garbage can where water ponds and seeps under the road from left to right onto the subject site.

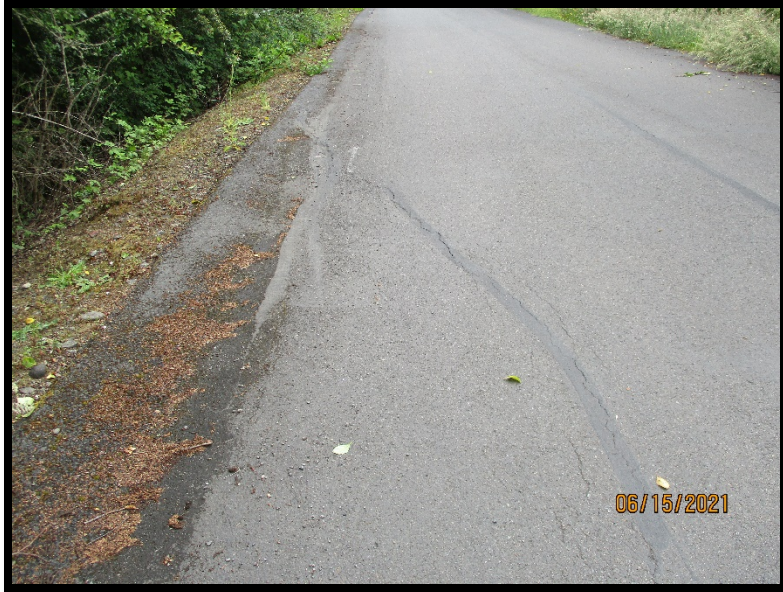
Photograph 4: Settling cracks on Hosanna Lane from saturated conditions under the asphalt. The subject site is to the left and ponded V-shaped ditch to the left.
