Hicks RV Park

Chehalis, WA

Drainage and Erosion Control Report

Fuller Designs Project No. 2140

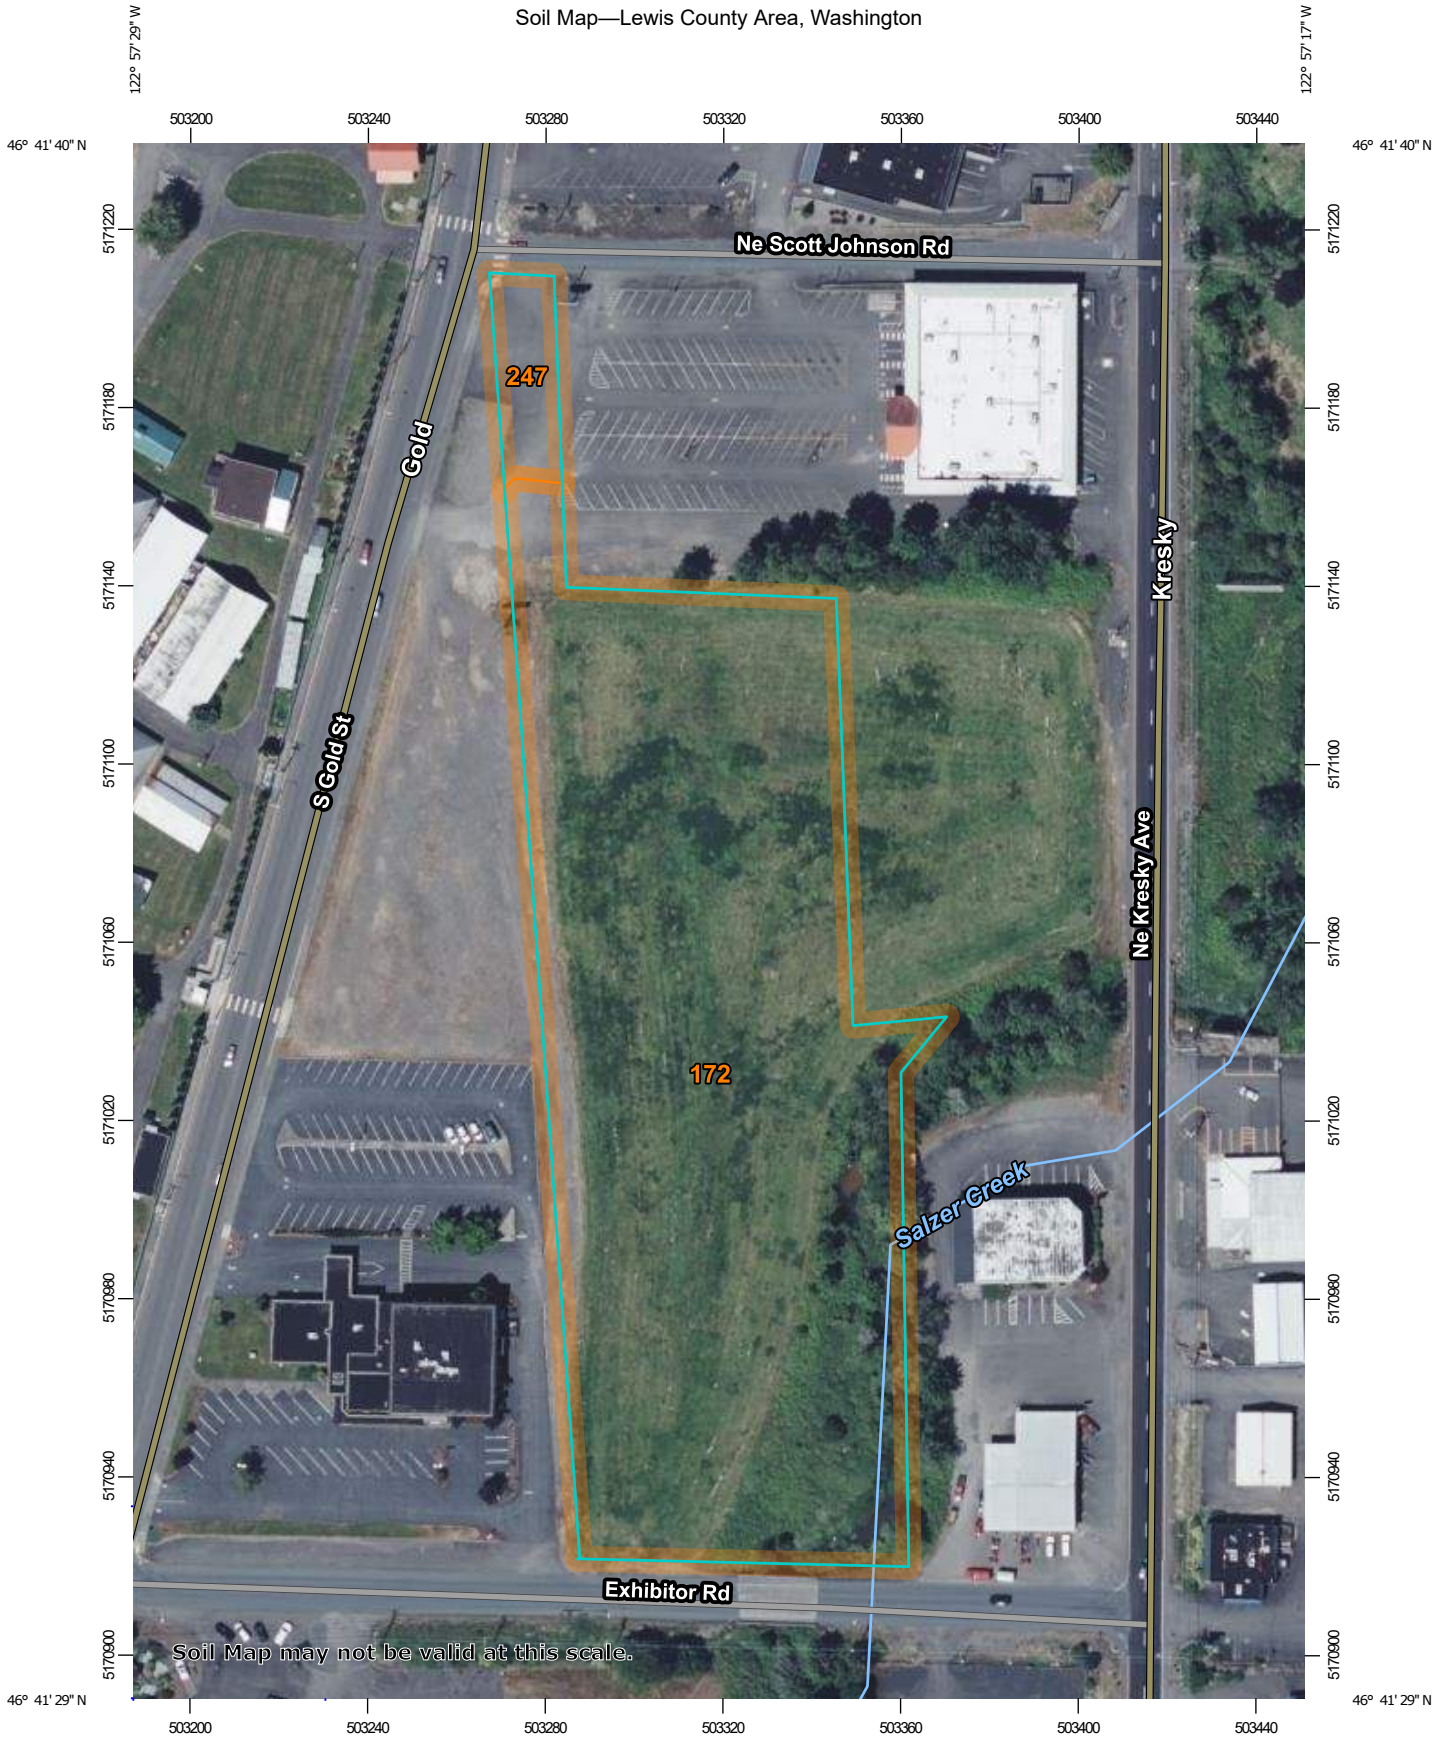
Soil Map—Lewis County Area, Washington

Map Unit Symbol	Map Unit Name	Acres in AOI	Percent of AOI
172	Reed silty clay loam	4.1	96.3%
247	Xerorthents, spoils	0.2	3.7%
Totals for Area of Interest		4.3	100.0%

According to the online USDA Web Soil Survey tool, soils in the area are reed silty clay loam (172). In the Geotechnical report it is recommended that for in-ground infiltration galleries, a maximum design infiltration rate of 13.9 in/hr to be used.

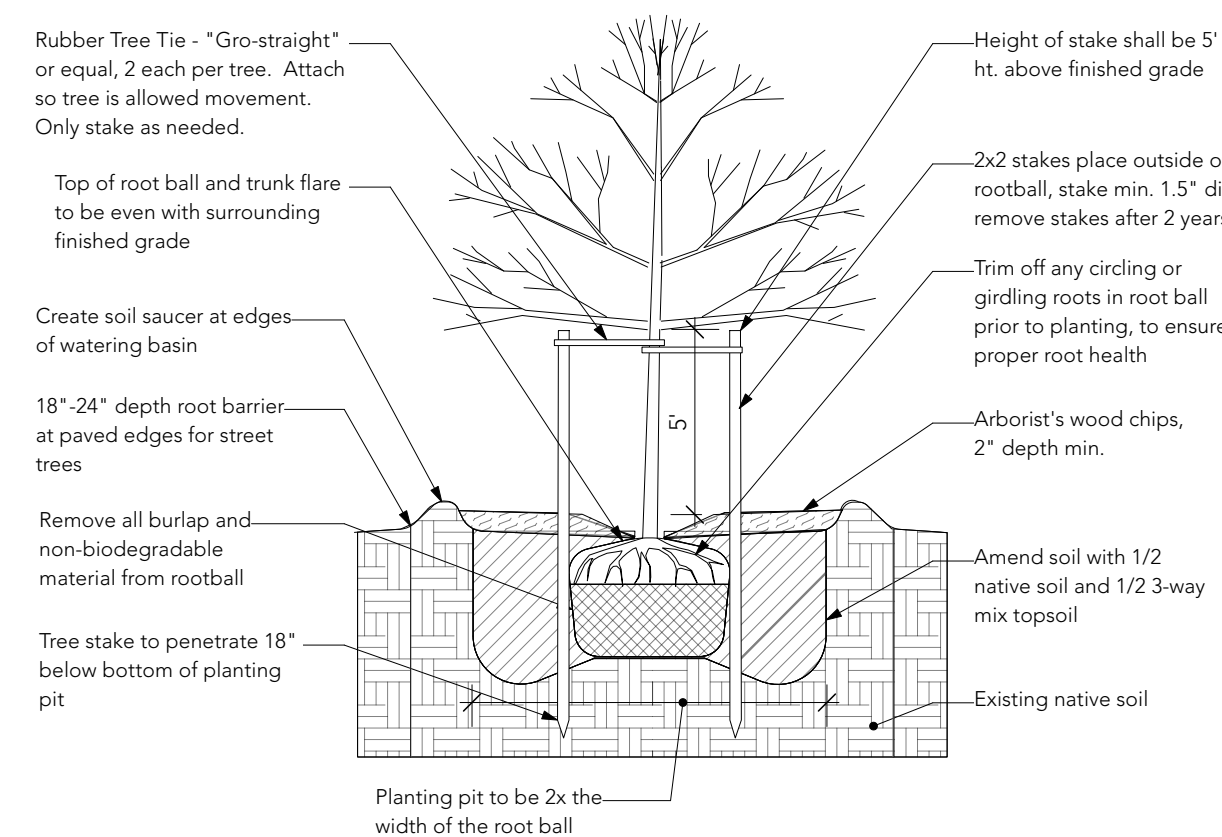
Tree Planting Detail
NTS

Notes:
1) Contractor to ensure roots are not kinked, circling, or girdling the trunk, prior to installation.
2) If roots are found to be defective, contractor to correct or replace plant material prior to installation.
