# FIRE DEPARTMENT BUILDING UPDATE

FEBRUARY 11, 2019

# BUILDING “STRUCTURAL SYSTEMS” UPDATE

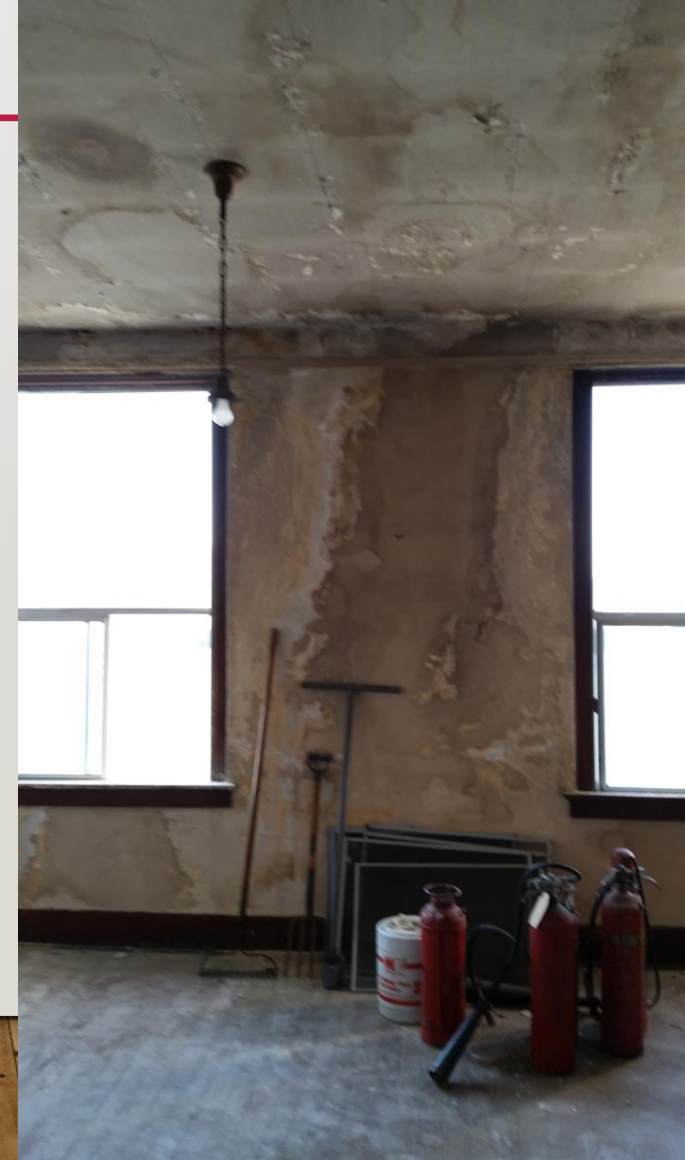
- In late March, 2017, the City obtained the services of James Ashley-Cole, P.E. to provide a limited visual observation of the structure at the fire station building due to:
  - Past problems with the roof
  - Event where lighting fixture had fallen from the ceiling in an office
