McCallum Rock Site Design

Chehalis, WA

Final Drainage and Erosion Control Report

Fuller Designs Project No. 2076

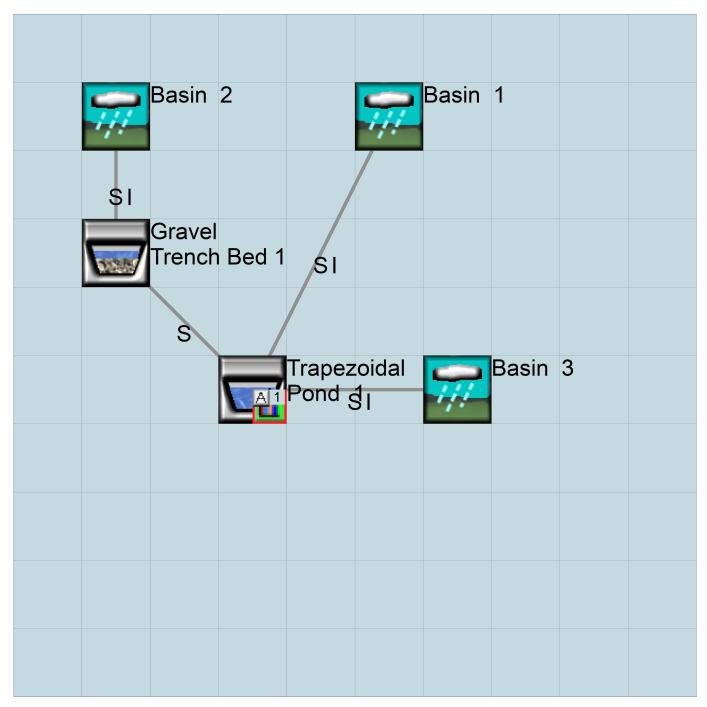
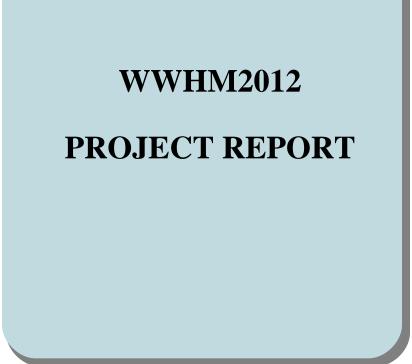
Mitigated Schematic

ALTERNATE MODEL EXCLUDES RUNOFF AREAS AND IT IS ONLY USED TO SIZE WETPOOL VOLUME AREAS

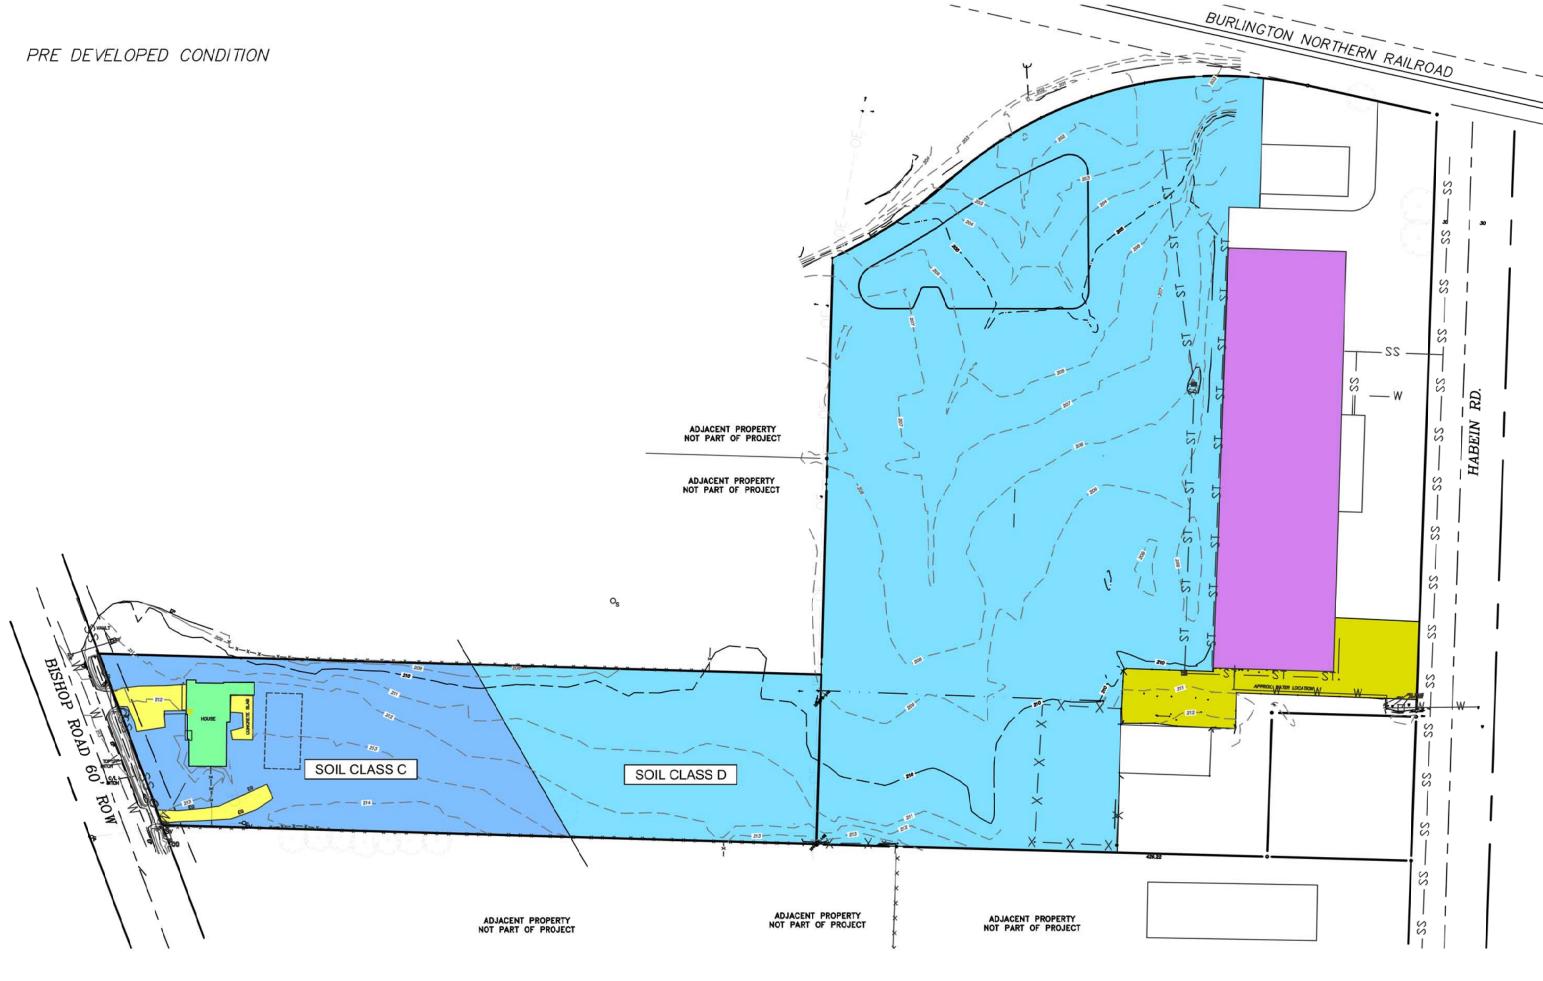
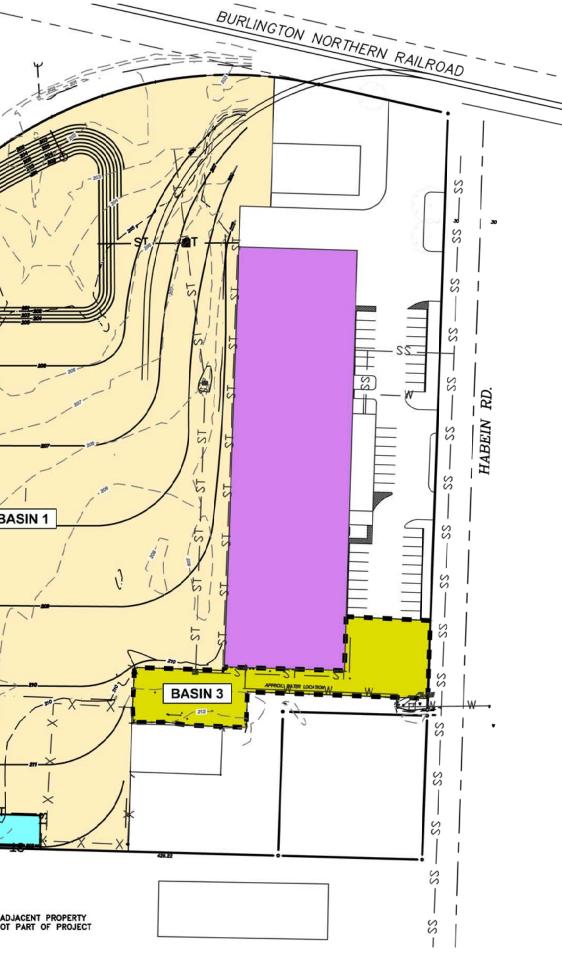
POST DEVELOPED CONDITION

PRE DEVELOPED CONDITION

BASIN 1	
ROOFS, SOIL D	= 0.800 AC
GRAVEL/DRIVEWAY, SOIL D	= 4.182 AC
PARKING, SOIL D	= 0.060 AC
TOTAL AREA BASIN 1	= 5.042 AC
BASIN 2	
ROOFS, SOIL C	= 0.223 AC
PARKING, SOIL C	= 0.138 AC
GRAVEL/DRIVEWAY, SOIL C	= 0.694 AC
ROOFS, SOIL D	= 0.067 AC
GRAVEL/DRIVEWAY, SOIL D	= 0.738 AC
TOTAL AREA BASIN 2	= 1.860 AC
BASIN 3	
DRIVEWAY, SOIL D	= 0.245 AC
TOTAL AREA BASIN 3	= 0.245 AC
TOTAL AREA BASIN 1+2+3	= 7.147 AC

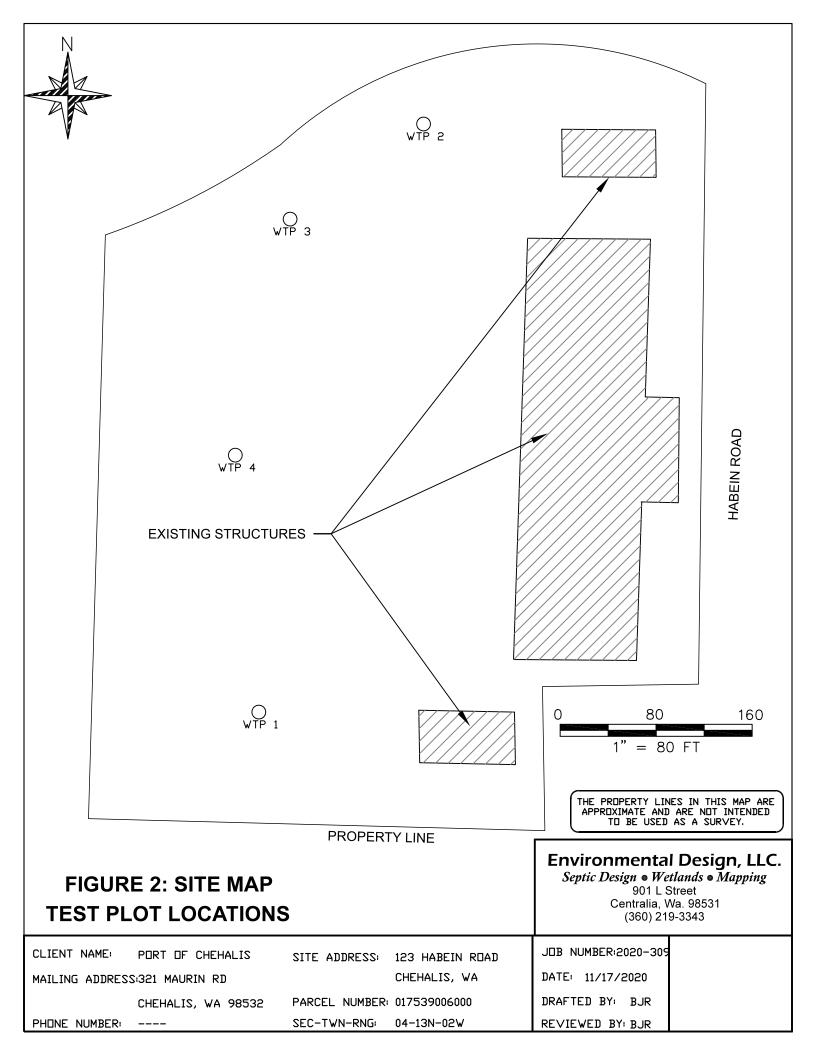
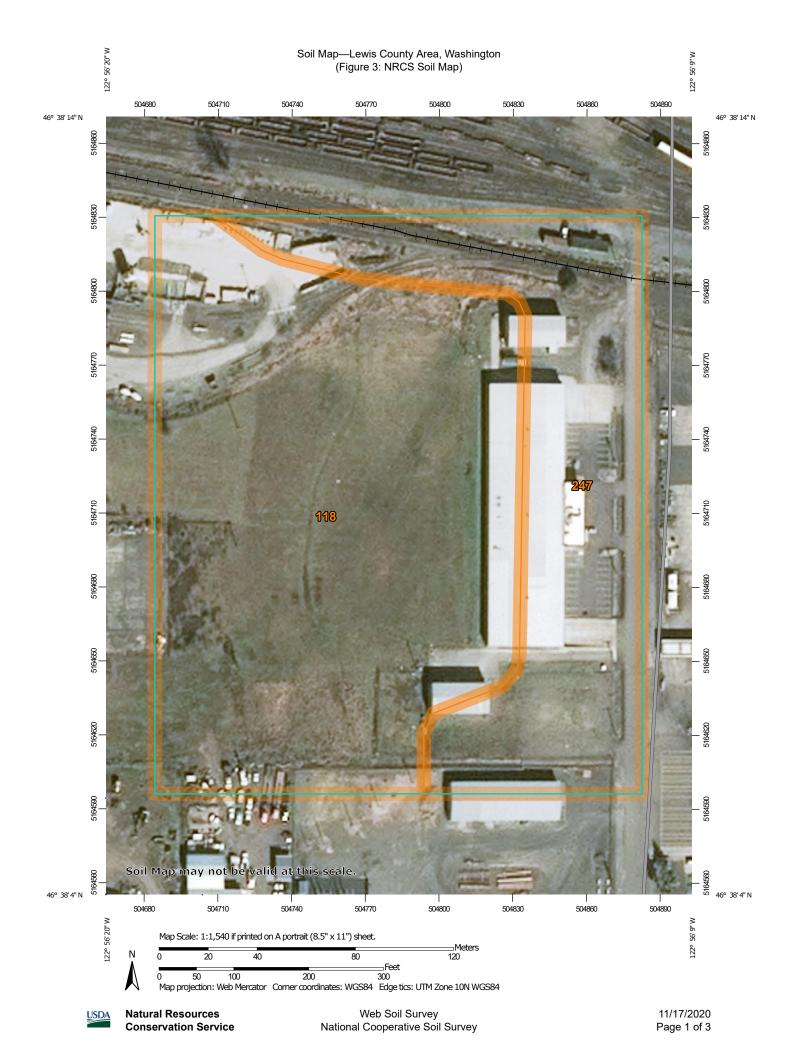
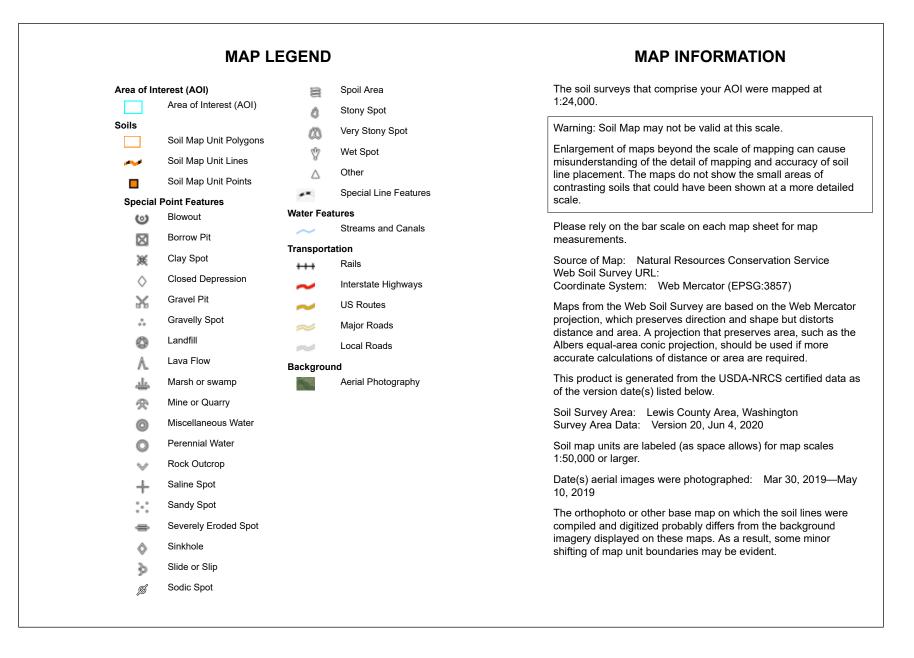
Map Unit Legend

Map Unit Symbol	Map Unit Name	Acres in AOI	Percent of AOI
118	Lacamas silt loam, 0 to 3 percent slopes	7.6	65.9%
247	Xerorthents, spoils	3.9	34.1%
Totals for Area of Interest		11.5	100.0%
