Jackson Villa Expansion 4

Chehalis, WA

Preliminary Drainage and Erosion Control Report

Fuller Designs Project No. 2084

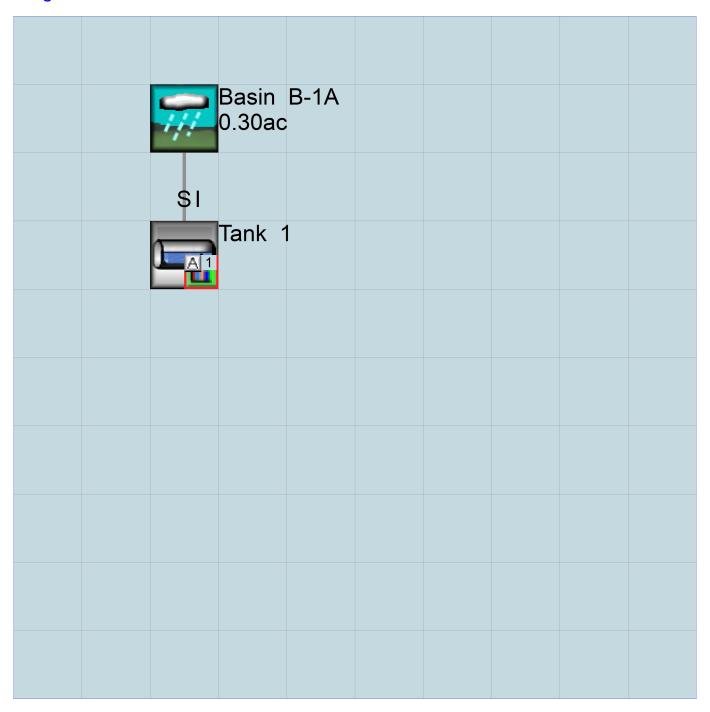
Basin B-1A 0.30ac

Mitigated Schematic

Mitigated Routing facility depth Tank 1 **Dimensions** Depth: 4 ft. Tank Type: Circular Diameter: 4 ft. Length: 57 ft. Infiltration On Infiltration rate: Infiltration safety factor: Total Volume Infiltrated (ac-ft.): 7.386 Total Volume Through Riser (ac-ft.): 0.616 Total Volume Through Facility (ac-ft.): 8.002 Percent Infiltrated: 92.3 Total Precip Applied to Facility: 0 Total Evap From Facility: 0 orifice dimensions Discharge Structure Riser Height: 3.9 ft. Riser Diameter: 24 in. Orifice 1 Diameter: 0.125 in. Elevation:0 ft. Orifice 2 Diameter: 0.5 in. Elevation: 2.668 ft.

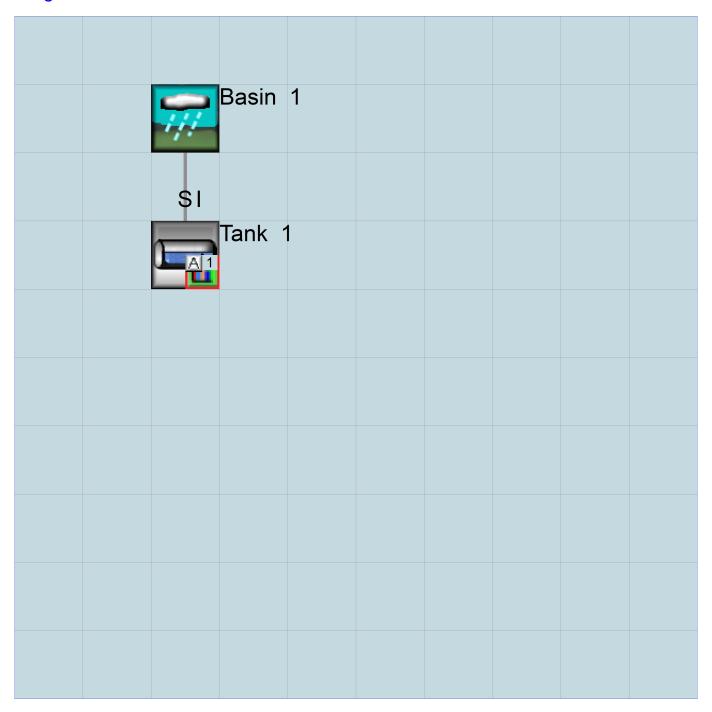
7,1	Basin 0.05ac	B-1B

Mitigated Schematic

Mitigated Routing facility depth Tank 1 **Dimensions** Depth: 4 ft. Tank Type: Circular Diameter: 4 ft. Length: 128 ft. Infiltration On Infiltration rate: Infiltration safety factor: Total Volume Infiltrated (ac-ft.): 17.969 Total Volume Through Riser (ac-ft.): 6.016 Total Volume Through Facility (ac-ft.): 23.984 Percent Infiltrated: 74.92 Total Precip Applied to Facility: 0 Total Evap From Facility: 0 orifice dimensions Discharge Structure Riser Height: 3.9 ft. Riser Diameter: 24 in. Orifice 1 Diameter: 0.375 in. Elevation:0 ft. Orifice 2 Diameter: 0.5 in. Elevation: 2.668 ft. 0.3125 in Elevation: 2.97416666666667 ft. Orifice 3 Diameter: Element Flows To: Outlet 1 Outlet 2

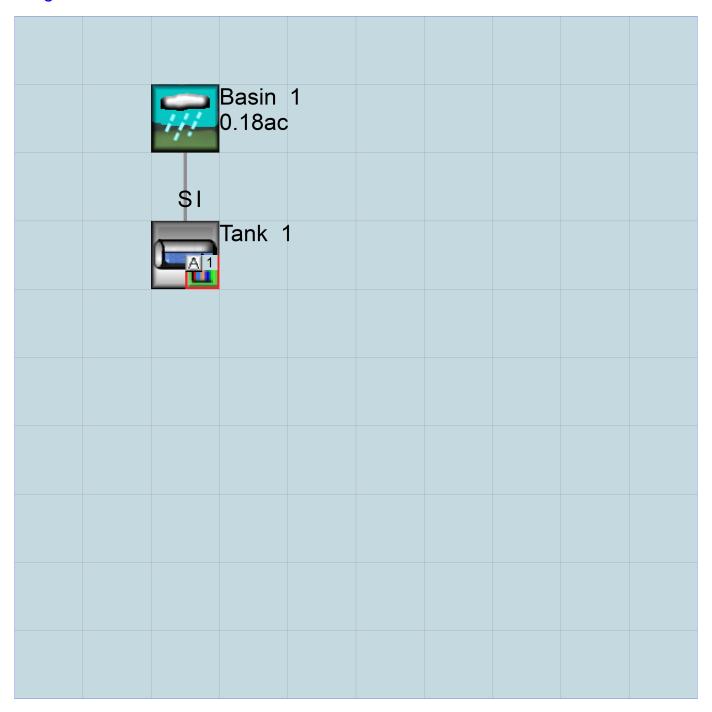
Basin 1 0.18ac

Mitigated Schematic

Total Volume Infiltrated (ac-ft.): 25.31
Total Volume Through Riser (ac-ft.): 9.593
Total Volume Through Facility (ac-ft.): 34.903
Percent Infiltrated: 72.52
Total Precip Applied to Facility: 0

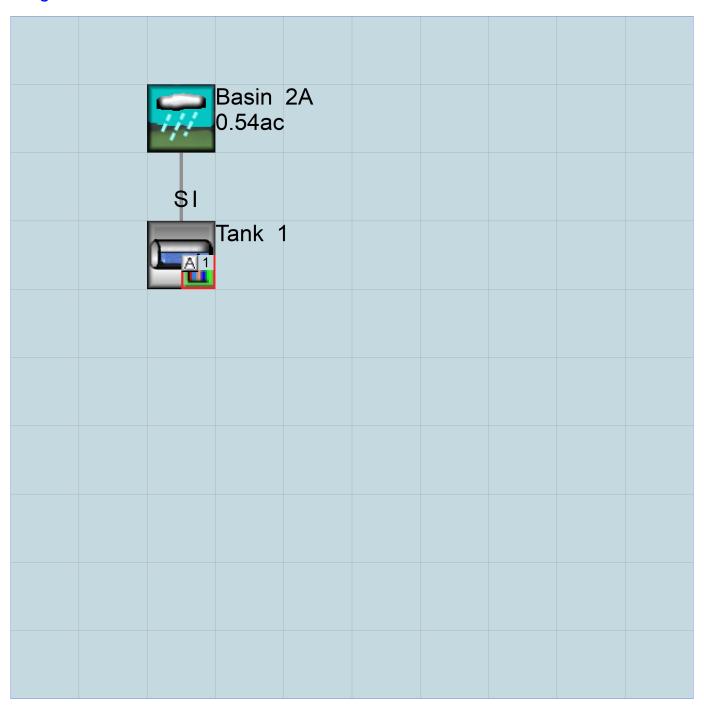
Basin 2A 0.54ac

Mitigated Schematic

facility depth Tank 1 **Dimensions** Depth: 4 ft. Tank Type: Circular Diameter: 4 ft. Length: 360 ft. Infiltration On Infiltration rate: 1 Infiltration safety factor: Total Volume Infiltrated (ac-ft.): 48.562 Total Volume Through Riser (ac-ft.): 19.396 Total Volume Through Facility (ac-ft.): 67.958 Percent Infiltrated: 71.46 Total Precip Applied to Facility: 0 Total Evap From Facility: 0 orifice dimensions Discharge Structure Riser Height: 3.9 ft. Riser Diameter: 24 in. Orifice 1 Diameter: 0.6875 inElevation:0 ft. Orifice 2 Diameter: 0.75 in. Elevation: 2.388 ft. Orifice 3 Diameter: Elevation: 3.26291666666669 ft. 0.5 in. Element Flows To: Outlet 1 Outlet 2

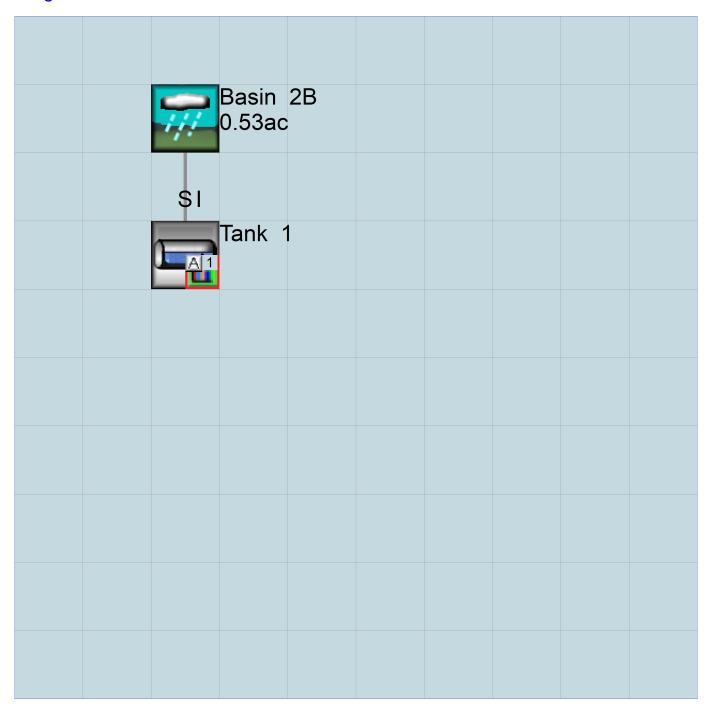
Rasin 2R		
Basin 2B 0.53ac

Mitigated Schematic

Total Volume Infiltrated (ac-ft.): 54.787
Total Volume Through Riser (ac-ft.): 4.688
Total Volume Through Facility (ac-ft.): 59.475
Percent Infiltrated: 92.12
Total Precip Applied to Facility: 0
Total Evap From Facility: 0

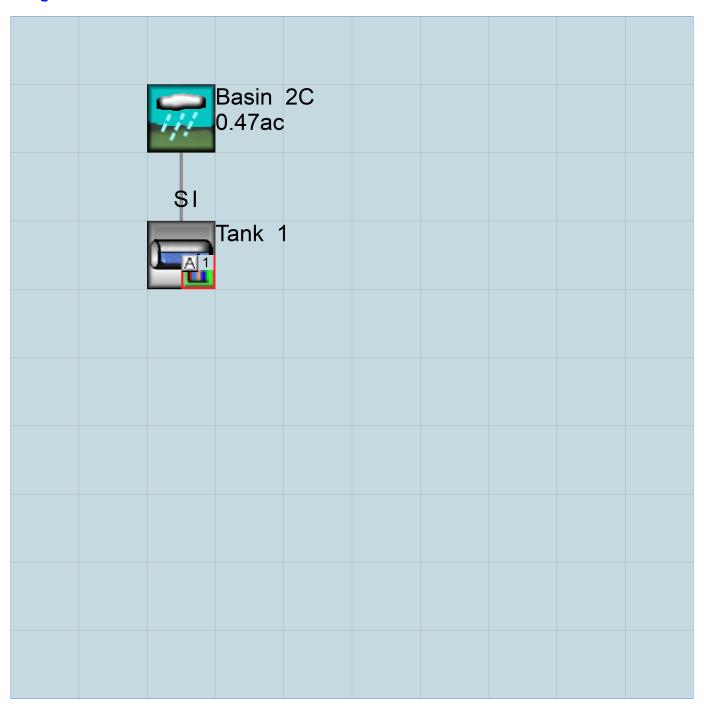
7	Basin 0.47ac	2C

Mitigated Schematic

Facility Depth Tank 1 **Dimensions** Depth: 4 ft. Tank Type: Circular Diameter: 4 ft. Length: 113 ft. Infiltration On Infiltration rate: Infiltration safety factor: Total Volume Infiltrated (ac-ft.): 15.391 Total Volume Through Riser (ac-ft.): 5.825 Total Volume Through Facility (ac-ft.): 21.216 Percent Infiltrated: 72.54 Total Precip Applied to Facility: 0 Total Evap From Facility: 0 orifice dimensions Discharge Structure Riser Height: 3.9 ft. Riser Diameter: 24 in. Orifice 1 Diameter: 0.375 in. Elevation:0 ft. Orifice 2 Diameter: 0.5 in. Elevation: 2.668 ft. 0.3125 in Elevation: 3.55875000000003 ft. Orifice 3 Diameter: Element Flows To: Outlet 1 Outlet 2

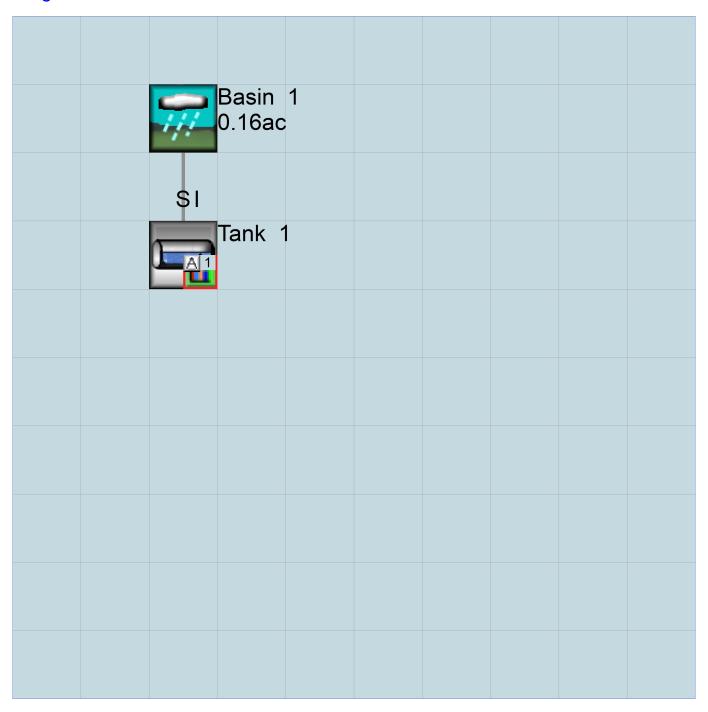
Basin 2D 0.16ac

Mitigated Schematic

Trapezoidal Pond	1		
Bottom Length:	31.30 ft.	facility	depth including
Bottom Width:	31.30 ft.	1' of fr	eeboard
Depth:	51.50 lt.		
Volume at riser head:		ot /	facility and is a
Infiltration On	0.1407 acre-lee	51.	_ facility active
Infiltration rate:	1		volume require
Infiltration safety factor	or· 1		
Wetted surface area (
Total Volume Infiltrate		81.559	
Total Volume Through		23.353	
Total Volume Through		104.912	
Percent Infiltrated:	i i aciity (ac-it.).	77.74	
Total Precip Applied to	o Facility:	0	
Total Evap From Faci		0	
Side slope 1:	2 To 1	O	
Side slope 1:	2 To 1		
Side slope 3:	2 To 1		
Side slope 4:	2 To 1	riser height	t required
Discharge Structure	2101		•
Riser Height:	4 ft.		orifice dimension
Riser Diameter:	18 in.		\(\lambda \)
Orifice 1 Diameter:		tion:0 ft.	V _
Orifice 2 Diameter:		tion:2.598 ft.	
Orifice 3 Diameter:		tion:3.4545833333333	36 ft
Element Flows To:	U.7 III. Eleva	1011.0.4040000000000	50 It.
