Subject: Geotechnical Services Report
Hick RV Park- Geotechnical Investigation
TPN 005605080007, 0 Exhibitor Rd, Chehalis, WA
Project Number: QG21-104

SOILS REPORT

HICK RV PARK
TPN 005605080007, 0 EXHIBITOR RD
CHEHALIS, WA

QG Project # QG21-104

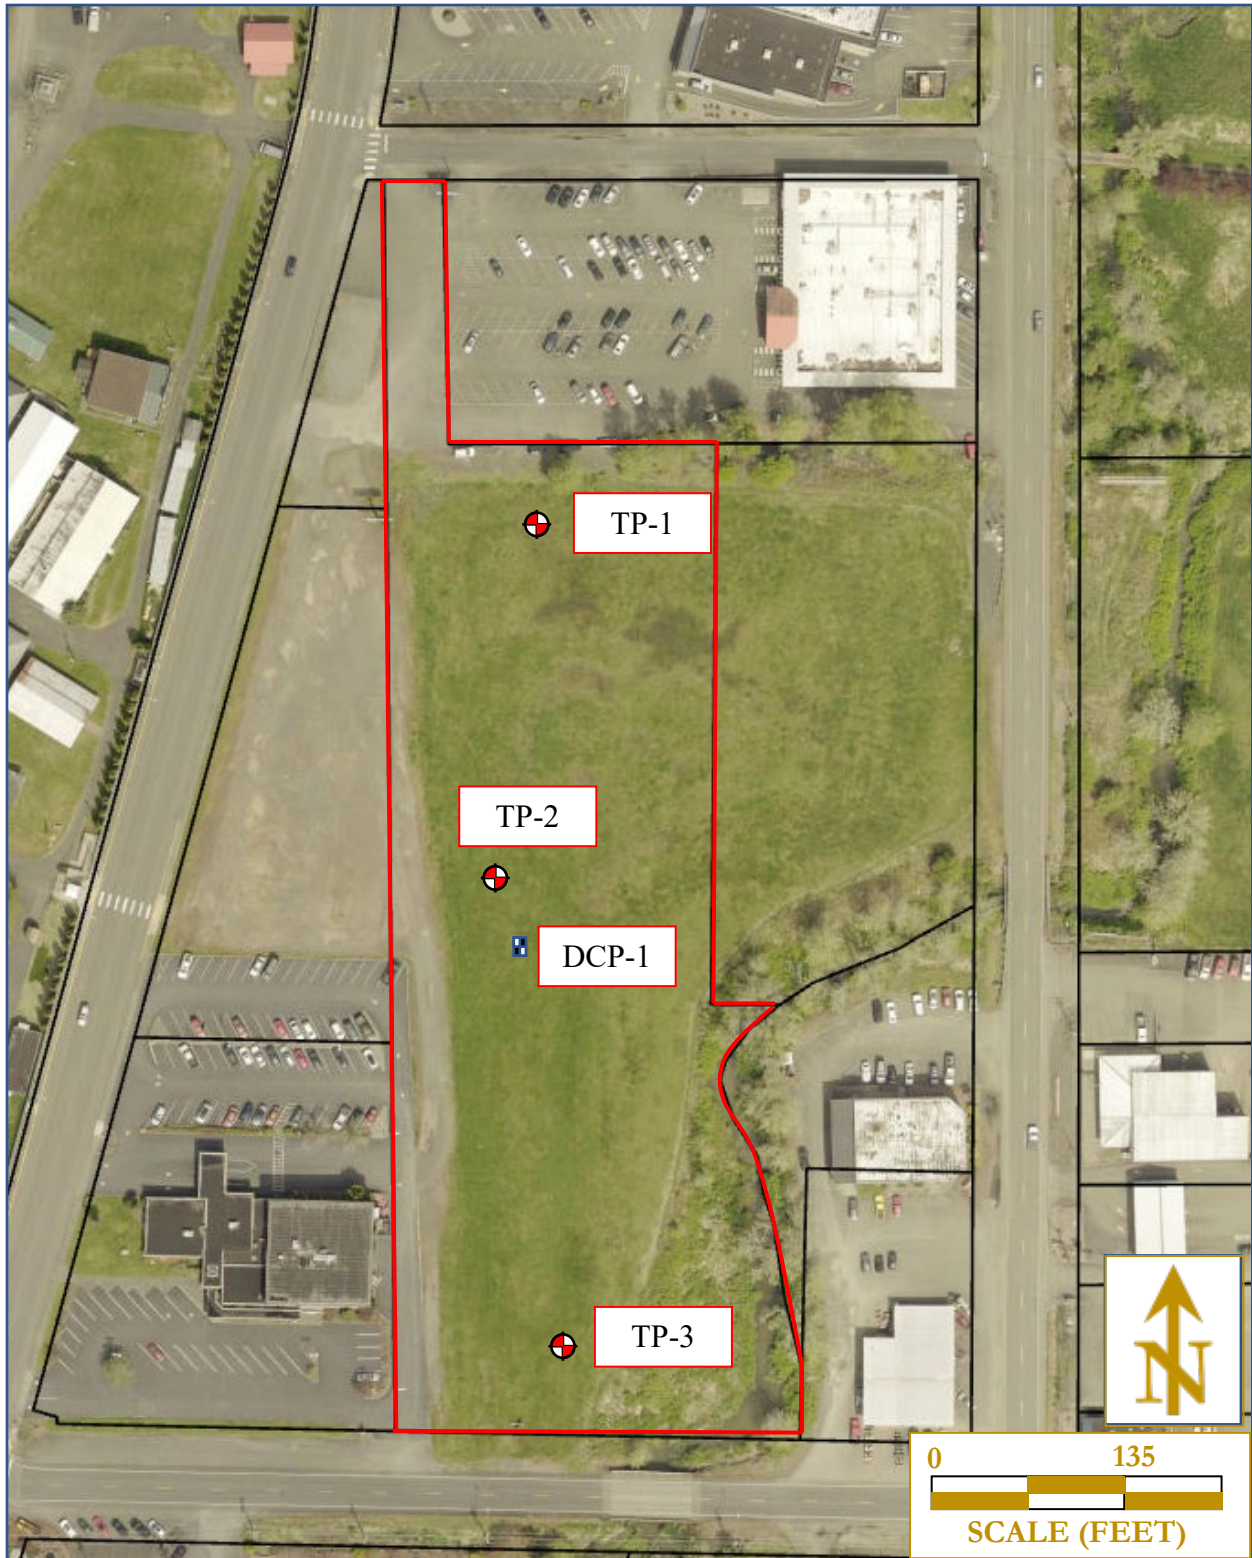
Appendix B. Exploration Map

Site Map
Hick RV Park

Site soil conditions were generally identical across the property in all 3 test pits. Representative lab samples were taken from TP-1. Soil conditions on site were as follows:

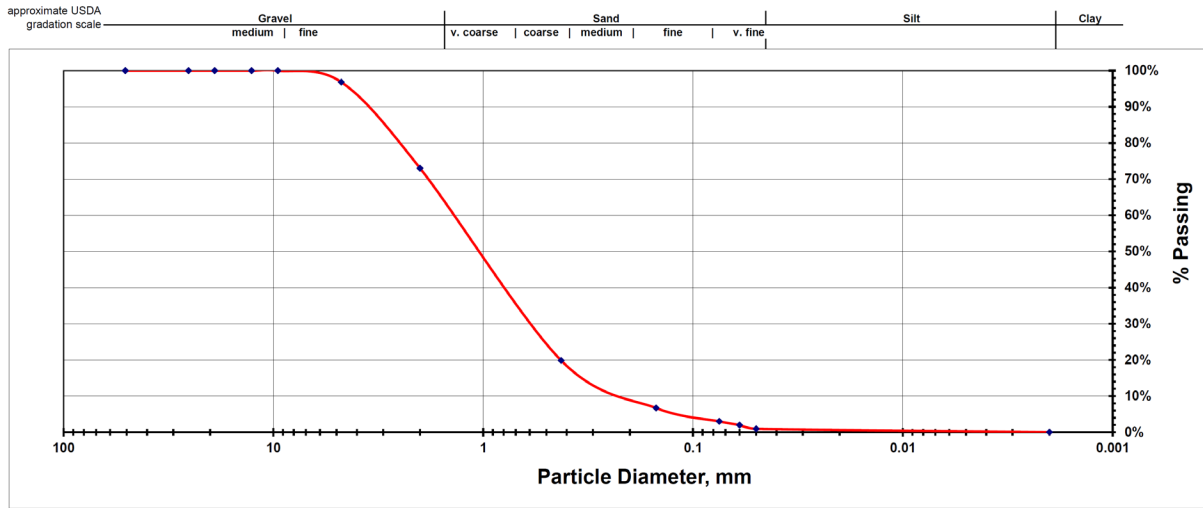
SAMPLE ID: TP-1 at 7'

description sieve # diameter, mm	CoCr	CoGr	MedGr	MedGr	MedGr	FIgr	vCoS	MedS	FIS	vFIS	(% of Whole Sample Passing last Sieve)			Sand Total	Gravel Total
	2"	1"	3/4"	1/2"	3/8"	4	10	40	100	200	Hydrometer Method				
	50.8	25.4	19.05	12.70	9.53	4.75	2.00	0.425	0.150	0.075	0.060	0.050	0.002		
Retained	0.0%	0.0%	0.0%	0.0%	0.0%	3.2%	23.8%	53.2%	13.2%	3.7%	1.0%	1.0%	1.0%	94.8%	3.2%
Passing	100%	100%	100%	100.0%	100.0%	96.8%	73.0%	19.8%	6.7%	3.0%

Graph Values	D ₅₀	3.3	Coefficient of Uniformity: 11.5	Coefficient of Gradation: 82.05	% of Sample < 2mm			USDA TEXTURAL CLASSIFICATION of FRACTION PASSING 2mm SEIVE	CLAY LOAM
	D ₆₀	1.5			Sand	Silt	Clay		
	D ₃₀	4.00			34%	34%	32%		
	D ₁₀	0.13

TP #	Sample Depth (BPG)	Unit Extent (ft)	Soil Type	D10	D60	D90	Fines (%)	Ksat (in/hr)	Correct ed Ksat (in/hr)	LT Design Infiltration Rate(in/hr)	Cation Exchange Capacity (meq/100g)	Organic Content %
1	2.0	1' to 5'	SP	0.34	1.8	5.3	0.8	147.55	36.8	20.0	21.9	1.8
1	7.0	5' to 10'+	SW	0.13	1.5	3.3	3.0	55.68	13.92	13.92	19.1	3.0
